2010 FACILITIES ASSESSMENT
 BOOKER T. WASHINGTON HIGH

Project Data	
Location Code:	148
Address:	715 Lauderdale
Year Built:	1949
Grade Configuration:	9-12
Student Capacity:	650
Ideal Capacity:	803
ADA Student Enrollment:	0
Size:	10.37 acres
Portables:	0
Building & additions	202,918 s. f.

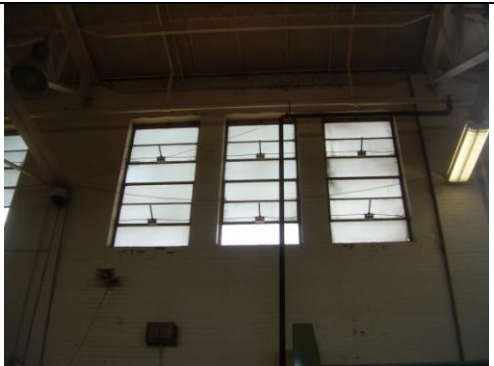
<p>Description:</p> <p>Replace approximately (90) windows in gym and annex building</p>

<p>Timeline:</p> <p>2010-11</p>	<p>Cost:</p> <p>\$229,500</p>

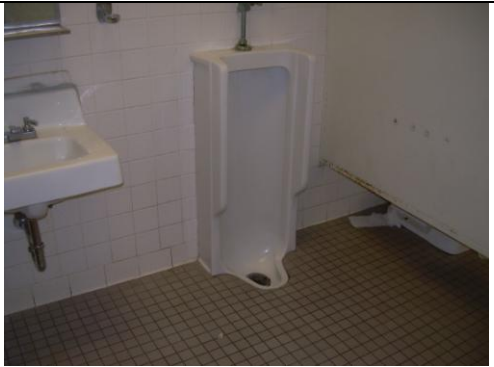
<p>Description:</p> <p>Upgrade to ADA guidelines</p>

<p>Timeline:</p> <p>TBD</p>	<p>Cost:</p> <p>\$14,000</p>

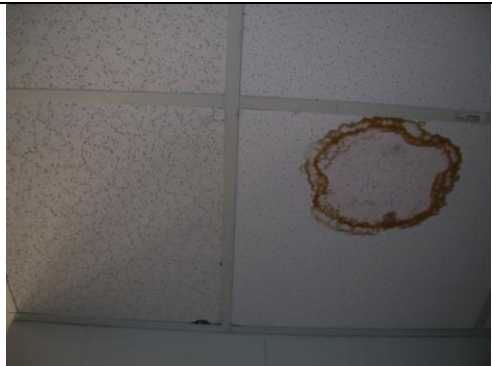
<p>Description:</p> <p>Lay-in ceiling tile in poor condition, mold forms and causes potential health concerns</p>

<p>Timeline:</p> <p>TBD</p>	<p>Cost:</p> <p>\$6,000</p>

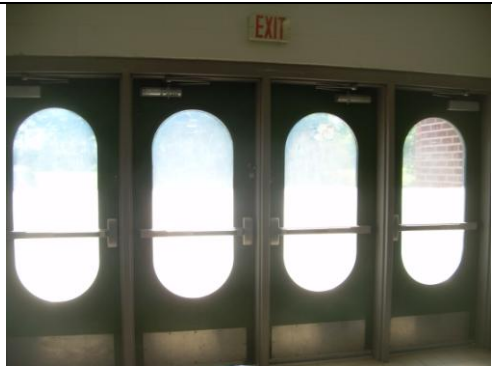
<p>Description:</p> <p>Store Front doors and windows in gym are in poor condition</p>

<p>Timeline:</p> <p>TBD</p>	<p>Cost:</p> <p>\$22,000</p>

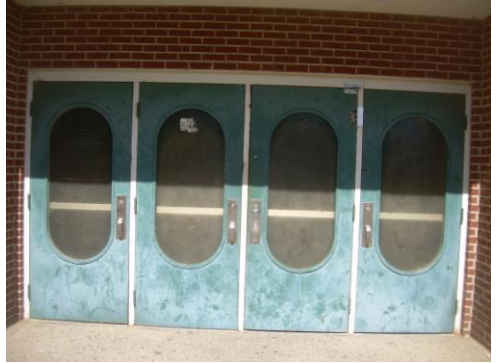
<p>Description:</p> <p>See previous item</p>

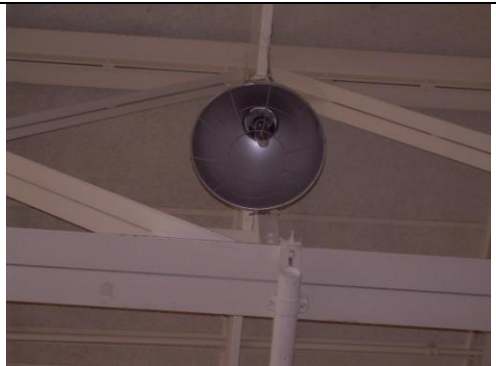
<p>Description:</p> <p>Gym lighting is inadequate.</p>

<p>Timeline:</p> <p>TBD</p>	<p>Cost:</p> <p>\$60,000</p>

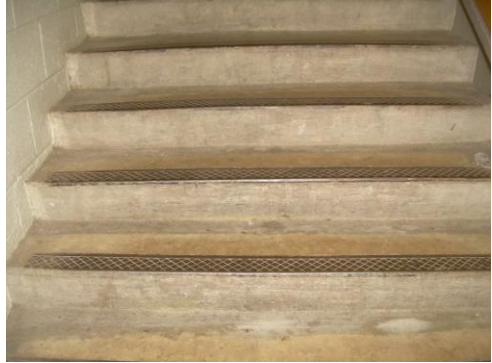
<p>Description:</p> <p>Stairwell treads have lost their integrity</p>

<p>Timeline:</p> <p>TBD</p>	<p>Cost:</p> <p>\$24,000</p>

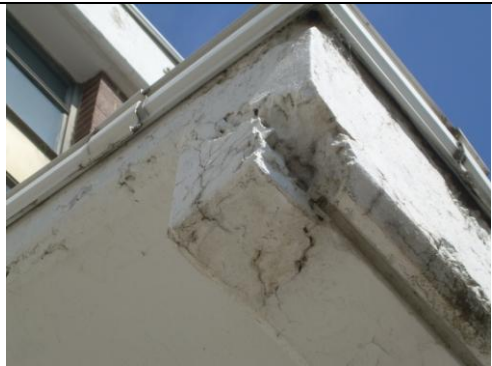
<p>Description:</p> <p>Awnings are damaged in annex.</p>

<p>Timeline:</p> <p>TBD</p>	<p>Cost:</p> <p>\$18,000</p>

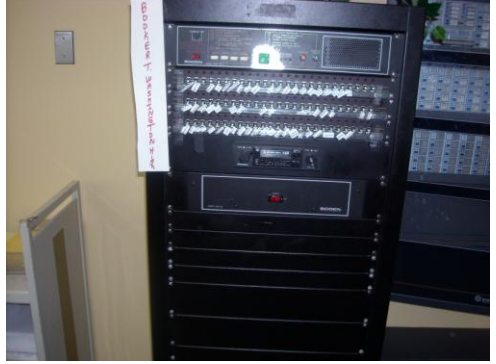
<p>Description:</p> <p>Washington Sr.</p> <p>Bogen MCP35A</p> <p>Installation Date: 1997</p>

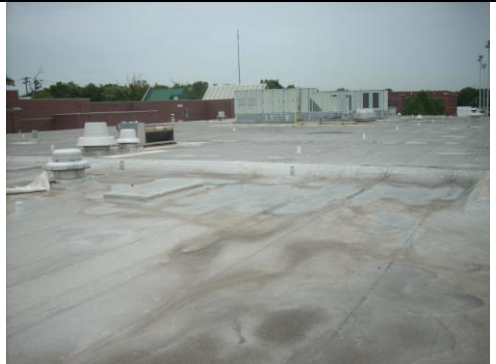
<p>Timeline:</p> <p>2014-15</p>	<p>Cost:</p> <p>\$90,000</p>
<p>Description:</p> <p>PVC Single ply roof: 12 years-poor</p> <p>Built up modified roof: 15 years-poor</p> <p>Metal roof 15 years-fair</p> <p>Plex-i- glass roof: 15 years-fair</p>

<p>Timeline:</p> <p>TBD</p>	<p>Cost:</p> <p>\$659,000</p>
