2010 FACILITIES ASSESSMENT CALDWELL ELEMENTARY

Project Data

Location Code:	006
Address:	230 Henry Street 38107
Year Built:	1918
Grade Configuration:	K-5
Student Capacity:	1340
Ideal Capacity:	937
ADA Student Enrollment:	0
Size:	N/A
Campus:	7.54 acres
Portables:	0
Building & Addition	104,656 s. f.

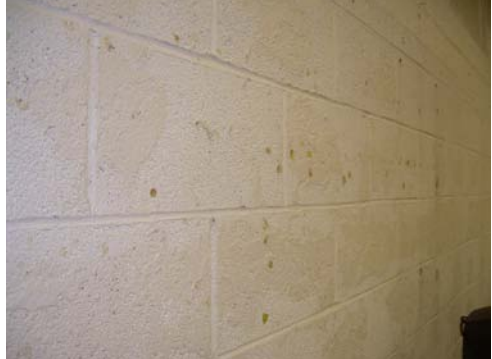
Description: Paint interior of bldg.

Timeline: 2010-11	Cost: \$176,400

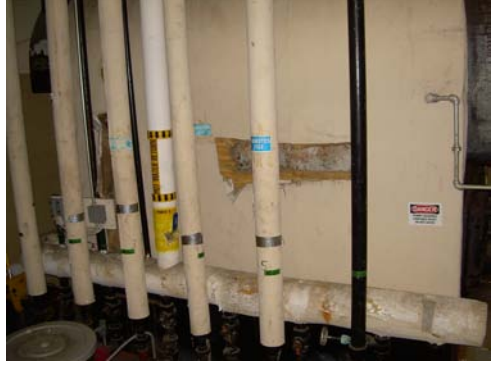
<p>Description:</p> <p>Asbestos insulation in boiler room in poor condition.</p>

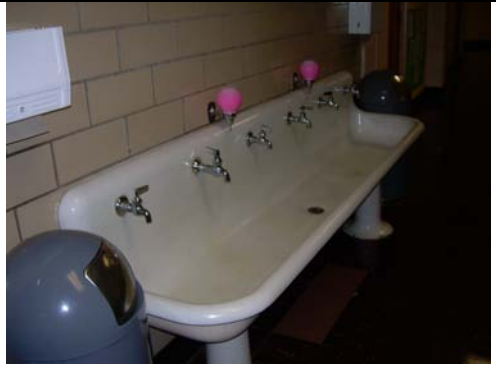
<p>Timeline:</p> <p>TBD</p>	<p>Cost:</p> <p>\$15,000</p>
<p>Description:</p> <p>School has trough sinks that are antiquated and do not meet ADA requirements.</p>

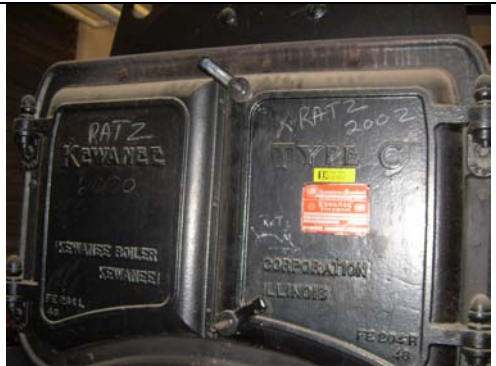
<p>Timeline:</p> <p>TBD</p>	<p>Cost:</p> <p>\$56,000</p>
<p>Description:</p> <p>Boilers are old, but appear to be in good working condition.</p>

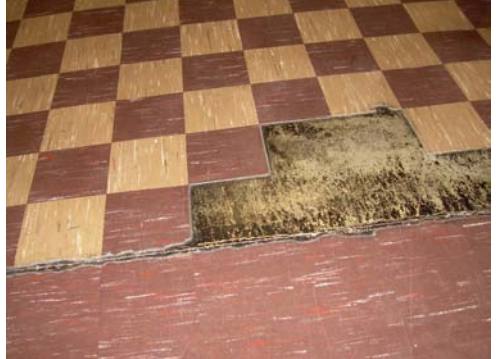
<p>Description:</p> <p>Existing floor tile contains asbestos and is in poor condition.</p>

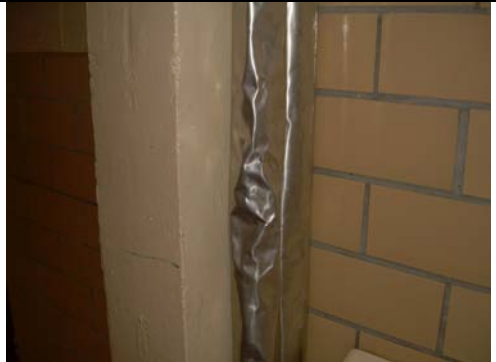
<p>Description:</p> <p>Existing pipe sleeve has suffered physical damage over time- (several locations).</p>

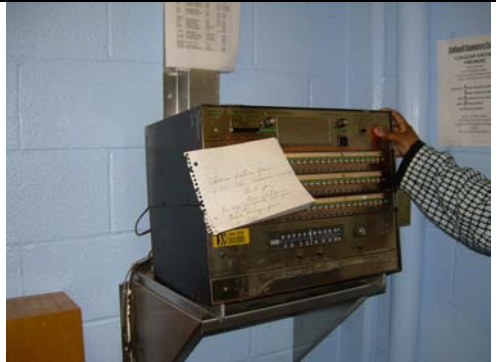
<p>Description:</p> <p>Intercom System: Rauland 350 Installation Date: 1986</p>

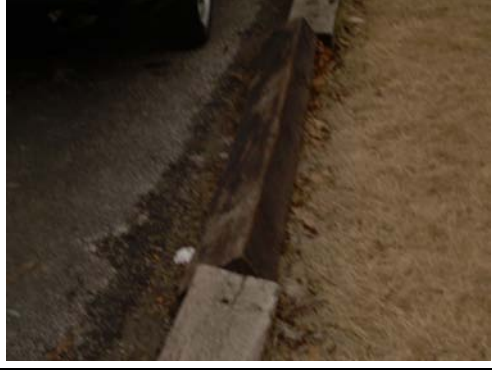
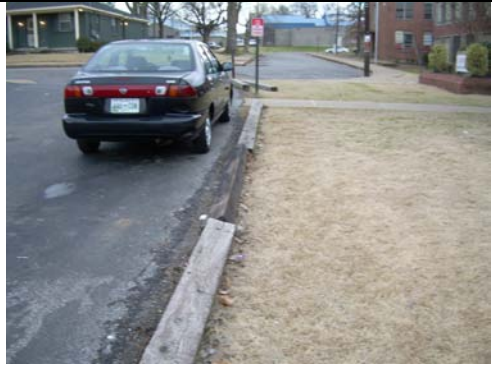
<p>Description:</p> <p>Curbing in front parking area is railroad ties.</p>

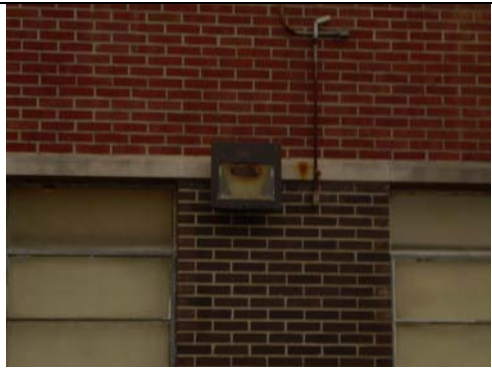
<p>Description:</p> <p>Exterior lights are broken or damaged.</p>

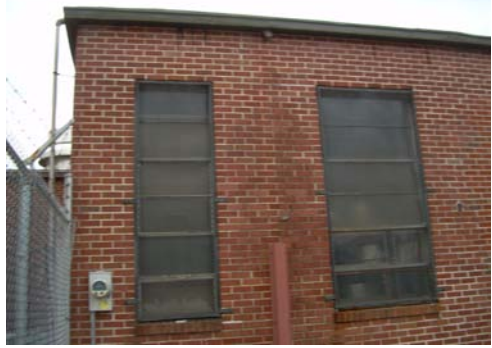
<p>Description:</p> <p>Downspouts missing and damaged in several places.</p>

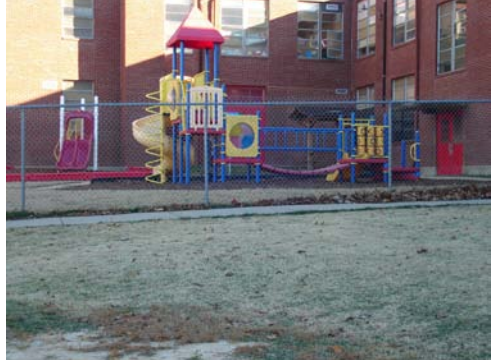
<p>Playground/Surfaces Equipment Status:</p> <p>Fully equipped; Woodchips w/ heavy plastic border surface</p>

<p>Playground Equipment / Surface Condition:</p> <p>New equipment good Surface good Fence enclosure good</p>
