2010 FACILITIES ASSESSMENT CRUMP ELEMENTARY

Location Code:	253
Address:	4405 Crump Rd
Year Built:	1978
Grade Configuration:	K-5
Student Capacity:	880/1080
Ideal Capacity:	830
ADA Student Enrollment:	5
Size:	N/A
Portables:	10
Building & Additions:	29,750 s. f.

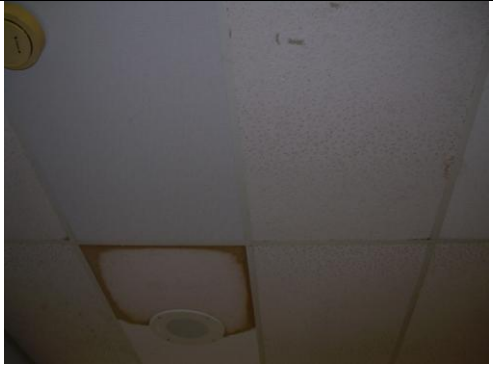
Description: Existing lay-in tile in poor condition.

Timeline: TBD	Cost: \$120,000

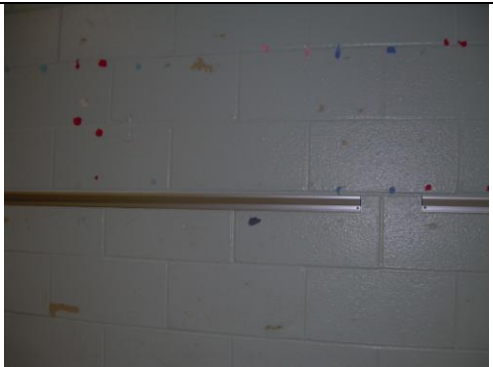
Description: Interior of school needs painting

Timeline: TBD	Cost: \$82,000

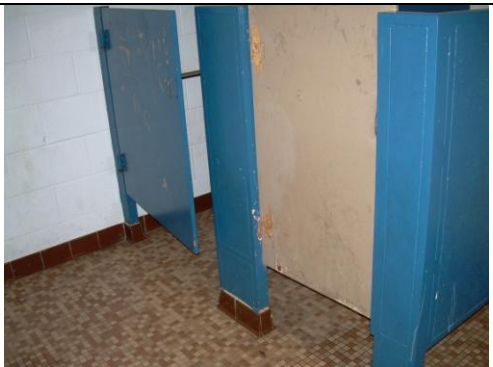
Description: Restroom stall doors through-out school in poor condition.

Timeline: TBD	Cost: \$5,000

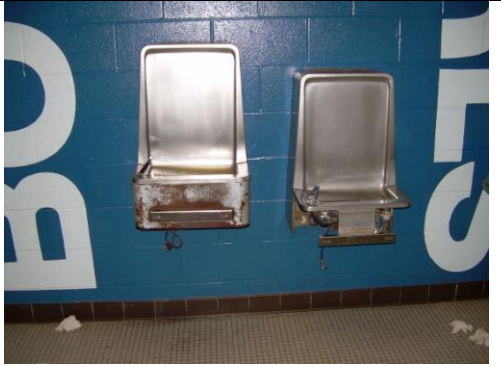
Description: Upgrade to ADA guidelines.

Timeline: TBD	Cost: \$30,000

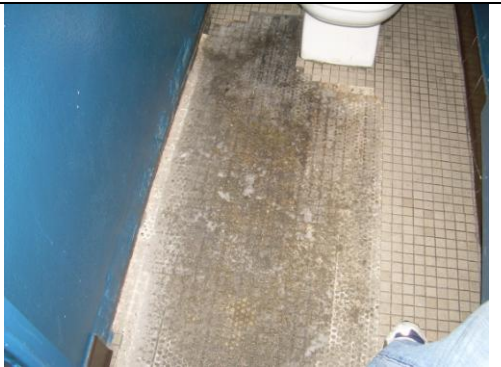
Description: Ceramic tile in restroom damaged and missing.

Timeline: TBD	Cost: \$1,200

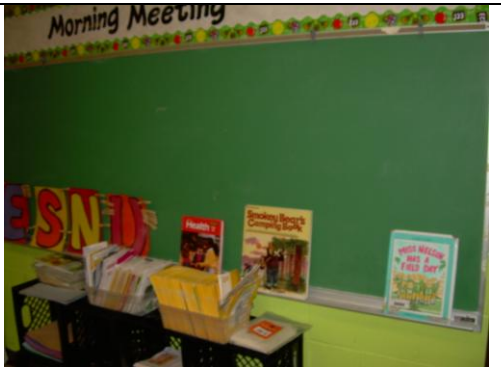
Description: Whiteboards needed in some classrooms

Timeline: TBD	Cost: \$2,000

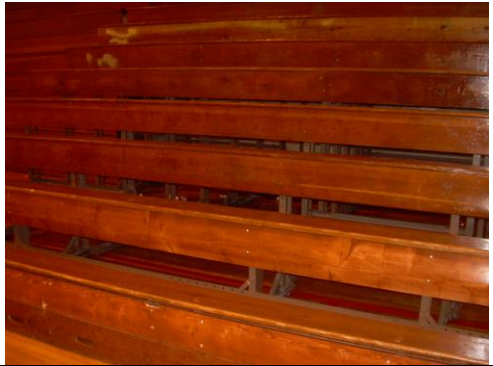
Description: Replace bleachers

Timeline: 2011-12	Cost: \$104,000

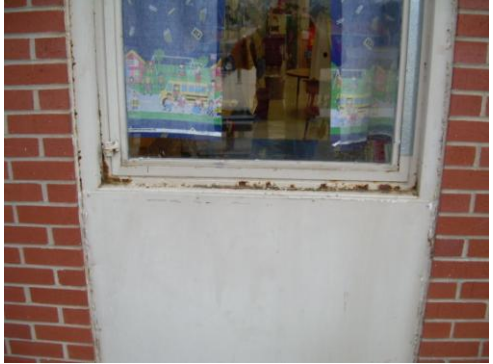
Description: Replace approximately (64) windows.

Timeline: 2013-14	Cost: \$173,000

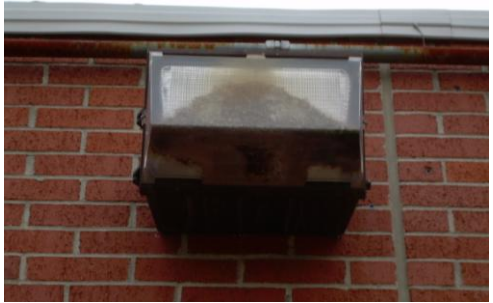
Description: Exterior wall-mounted lighting not functional.

Timeline: TBD	Cost: \$7,000

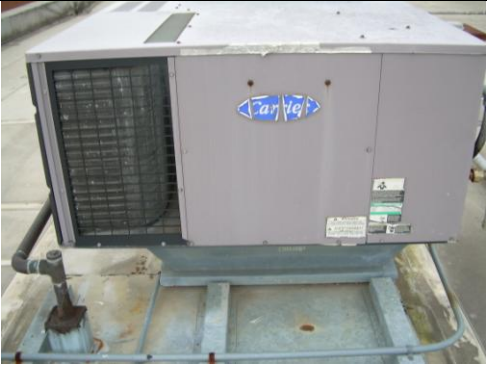
<p>Description:</p> <p>Roof top units have exceeded their life expectancy</p>

<p>Timeline:</p> <p>TBD</p>	<p>Cost:</p> <p>\$230,000</p>

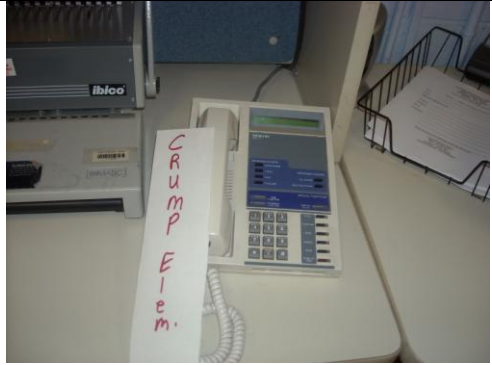
<p>Description:</p> <p>Intercom System: Telecor XL Installation Date: 1996</p>

<p>Timeline:</p> <p>TBD</p>	<p>Cost:</p> <p>\$50,000</p>
<p>Playground/Surfaces Equipment Status:</p> <p>Fully equipped Has cast in place rubber surface</p>

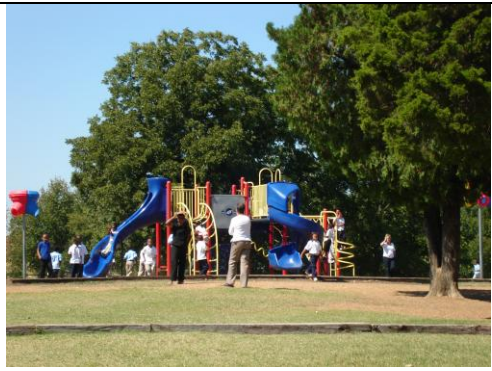
<p>Playground Equipment / Surface Condition:</p> <p>New equipment, good Good surface No fence enclosure</p>	
<p>Description:</p> <p>PVC Single ply roof: 8 years-fair</p>
