2010 FACILITIES ASSESSMENT
CYPRESS MIDDLE

Project Data	
Location Code:	121
Address:	2109 Howell Ave
Year Built:	1966
Grade Configuration:	6-8
Student Capacity:	825
Ideal Capacity:	995
ADA Student Enrollment:	18
Size:	8 acres
Portables:	0
Building & Addition	216,171 s. f.

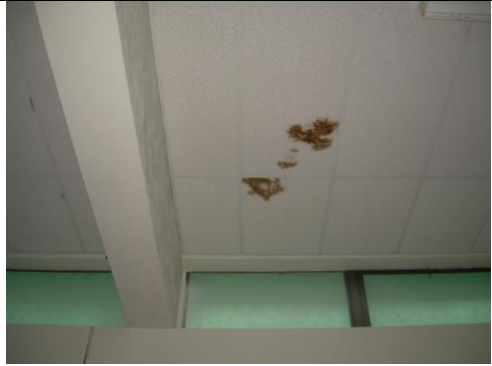
<p>Description:</p> <p>Existing lay-in tiles are of different types giving it an overall poor appearance; there are also several areas of damaged or molded tiles throughout entire facility.</p>

<p>Timeline:</p> <p>TBD</p>	<p>Cost:</p> <p>\$150,000</p>

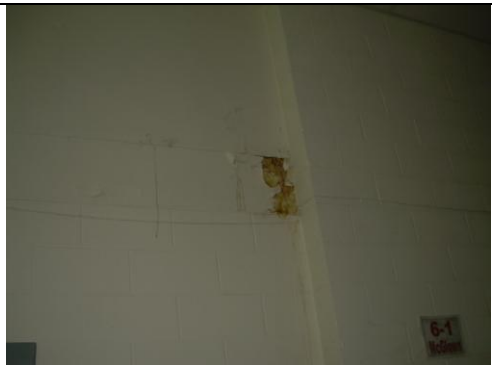
<p>Description:</p> <p>Interior of school needs painting.</p>

<p>Timeline:</p> <p>TBD</p>	<p>Cost:</p> <p>\$292,000</p>

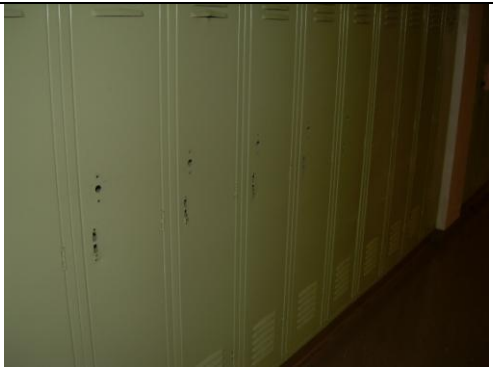
Description: Existing lockers missing hardware and do not function properly.

Timeline: TBD	Cost: \$70,000

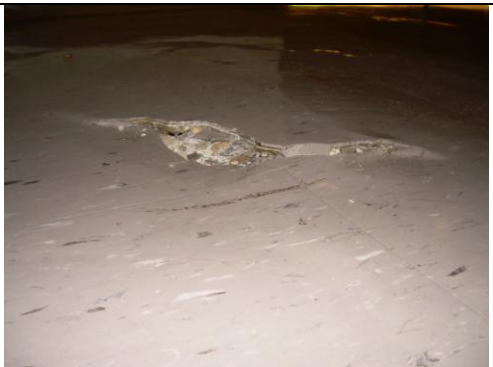
Description: Foundation concerns in auditorium foyer. Floor tile also contains asbestos.

Timeline: TBD	Cost: \$487,000

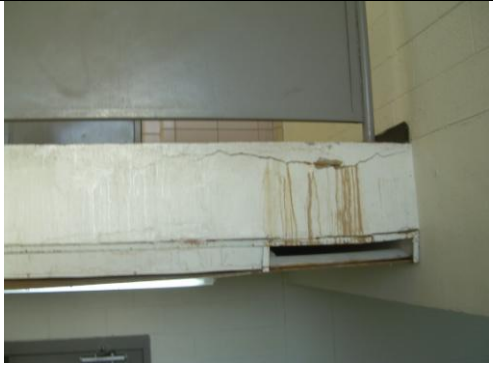
Description: Stairwell landing is cracked.

Timeline: TBD	Cost: \$2,000

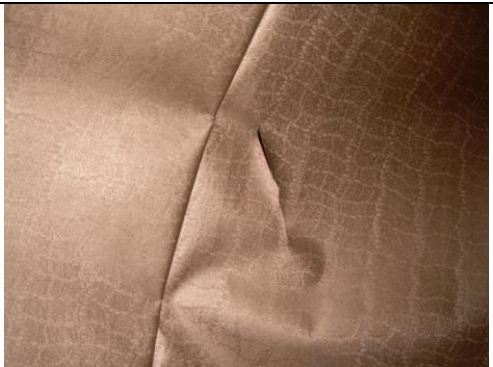
Description: Stage curtains are in poor condition.

Timeline: TBD	Cost: \$30,000

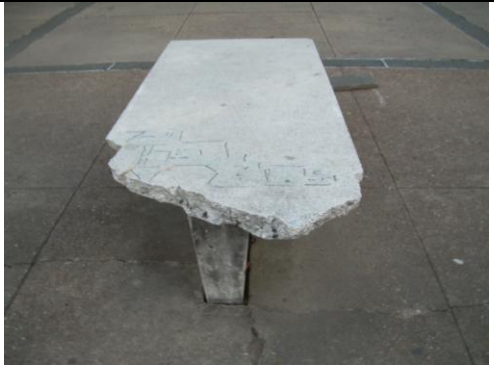
Description: Exterior benches are badly damaged and in poor condition.

Timeline: TBD	Cost: \$7,000

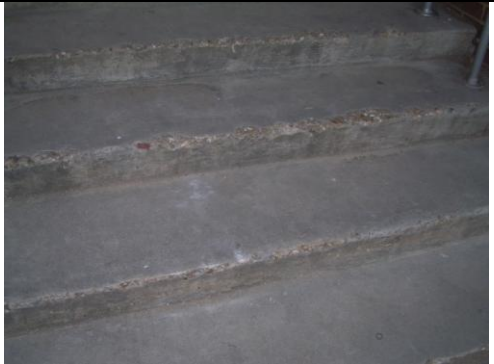
Description: Stair treads have lost their integrity.

Timeline: TBD	Cost: \$17,000

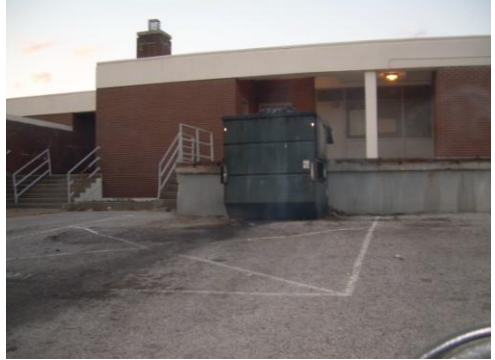
<p>Description:</p> <p>Dumpster needs enclosure.</p>

<p>Timeline:</p> <p>TBD</p>	<p>Cost:</p> <p>\$5,000</p>
