# 2010 FACILITIES ASSESSMENT EGYPT ELEMENTARY

<b>Project Data</b>	
<b>Location Code:</b>	238
<b>Address:</b>	4160 Karen Cove
<b>Year Built:</b>	1964
<b>Grade Configuration:</b>	K-5
<b>Student Capacity:</b>	800/940
<b>Ideal Capacity:</b>	710
<b>ADA Student Enrollment:</b>	1
<b>Size:</b>	40.554 acres
<b>Portables:</b>	5
<b>Building &amp; Addition</b>	75,195 s. f.

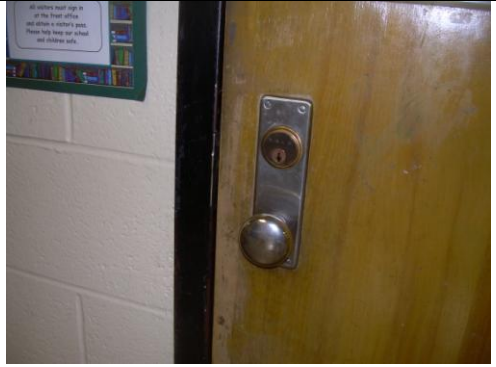
<p><b>Description:</b></p> <p>Upgrade to ADA guidelines</p>

<p><b>Timeline:</b></p> <p>2014-15</p>	<p><b>Cost</b></p> <p>\$726,000</p>

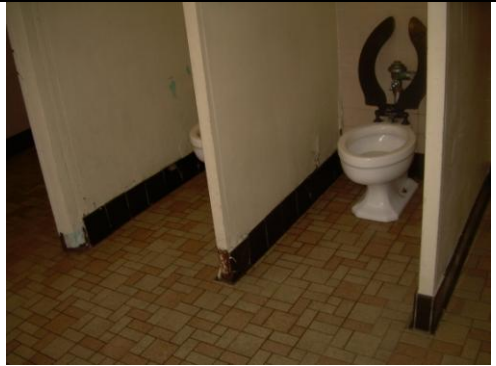
<p><b>Description:</b></p> <p>Bathroom stall doors are missing.</p>

<p><b>Timeline:</b></p> <p>TBD</p>	<p><b>Cost</b></p> <p>\$2,200</p>

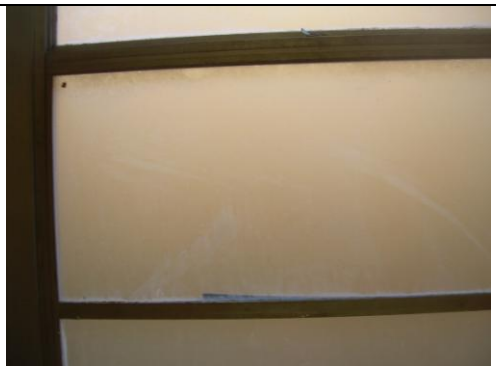
<p><b>Description:</b></p> <p>Replace approximately (310) windows.</p>

<p><b>Timeline:</b></p> <p>2014-15</p>	<p><b>Cost</b></p> <p>\$868,000</p>

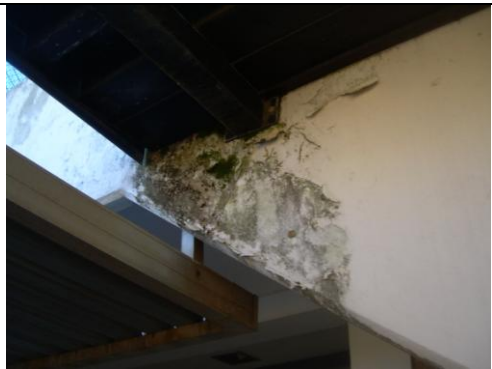
<p><b>Description:</b></p> <p>Clean, seal and paint exterior</p>

<p><b>Timeline:</b></p> <p>2011-12</p>	<p><b>Cost</b></p> <p>\$142,000</p>

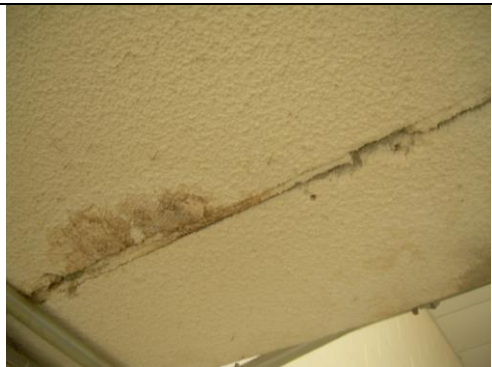
<p><b>Description:</b></p> <p>Water damage to spray applied ceilings. Overall, the ceiling is in poor condition. Laboratory testing will need to be performed to determine whether or not the material contains asbestos before any action can be taken.</p>

<p><b>Timeline:</b></p> <p>TBD</p>	<p><b>Cost</b></p> <p>Dependent on lab results</p>

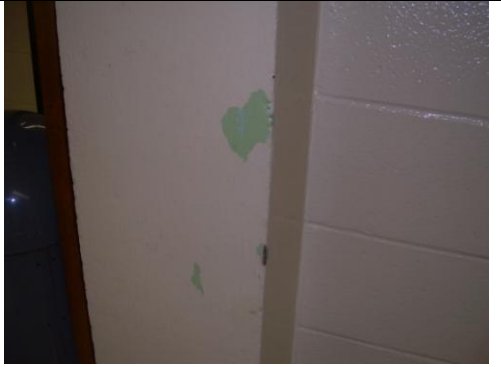
<b>Description:</b>  Paint interior of building

<b>Timeline:</b>  2010-11	<b>Cost</b>  \$110,000

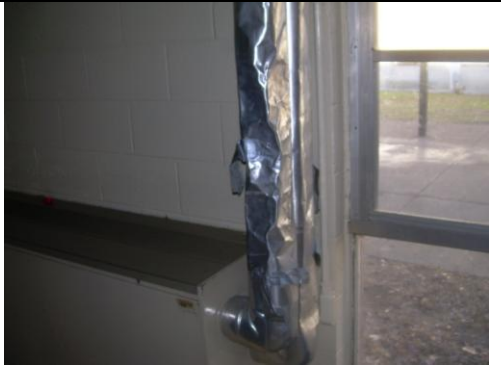
<b>Description:</b>  Metal piping insulation in bad condition.

<b>Timeline:</b>  TBD	<b>Cost</b>  \$3,500

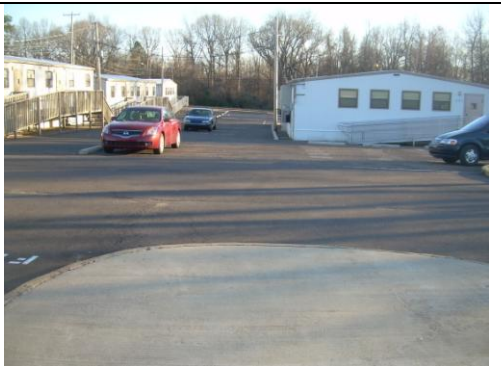
<b>Description:</b>  Existing parking area does not have enough parking spaces.

<b>Timeline:</b>  2010-11	<b>Cost</b>  \$90,000

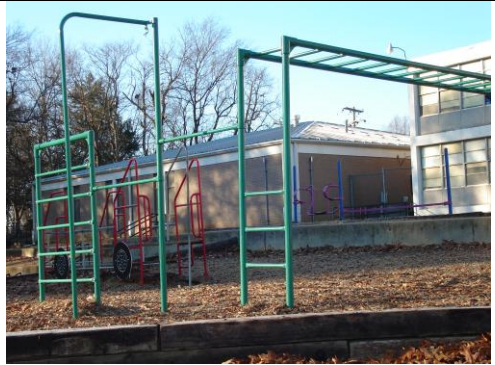
<p><b>Playground/Surfaces Equipment Status:</b></p> <p>Partially equipped Has woodchips w/ crossties border surface</p>

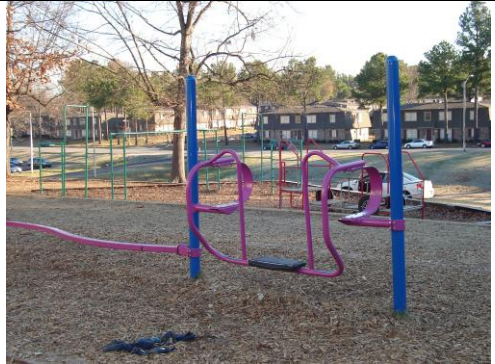
<p><b>Playground Equipment / Surface Condition:</b></p> <p>Used, needs updating Good surface No fence enclosure</p>

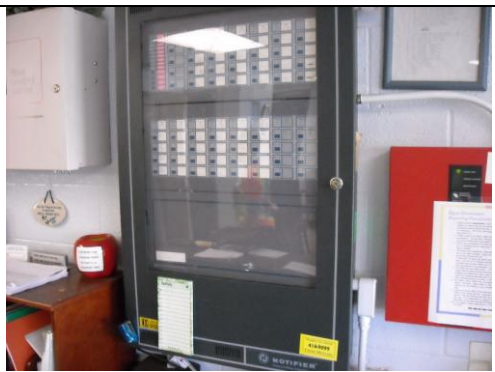
<p><b>Description:</b></p> <p>Replace EMS system and controls</p>

<p><b>Timeline:</b></p> <p><b>2010-11</b></p>	<p><b>Cost</b></p> <p><b>\$82,500</b></p>

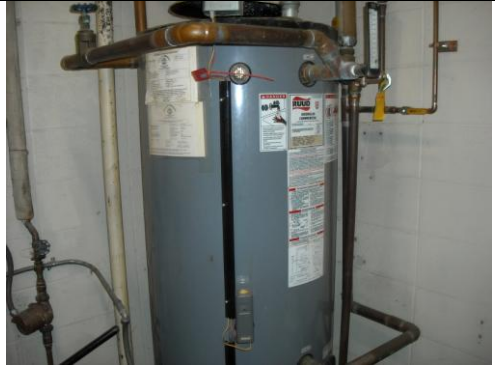
<p><b>Description:</b></p> <p>Replace (2) domestic hot water tanks</p>

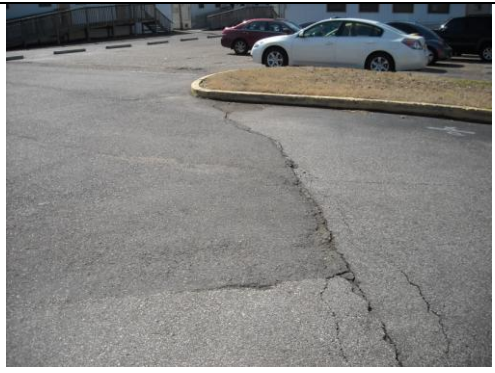
<p><b>Timeline:</b></p> <p>2014-15</p>	<p><b>Cost</b></p> <p><b>\$15,000</b></p>
<p><b>Description:</b></p> <p>Repair overlay of 5,484 sq. yd. of asphalt surface</p>

<p><b>Timeline:</b></p> <p>2010-11</p>	<p><b>Cost</b></p> <p><b>\$60,000</b></p>
<p>PVC Single Ply roof: 11 years-fair</p> <p>Metal roof: 18 years-good</p>

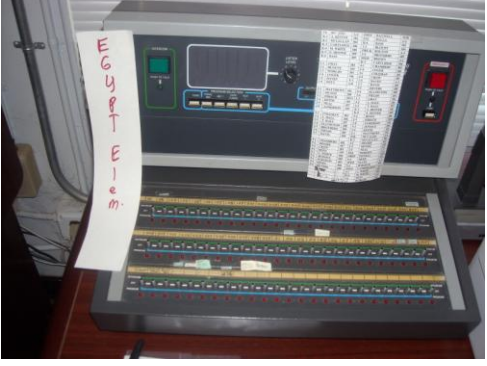
<p><b>Description:</b></p> <p>Intercom system</p> <p>Dukane 3200</p> <p>Installation Date: 1994</p>

<p><b>Timeline:</b></p> <p>2013-14</p>	<p><b>Cost:</b></p> <p>\$50,000</p>
