2010 FACILITIES ASSESSMENT  
 FAIRLEY ELEMENTARY

<b>Location Code:</b>	200
<b>Address:</b>	4950 Fairley Rd
<b>Year Built:</b>	1960
<b>Grade Configuration:</b>	K-5
<b>Student Capacity:</b>	740
<b>Ideal Capacity:</b>	672
<b>ADA Student Enrollment:</b>	0
<b>Size:</b>	21.09 acres
<b>Portables:</b>	0
<b>Building &amp; Additions</b>	69,501 s. f.

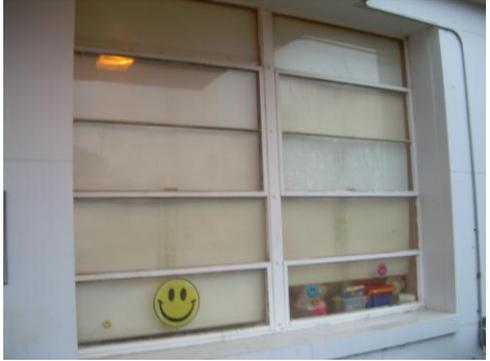
<b>Description:</b>  Existing window system is old and water comes in during heavy rains in several areas.

<b>Timeline:</b>  TBD	<b>Cost:</b>  \$475,000

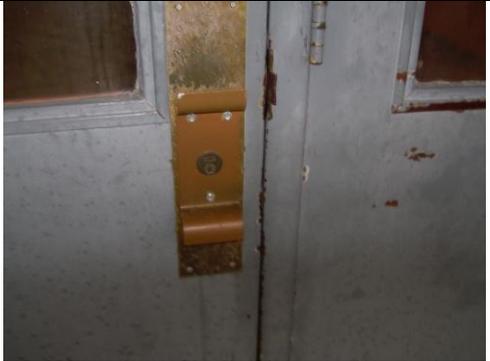
<b>Description:</b>  Upgrade to ADA guidelines

<b>Timeline:</b>  TBD	<b>Cost:</b>  \$80,000

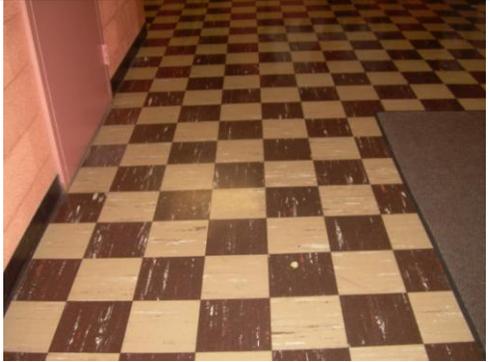
<b>Description:</b>  Existing floor tile contain asbestos and is in poor condition.

<b>Timeline:</b>  TBD	<b>Cost:</b>  \$120,000

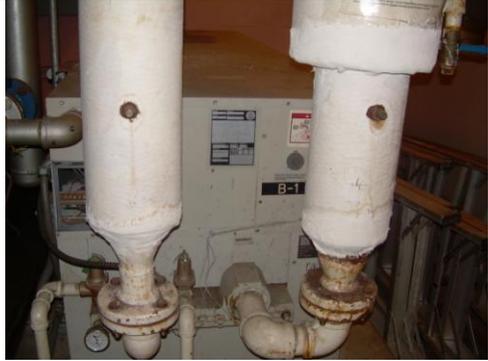
<p><b>Description:</b></p> <p>Thermal pipe insulation in mechanical room contains asbestos. Insulation is in poor condition.</p>

<p><b>Timeline:</b></p> <p>TBD</p>	<p><b>Cost:</b></p> <p>\$7,500</p>

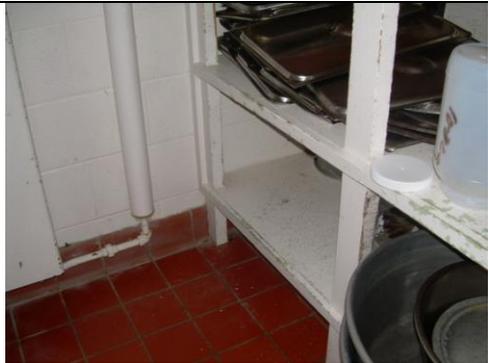
<p><b>Description:</b></p> <p>Wooden shelves in pantry.</p>

<p><b>Timeline:</b></p> <p>TBD</p>	<p><b>Cost:</b></p> <p>\$4,500</p>

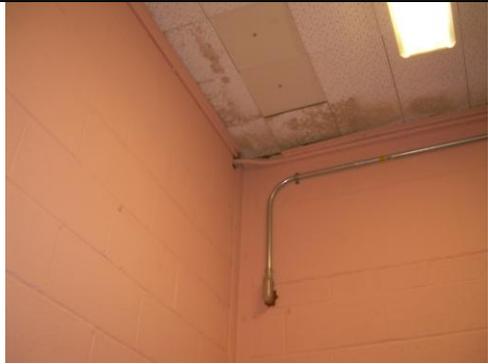
<p><b>Description:</b></p> <p>Existing cafeteria ceiling has significant water and physical damage.</p>

<p><b>Timeline:</b></p> <p>TBD</p>	<p><b>Cost:</b></p> <p>\$70,000</p>

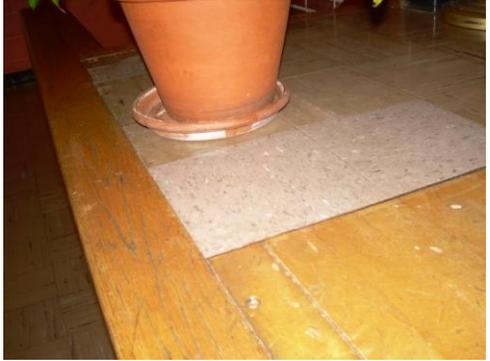
<p><b>Description:</b></p> <p>Existing stage floor in poor condition.</p>

<p><b>Timeline:</b></p> <p><b>TBD</b></p>	<p><b>Cost:</b></p> <p><b>\$70,000</b></p>

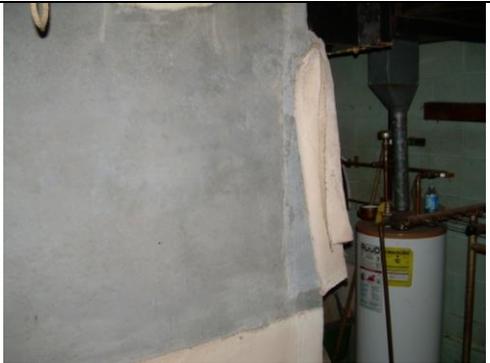
<p><b>Description:</b></p> <p>Replace (2) air cooled, (7) pumps, (2) boilers, domestic water heater/tank, (49) unit ventilators, (2) AHU</p>

<p><b>Timeline:</b></p> <p><b>2015-16</b></p>	<p><b>Cost:</b></p> <p><b>\$2,387,000</b></p>

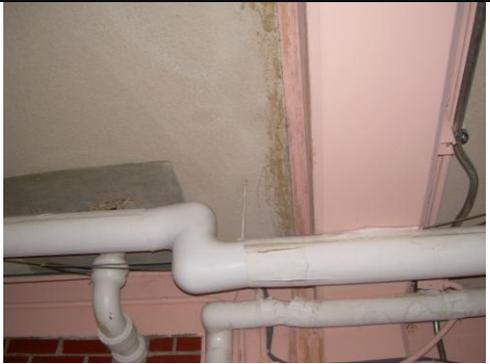
<p><b>Description:</b></p> <p>Sprayed-on ceiling in west annex contains asbestos and has significant water and physical damage. Lighting system does not provide adequate illumination.</p>

<p><b>Timeline:</b></p> <p><b>TBD</b></p>	<p><b>Cost:</b></p> <p><b>\$86,000</b></p>

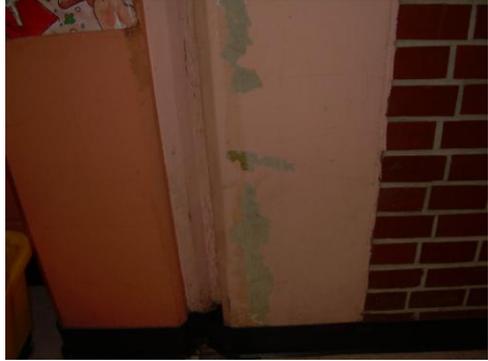
<p><b>Description:</b></p> <p>Interior paint is in fair to good condition as a whole.</p>

<p><b>Timeline:</b></p> <p>TBD</p>	<p><b>Cost:</b></p> <p>\$95,000</p>

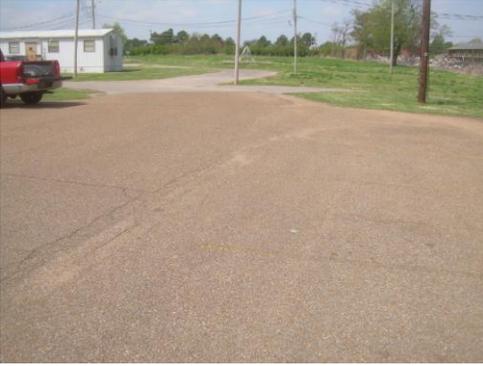
<p><b>Description:</b></p> <p>Patch, crack repair and overlay 4,500 sq. yd of asphalt parking lot</p>

<p><b>Timeline:</b></p> <p><b>2010-11</b></p>	<p><b>Cost:</b></p> <p><b>\$50,000</b></p>

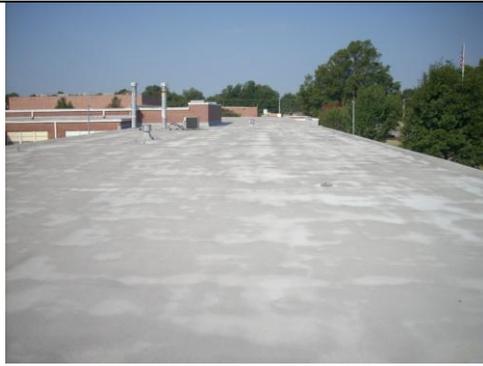
<p><b>Description:</b></p> <p>Foam roofing: 5 years-good</p>

<p><b>Timeline:</b></p> <p><b>TBD</b></p>	<p><b>Cost:</b></p> <p><b>\$315,000</b></p>

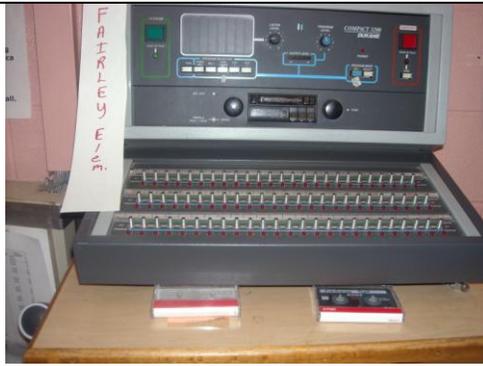
<p><b>Description:</b></p> <p>Intercom system: Dukane 3500 Installation Date: 1995</p>

<p><b>Timeline:</b></p> <p><b>TBD</b></p>	<p><b>Cost:</b></p> <p><b>\$50,000</b></p>
