2010 FACILITIES ASSESSMENT GRANDVIEW HEIGHTS ELEMENTARY

Project Data	
Location Code:	028
Address:	2342 Clifton Ave
Year Built:	1953
Grade Configuration:	K-6
Student Capacity:	760/800
Ideal Capacity:	627
	0
ADA Student Enrollment:	10.41 acres
Size:	4
Portables:	N/A
Building & Addition

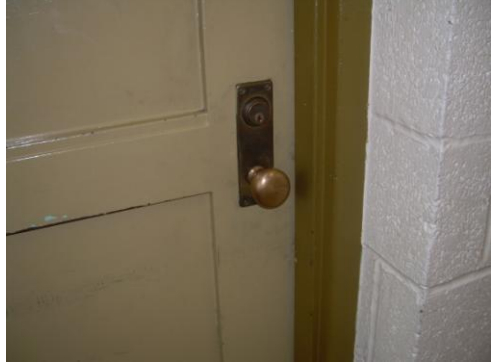
<p>Description:</p> <p>Upgrade to ADA guidelines</p>

<p>Timeline:</p> <p>2018-19</p>	<p>Cost:</p> <p>\$177,000</p>

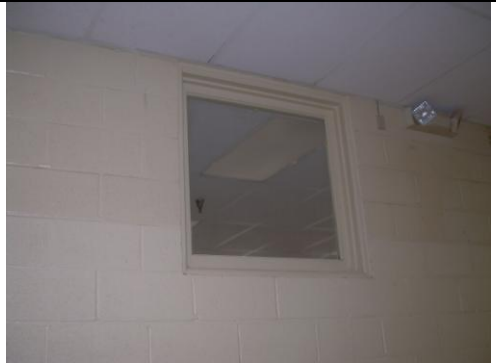
<p>Description:</p> <p>Transom windows do not provide code required 1 hour fire rating of compliance.</p>

<p>Timeline:</p> <p>TBD</p>	<p>Cost:</p> <p>\$12,000</p>

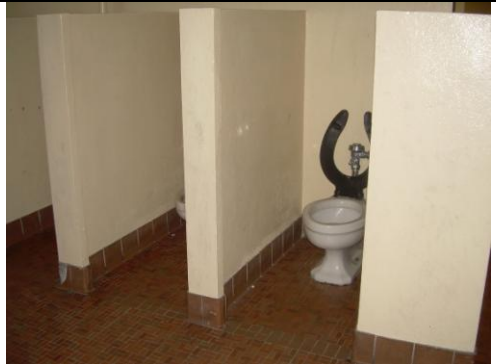
<p>Description:</p> <p>Restroom stall doors are missing.</p>

<p>Timeline:</p> <p>TBD</p>	<p>Cost:</p> <p>\$2,000</p>

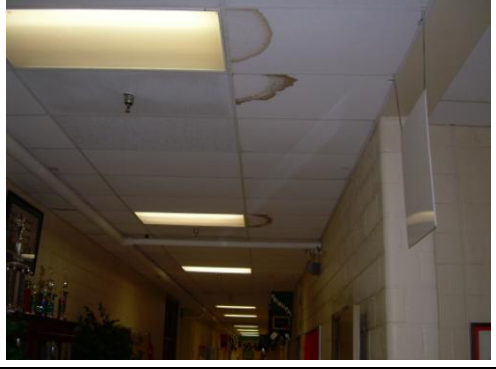
<p>Description:</p> <p>Ceiling tile glue spots are exposed from missing ceiling tile.</p>

<p>Timeline:</p> <p>TBD</p>	<p>Cost:</p> <p>\$7,500</p>

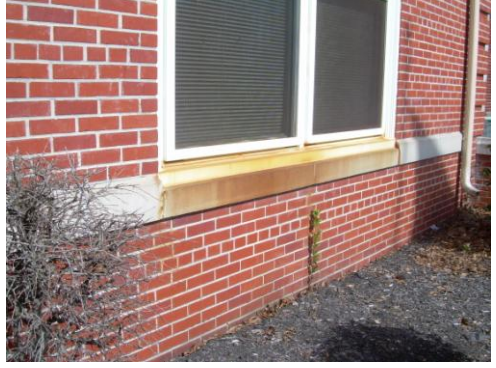
<p>Description:</p> <p>Exterior of building needs pressure washing.</p>

<p>Timeline:</p> <p>TBD</p>	<p>Cost:</p> <p>\$3,000</p>

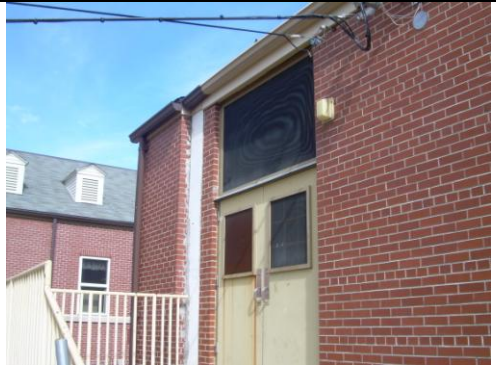
<p>Description:</p> <p>Exterior door does not have proper shading device. As a result, rainwater penetrates inside the building through the door.</p>

<p>Timeline:</p> <p>TBD</p>	<p>Cost:</p> <p>\$2,700</p>

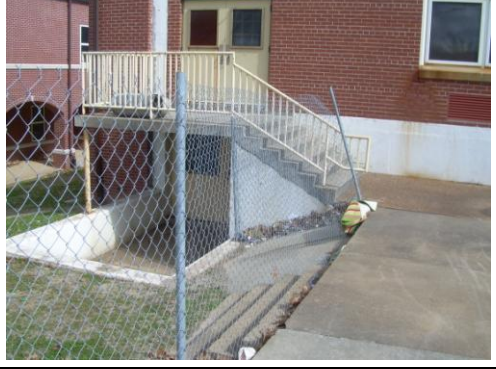
<p>Description:</p> <p>Fencing in need of repair</p>

<p>Timeline:</p> <p>TBD</p>	<p>Cost:</p> <p>\$2,000</p>

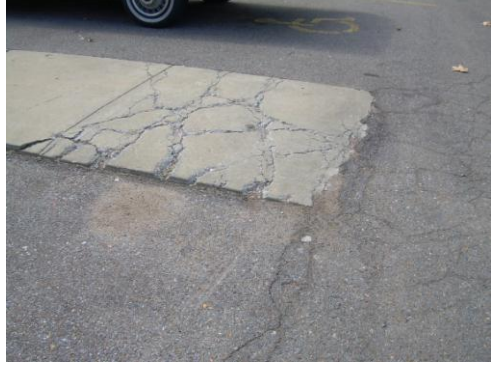
<p>Description:</p> <p>Existing parking area in poor condition.</p>

<p>Timeline:</p> <p>TBD</p>	<p>Cost:</p> <p>\$7,000</p>

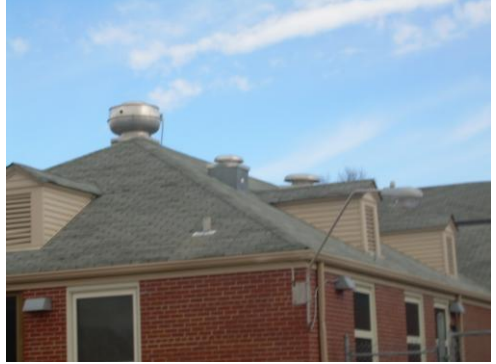
<p>Description:</p> <p>PVC Single Ply roof: 2 years-good</p> <p>Shingled roof: 2 years-good</p> <p>Build up modified and shingles: 10 years-fair</p>	 
<p>Timeline:</p> <p>TBD</p>	<p>Cost:</p> <p>\$337,500</p>

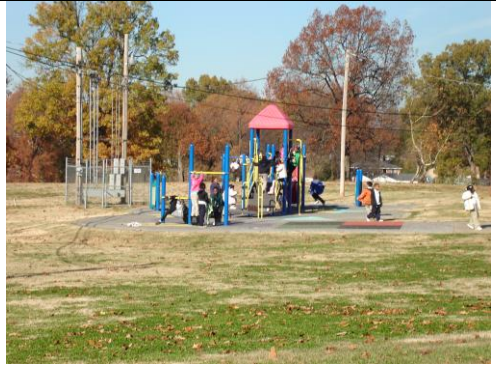
<p>Playground/Surfaces Equipment Status:</p> <p>Fully equipped Has hard asphalt surface</p> <p>Playground Equipment / Surface Condition:</p> <p>New equipment good condition Poor surface No fence enclosure</p>

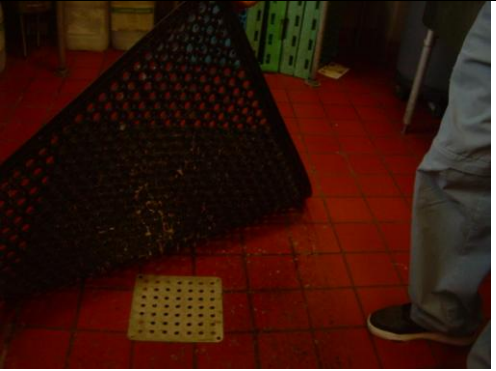
<p>Description:</p> <p>Grease traps needs replacing in kitchen</p>

<p>Timeline:</p> <p>2009-10</p>	<p>Cost:</p> <p>\$15,000</p>

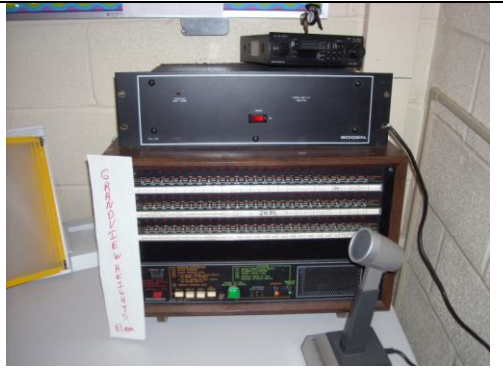
<p>Description:</p> <p>Intercom System:</p> <p>Bogen MCP35A</p> <p>Installation Date: 2001</p>

<p>Timeline:</p> <p>TBD</p>	<p>Cost:</p> <p>\$50,000</p>
