# 2010 FACILITIES ASSESSMENT HANLEY ELEMENTARY

Project Data	
<b>Location Code:</b>	028
<b>Address:</b>	680 Hanley Street
<b>Year Built:</b>	1959
<b>Grade Configuration:</b>	K-5
<b>Student Capacity:</b>	960
<b>Ideal Capacity:</b>	979
<b>ADA Student Enrollment:</b>	0
<b>Size:</b>	7.82 Acres
<b>Portables:</b>	0
<b>Building &amp; additions</b>	104,224 s. f.

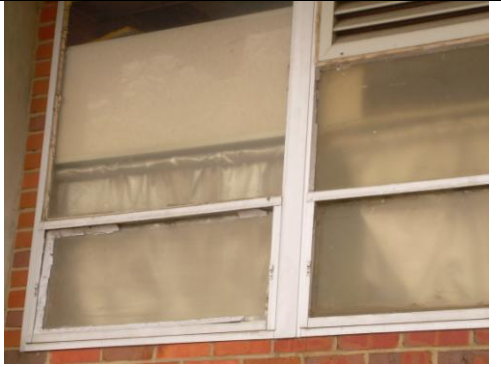
<b>Description:</b>  Window system is old and needs replacing.

<b>Timeline:</b>  TBD	<b>Cost:</b>  \$780,000

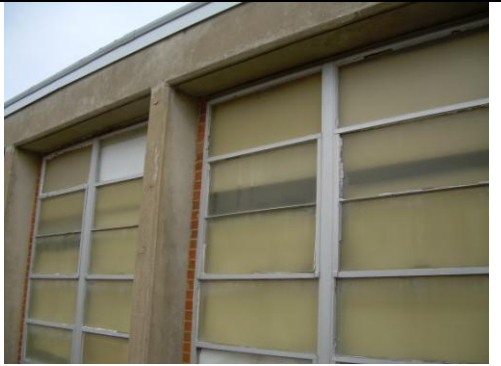
<b>Description:</b>  Same as previous item.

<b>Timeline:</b>  TBD	<b>Cost:</b>  \$

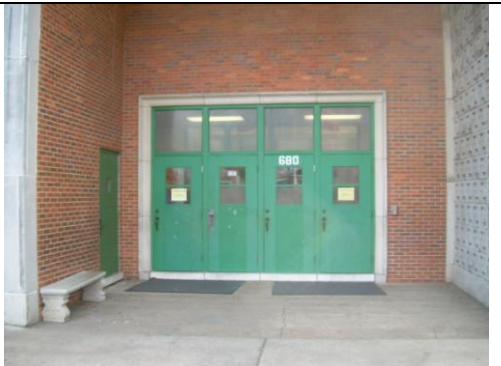
<b>Description:</b>  Store front doors and windows in poor condition.

<b>Timeline:</b>  TBD	<b>Cost:</b>  \$14,400

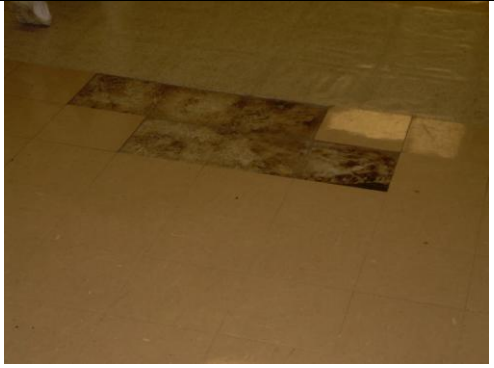
<b>Description:</b>  Some existing floor tile contains asbestos and is in poor condition.

<b>Timeline:</b>  <b>TBD</b>	<b>Cost:</b>  <b>\$98,000</b>

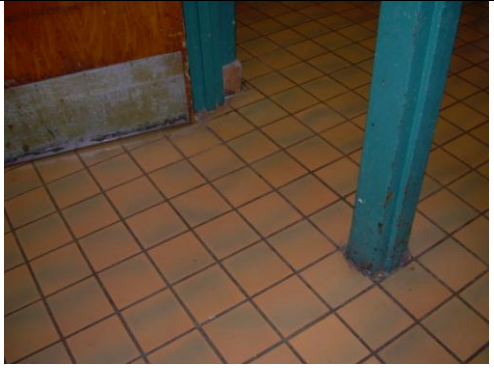
<b>Description:</b>  Door frames in kitchen are rusting creating health department issues.

<b>Timeline:</b>  <b>TBD</b>	<b>Cost:</b>  <b>\$2,700</b>

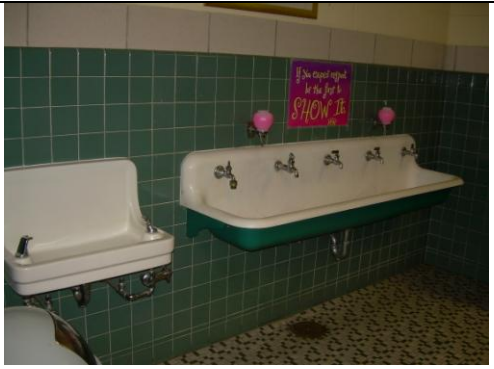
<b>Description:</b>  Upgrade to ADA guidelines

<b>Timeline:</b>  <b>TBD</b>	<b>Cost:</b>  <b>\$56,000</b>

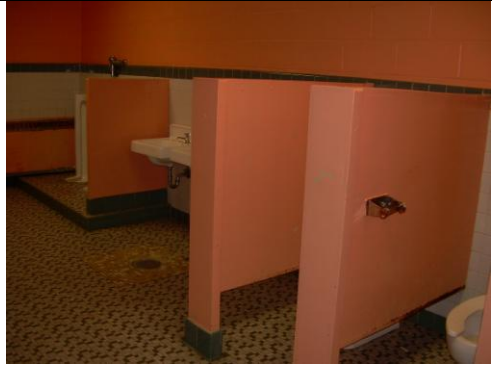
<p><b>Description:</b></p> <p>Restroom stall doors are missing.</p>

<p><b>Timeline:</b></p> <p>TBD</p>	<p><b>Cost:</b></p> <p>\$3,000</p>

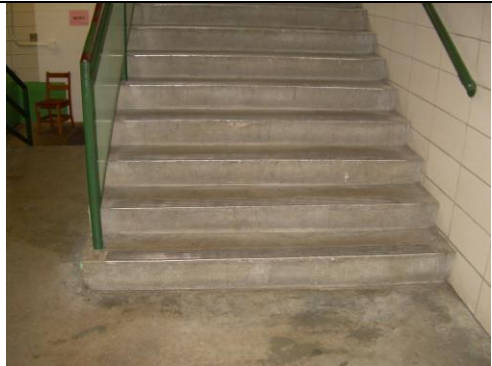
<p><b>Description:</b></p> <p>Stairwell treads have lost their integrity.</p>

<p><b>Timeline:</b></p> <p>TBD</p>	<p><b>Cost:</b></p> <p>\$17,000</p>

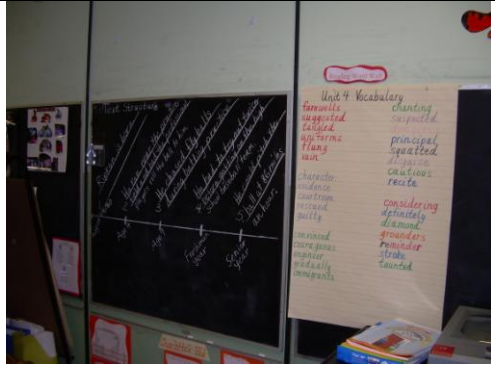
<p><b>Description:</b></p> <p>Whiteboards needed in some classrooms.</p>

<p><b>Timeline:</b></p> <p>TBD</p>	<p><b>Cost:</b></p> <p>\$4,500</p>

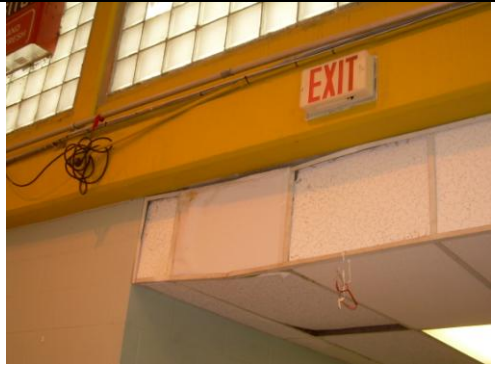
<p><b>Description:</b></p> <p>Lay-in ceiling tile is in poor condition in some areas.</p>

<p><b>Timeline:</b></p> <p>TBD</p>	<p><b>Cost:</b></p> <p>\$9,500</p>

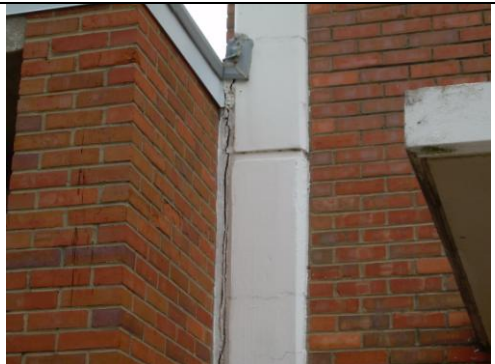
<p><b>Description:</b></p> <p>Foundation and structural issues.</p>

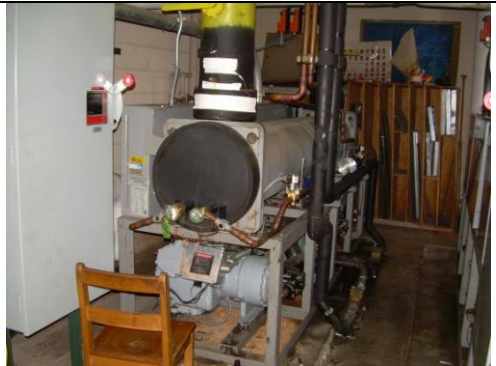
<p><b>Description:</b></p> <p>Split-system chiller and chiller barrel need replacing.</p>

A photograph of a large, industrial chiller unit with a large circular access panel on the front. It is situated in a utility room with various pipes and equipment visible in the background.
<p><b>Timeline:</b></p> <p><b>TBD</b></p>	<p><b>Cost:</b></p> <p><b>\$20,000</b></p>

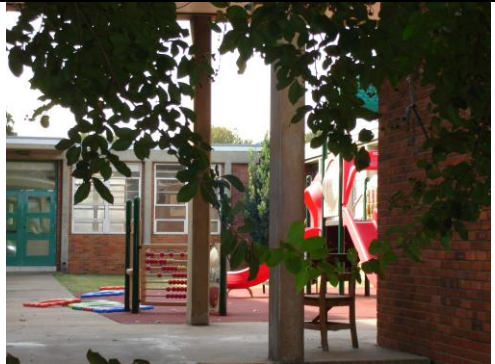
<p><b>Playground/Surfaces Equipment Status:</b></p> <p>Fully equipped Has cast in place rubber surface</p>

<p><b>Playground Equipment / Surface Condition:</b></p> <p>Good equipment Good Surface Good Courtyard Enclosure w/Gate</p>

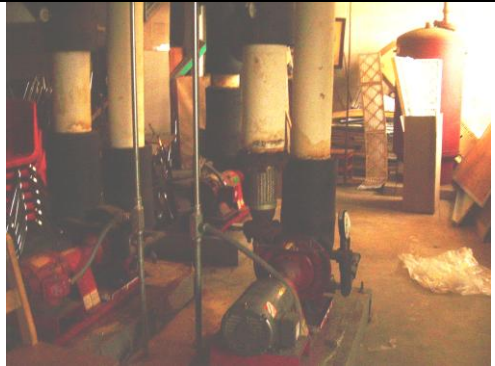
<p><b>Description:</b></p> <p>Replace boiler/pumps/(64) FCU and (7) AHU</p>

<p><b>Timeline:</b></p> <p><b>2014-15</b></p>	<p><b>Cost:</b></p> <p><b>\$2,420,000</b></p>

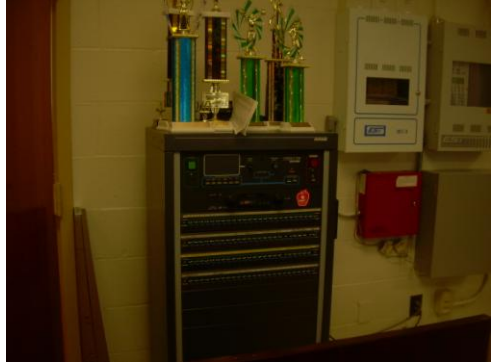
<p><b>Description:</b></p> <p>Intercom System:</p> <p>Dukane 2000</p> <p>Installation Date: 1993</p>

<p><b>Timeline:</b></p> <p><b>2015-16</b></p>	<p><b>Cost:</b></p> <p><b>\$50,000</b></p>

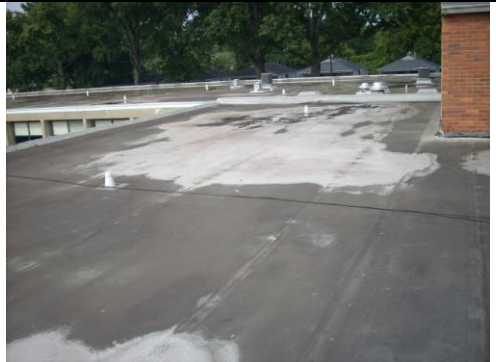
<p><b>Description:</b></p> <p>PVC Single Ply</p> <p>6 yrs-good</p>

<p><b>Timeline:</b></p> <p><b>TBD</b></p>	<p><b>Cost:</b></p> <p><b>\$405,000</b></p>
