2010 FACILITIES ASSESSMENT HAVENVIEW MIDDLE

Project Data	
Location Code:	204
Address:	1481 Hester Road
Year Built:	1958
Grade Configuration:	6-8
Student Capacity:	1100
Ideal Capacity:	876
ADA Student Enrollment:	0
Size:	16.28 Acres
Portables:	0
Building & additions	103,702 s. f.

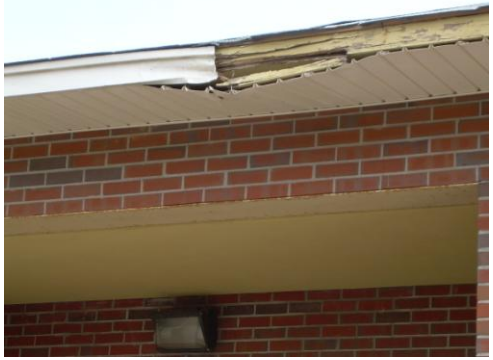
Description: Fascia board damaged

Timeline: TBD	Cost: \$2,000

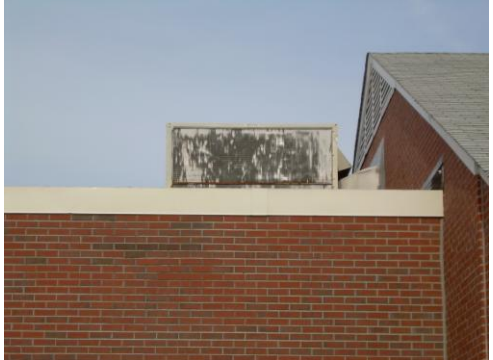
Description: Roof top units servicing gym not functioning properly.

Timeline: TBD	Cost: \$45,000

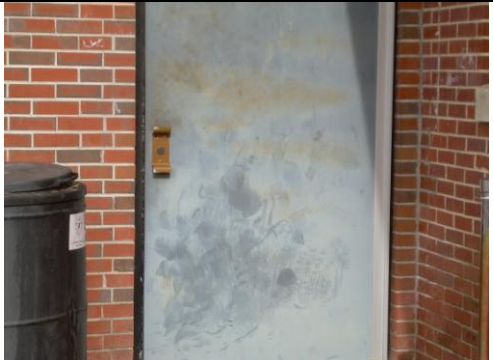
Description: Exterior doors in poor condition

Timeline: TBD	Cost: \$47,500

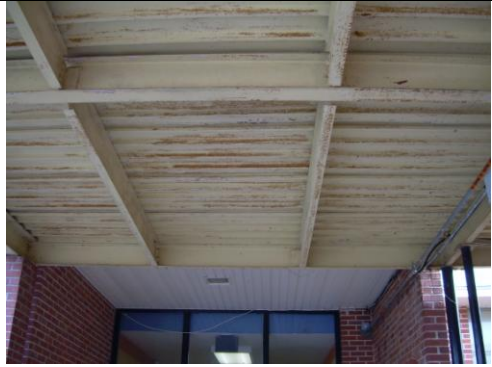
<p>Description:</p> <p>Canopy paint in poor condition</p>

<p>Timeline:</p> <p>TBD</p>	<p>Cost:</p> <p>\$6,000</p>

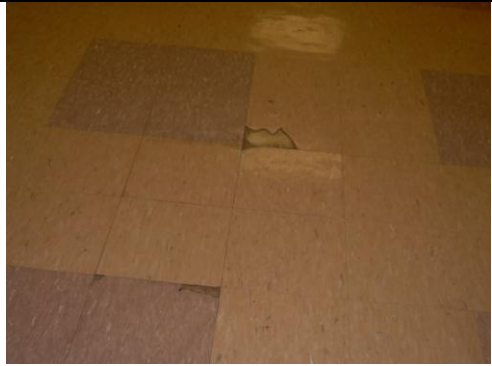
<p>Description:</p> <p>Existing floor tile contains asbestos and is in poor condition.</p>

<p>Timeline:</p> <p>TBD</p>	<p>Cost:</p> <p>\$169,000</p>

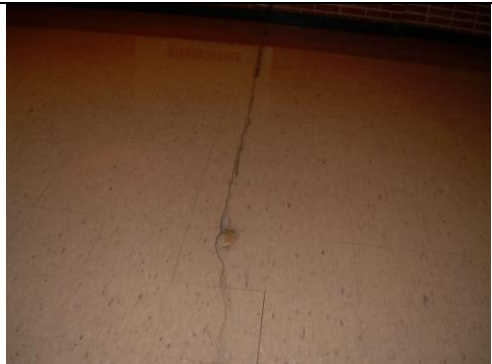
<p>Description:</p> <p>Same as previous.</p>

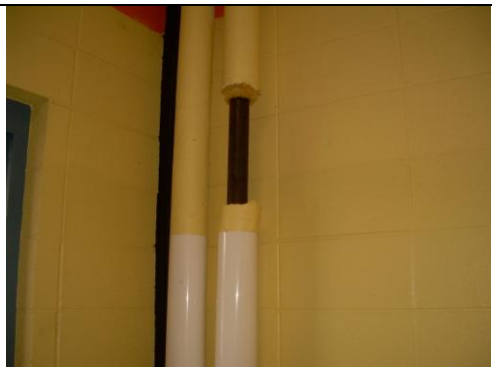
<p>Description:</p> <p>Existing non-asbestos pipe insulation has significant physical damage in several areas.</p>

<p>Timeline:</p> <p>TBD</p>	<p>Cost:</p> <p>\$5,000</p>

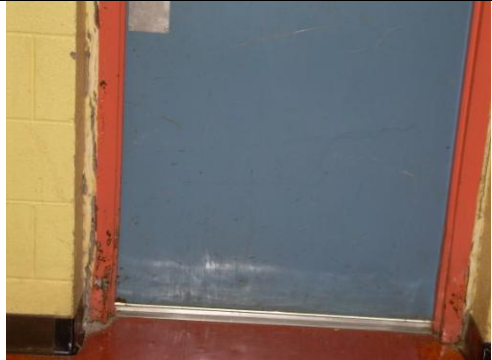
<p>Description:</p> <p>Existing door frames in kitchen are rusting and caulking has lost its integrity creating health department issues.</p>

<p>Timeline:</p> <p>TBD</p>	<p>Cost:</p> <p>\$4,700</p>

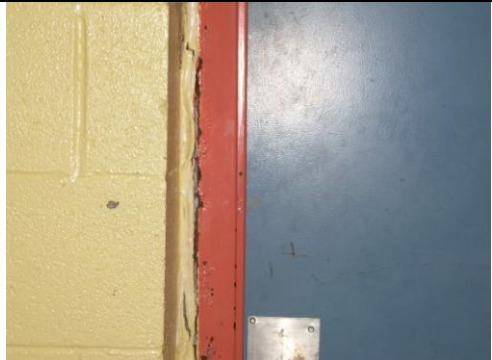
<p>Description:</p> <p>Same as previous.</p>

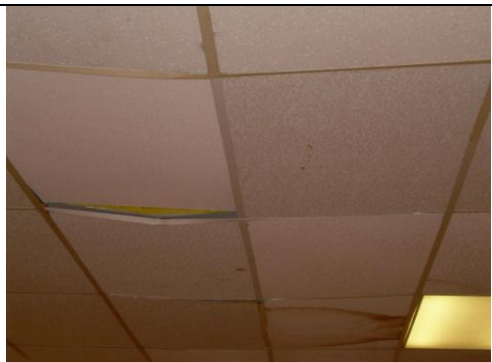
<p>Description:</p> <p>Lay-in ceiling tile is in poor condition.</p>

<p>Timeline:</p> <p>TBD</p>	<p>Cost:</p> <p>\$13,000</p>

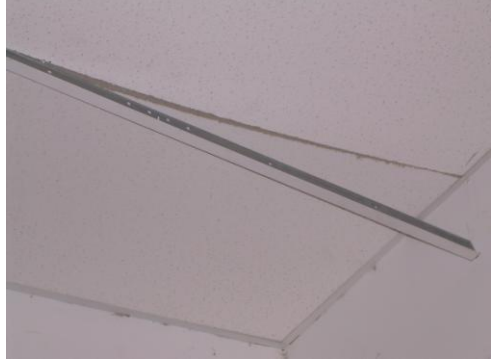
<p>Description:</p> <p>Example of damaged grid.</p>

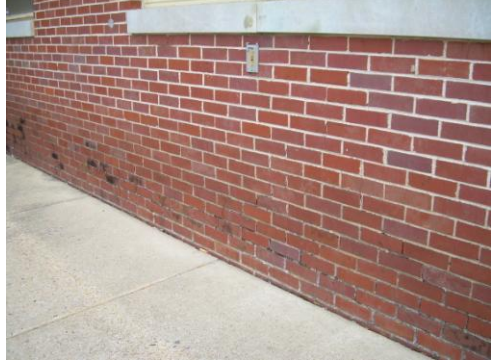
<p>Timeline:</p> <p>TBD</p>	<p>Cost:</p> <p>See Above</p>
<p>Description:</p> <p>Exterior bricks are in poor condition and exterior needs pressure washing.</p>

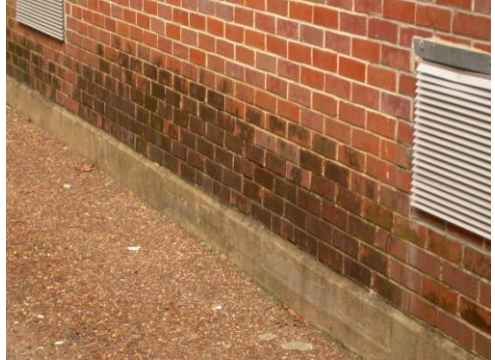
<p>Timeline:</p> <p>TBD</p>	<p>Cost:</p> <p>\$24,000</p>
<p>Description:</p> <p>Same as previous</p>

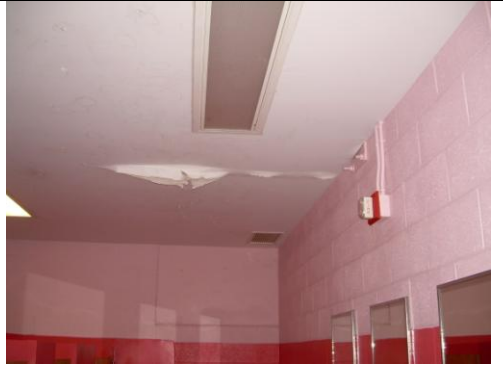
Description: Existing restroom plaster ceiling in poor condition.

Timeline: TBD	Cost: \$800

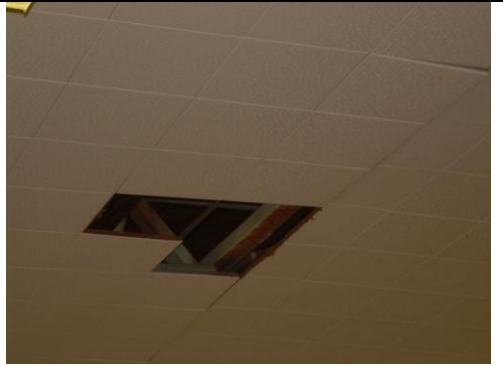
Description: Existing 12"x12" ceiling tiles are missing and several in poor condition.

Timeline: TBD	Cost: \$150,000

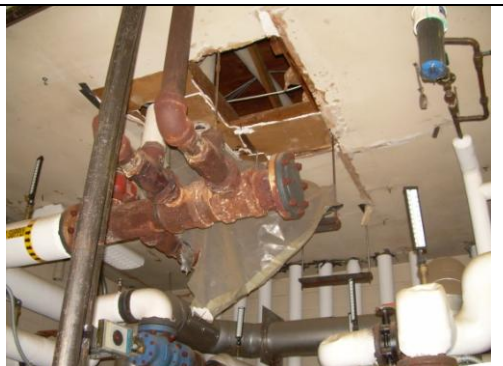
Description: Damaged ceiling in boiler room.

Timeline: TBD	Cost: \$1,600

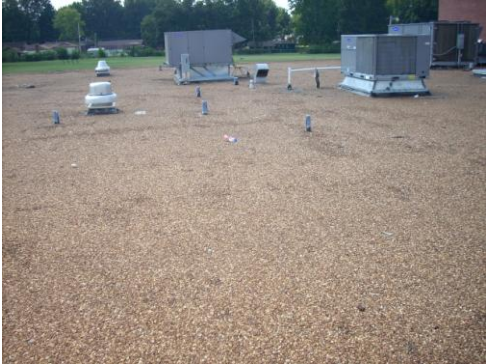
<p>Description:</p> <p>Built up with gravel: 30 years-poor</p> <p>Build up roof: 16 years-poor</p> <p>Shingled roof: 16 years-poor</p> <p>PVC Single Ply roof: 6 years-fair</p> <p>Metal roof: 15 years-fair</p>

<p>Timeline:</p> <p>TBD</p>	<p>Cost:</p> <p>\$466,725</p>
