# 2010 FACILITIES ASSESSMENT IDLEWILD ELEMENTARY

<b>Project Data</b>	
<b>Location Code:</b>	029
<b>Address:</b>	1950 Linden Ave.
<b>Year Built:</b>	1903
<b>Grade Configuration:</b>	K-5
<b>Student Capacity:</b>	600
<b>Ideal Capacity:</b>	537
<b>ADA Student Enrollment:</b>	2.86 acres
<b>Size:</b>	0
<b>Portables:</b>	65,025 s. f.
<b>Building &amp; Addition</b>

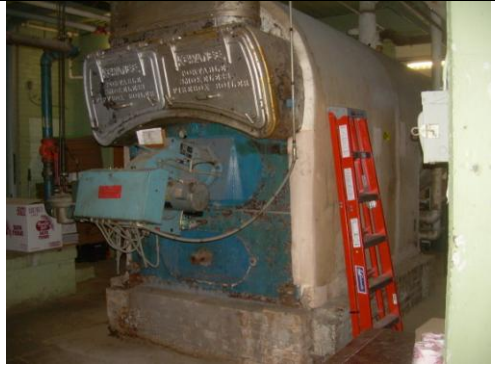
<p><b>Description:</b></p> <p>Boiler room has excessive amount of asbestos insulation materials including the boiler insulation, as well as on piping- All in very poor condition.</p>

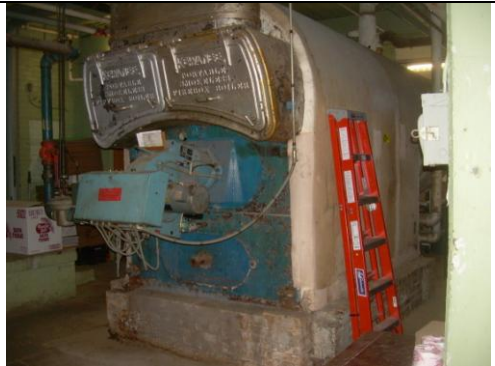
<p><b>Description:</b></p> <p>Replace domestic water boiler</p>

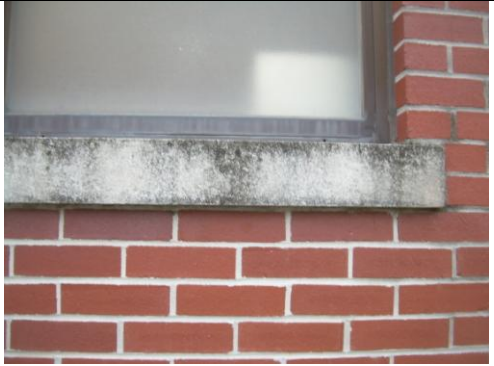
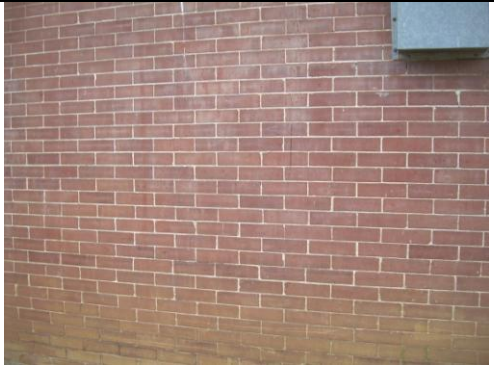
<b>Description:</b> Exterior of building needs pressure washing.

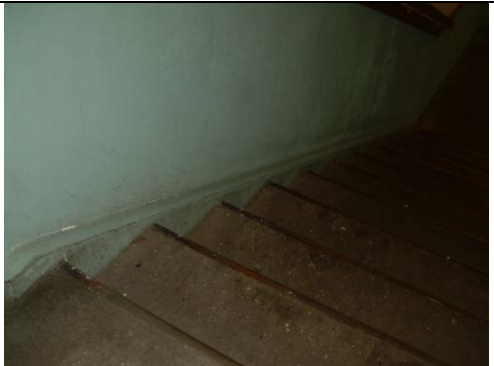
<b>Description:</b> Stairwells do not have slip-resistant surfaces.

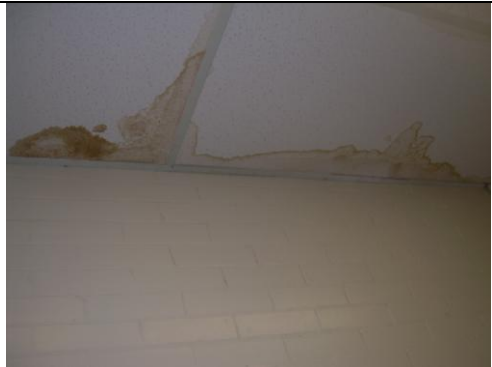
<p><b>Description:</b></p> <p>Lay-in ceiling tiles are in poor condition, mold forms and cause potential health concerns.</p>

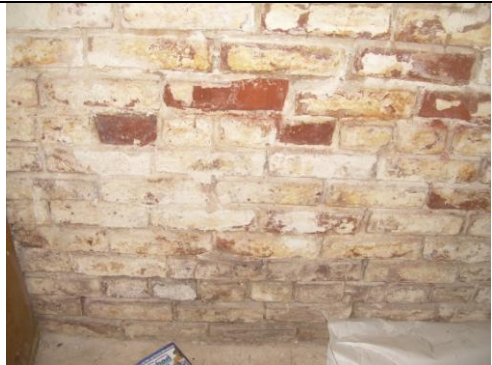
<p><b>Description:</b></p> <p>Walls in the boiler room are in horrendous condition.</p>

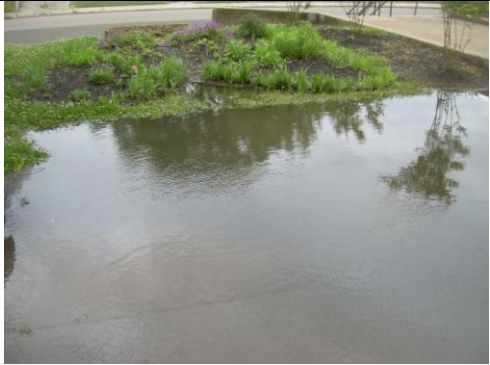
<p><b>Description:</b></p> <p>Area between main building and west annex has major flooding issues.</p>

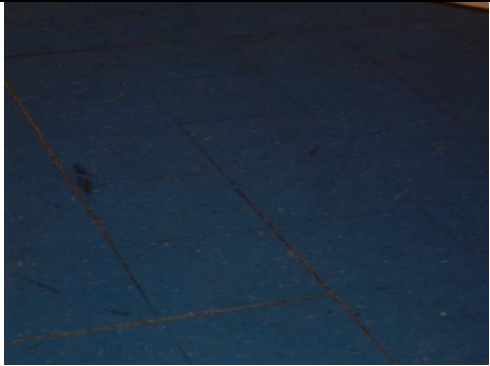
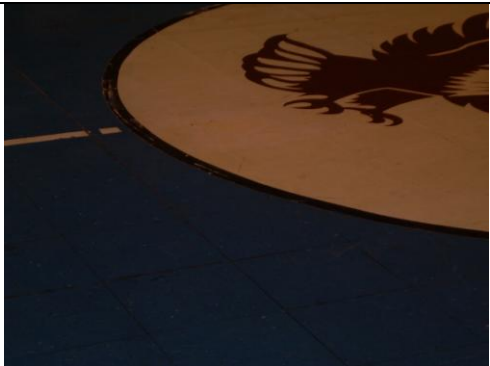
<p><b>Description:</b></p> <p>Gymnasium floor is damaged from storm several summers back (date uncertain, "Hurricane Elvis").</p>

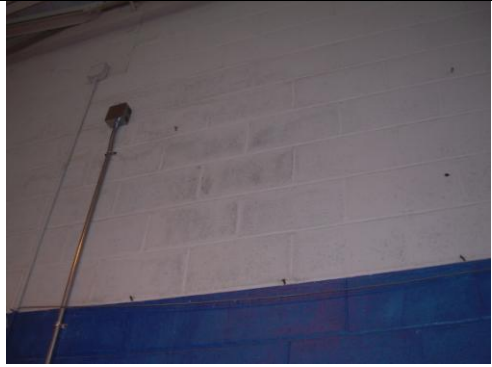
<p><b>Description:</b></p> <p>Paint interior of building</p>

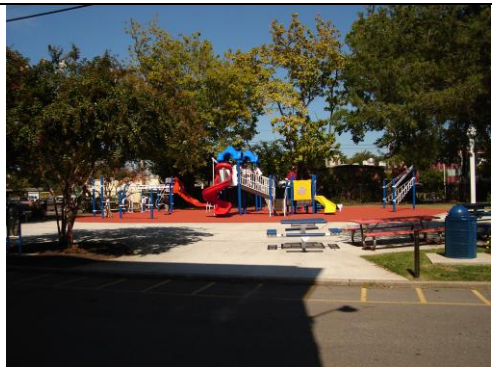
<p><b>Playground/Surfaces Equipment Status:</b></p> <p>Fully equipped Has cast in place rubber surface</p>

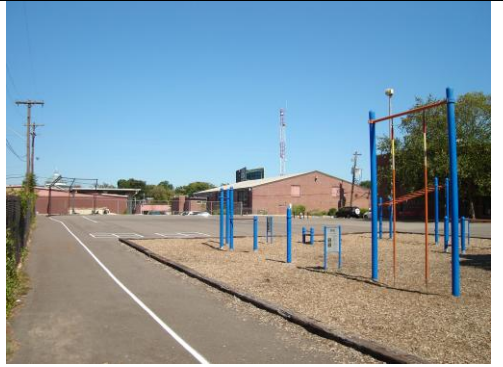
<p><b>Playground Equipment / Surface Condition:</b></p> <p>Good equipment Good surface Good fencing, not enclosed</p>

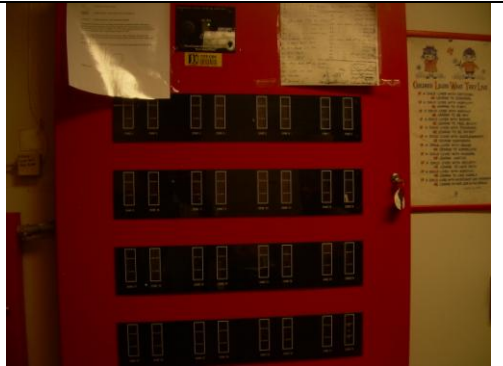
<p><b>Description:</b></p> <p>Replace FA system and upgrade cabling support</p>

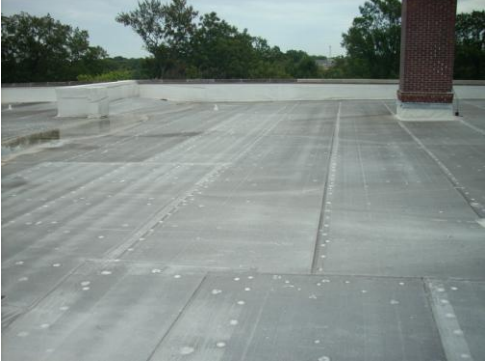
<p><b>Description:</b></p> <p>PVC Single ply roof: 8 years-fair</p> <p>Shingled roof: 12 years-fair</p>
