2010 FACILITIES ASSESSMENT KINGSBURY ELEMENTARY

Project Data	
Location Code:	032
Address:	4055 Bayliss
Year Built:	1959
Grade Configuration:	K-6
Student Capacity:	700/740
Ideal Capacity:	663
ADA Student Enrollment:	15
Size:	0 acres
Portables:	0
Building & Addition	65,250 s. f.

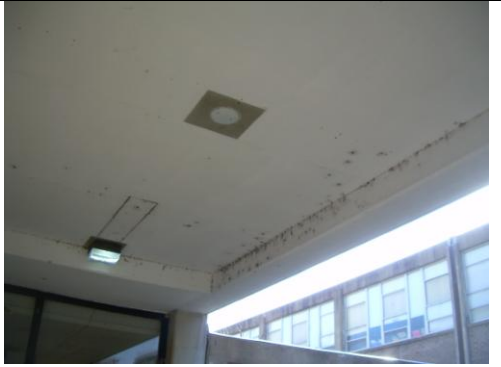
Description: Canopy ceiling paint in poor condition, mold is forming.

Timeline: TBD	Cost: \$8,000

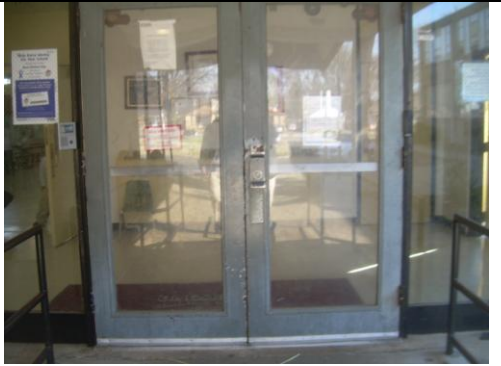
Description: Store front doors and windows in poor condition.

Timeline: TBD	Cost: \$40,000

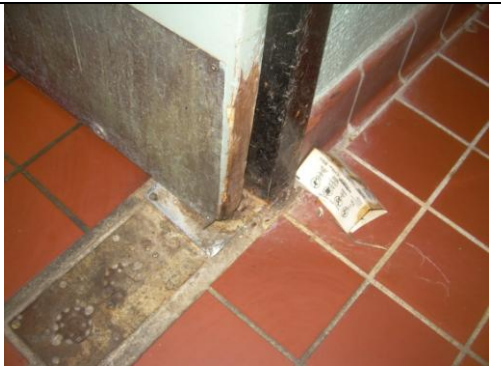
Description: Existing door frames in the kitchen are rusting creating health department issues.

Timeline: TBD	Cost: \$4,700

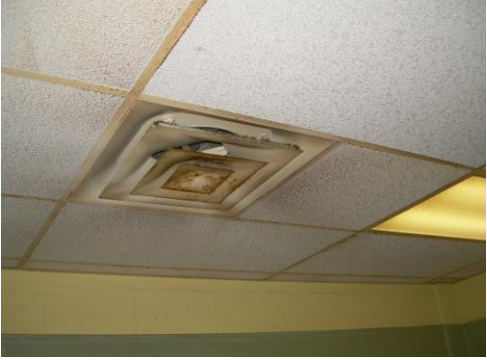
<p>Description:</p> <p>Ceiling tile in kitchen is dirty and grid is starting to rust.</p>

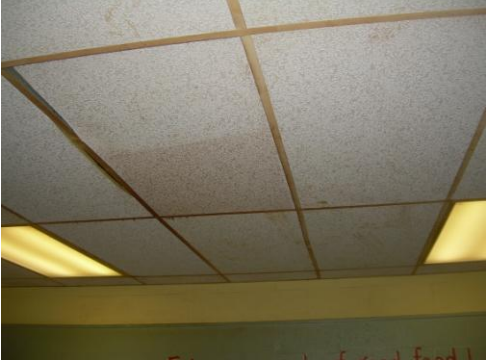
<p>Timeline:</p> <p>TBD</p>	<p>Cost:</p> <p>\$3,200</p>
<p>Description:</p> <p>Same as previous item.</p>

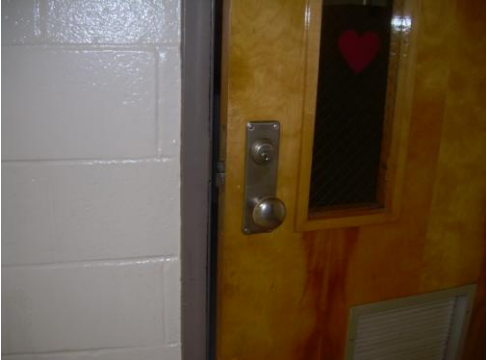
<p>Description:</p> <p>Upgrade to ADA guidelines</p>

<p>Timeline:</p> <p>2013-14</p>	<p>Cost:</p> <p>\$243,000</p>

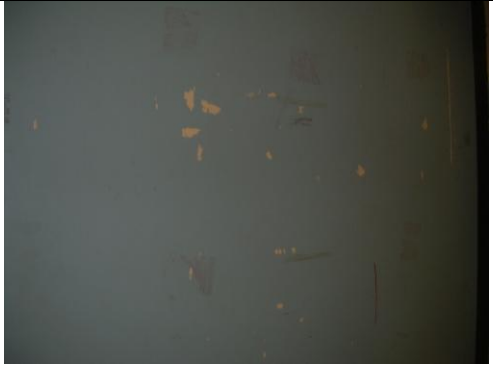
Description: Interior of school needs painting.

Timeline: TBD	Cost: \$89,000

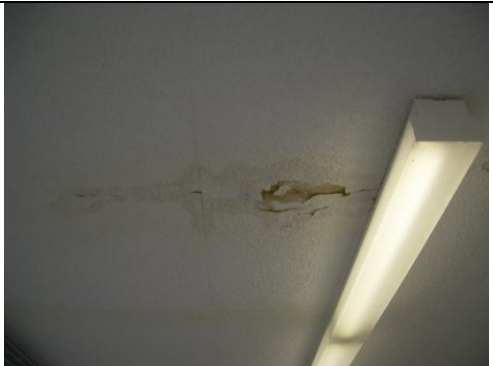
Description: Spayed ceiling in main hallway has water damage.

Timeline: TBD	Cost: \$22,000

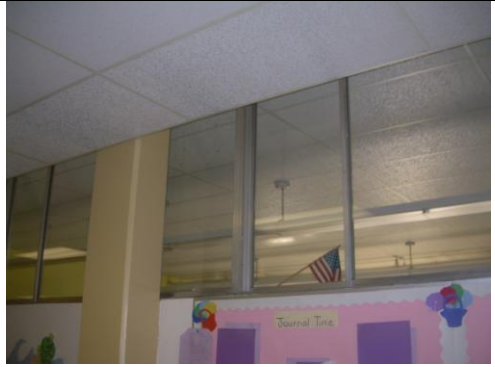
<p>Description:</p> <p>Transom windows do not provide code require 1 hour of fire rating of compliance.</p>

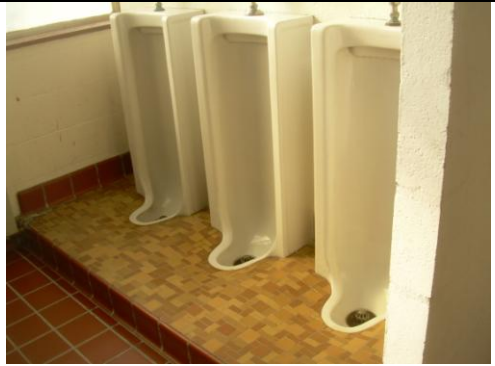
<p>Timeline:</p> <p>TBD</p>	<p>Cost:</p> <p>\$18,000</p>
<p>Description:</p> <p>Floor urinals antiquated and do not meet ADA standards.</p>

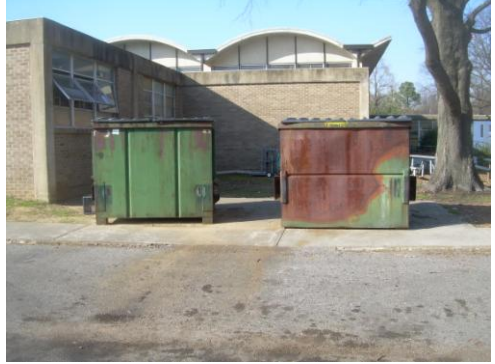
<p>Timeline:</p> <p>TBD</p>	<p>Cost:</p> <p>\$42,000</p>
<p>Description:</p> <p>Dumpsters (2) needs enclosed.</p>

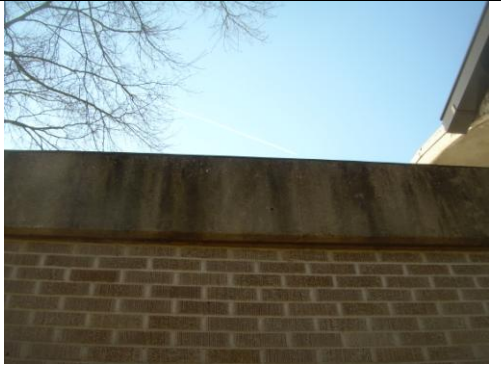
Description: Exterior of building needs pressure washing.

Timeline: TBD	Cost: \$6,000

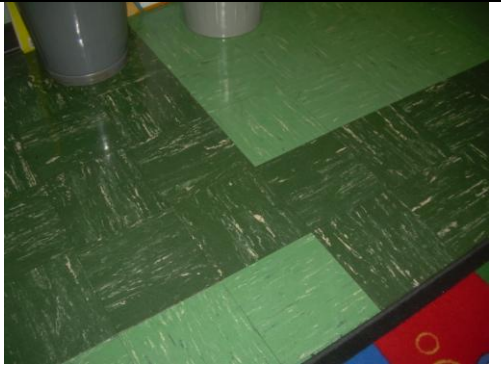
Description: Existing floor tiles contains asbestos and is in poor condition.

Timeline: TBD	Cost: \$147,000

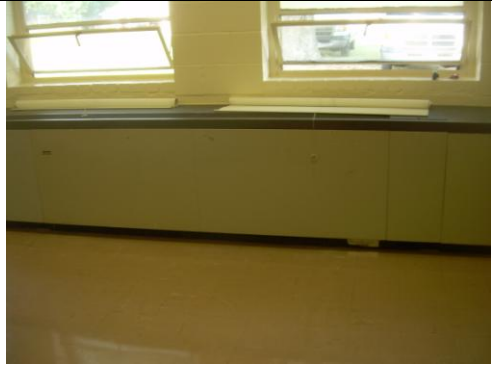
<p>Description:</p> <p>Self contained unit ventilators do not operate properly. History of costly maintenance issues.</p> <p>(In progress 3/23/2010)</p>

<p>Timeline:</p> <p>TBD</p>	<p>Cost:</p> <p>\$1,120,000</p>

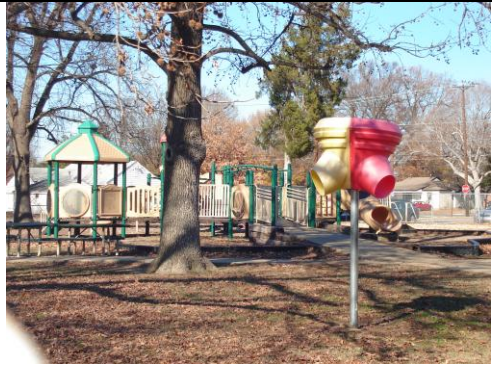
<p>Playground/Surfaces Equipment Status:</p> <p>Fully equipped Has woodchips w/crossties border surface,</p>

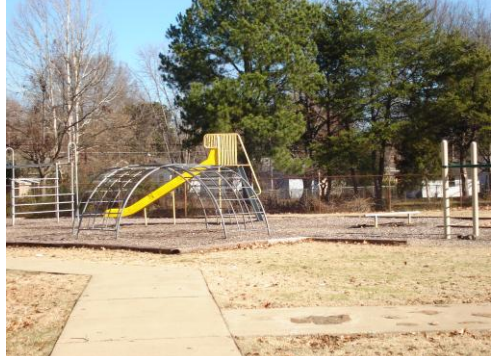
<p>Playground Equipment / Surface Condition:</p> <p>Old, used, adequate condition Adequate surface Good fence enclosure</p>

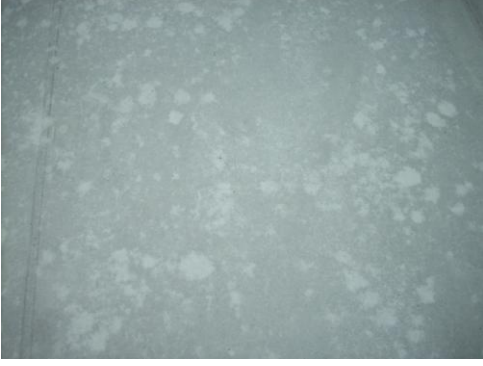
Description: PVC Single Ply Roof: 12 years-Fair

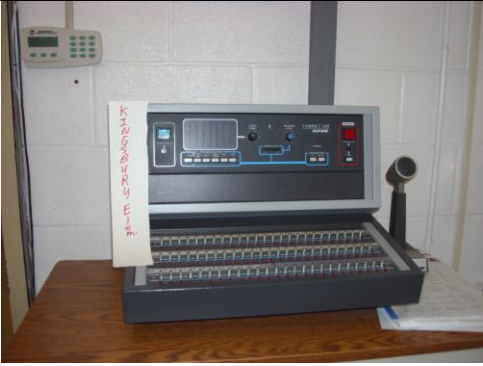
Timeline: TBD	Cost: \$232,155
Description: Kingsbury Elem. Dukane 3200 Installation Date: 2000

Timeline: TBD	Cost: \$50,000
