2010-FACILITIES ASSESSMENT SCENIC HILLS ELEMENTARY

Project Data	
Location Code:	233
Address:	3450 Scenic Highway
Year Built:	1957
Grade Configuration:	K-5
Student Capacity:	560/640
Ideal Capacity:	500
ADA Student Enrollment:	0
Size:	19.98 acres
Portables:	0
Building & Addition	48,388 s. f.

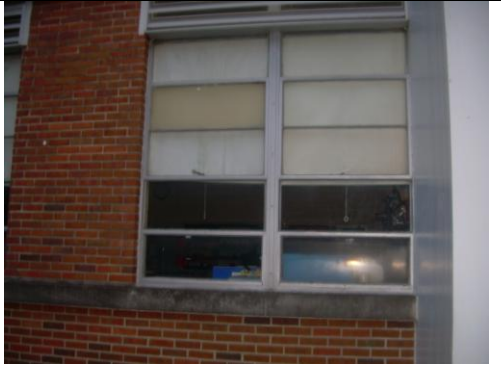
Description: Replace approximately (292) windows and storefront entrances

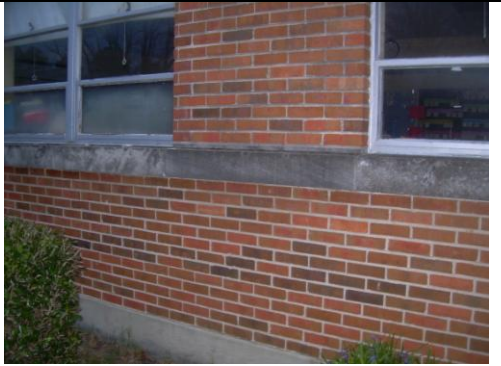
Description: Pressure wash and paint exterior

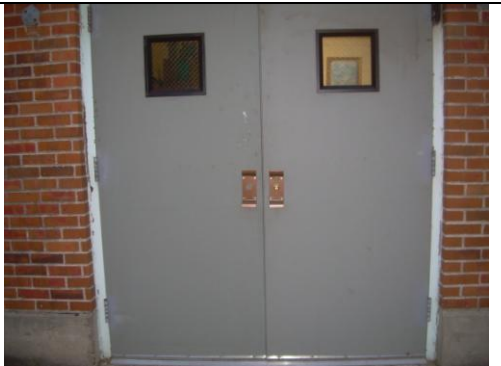
Description: Upgrade to ADA guidelines

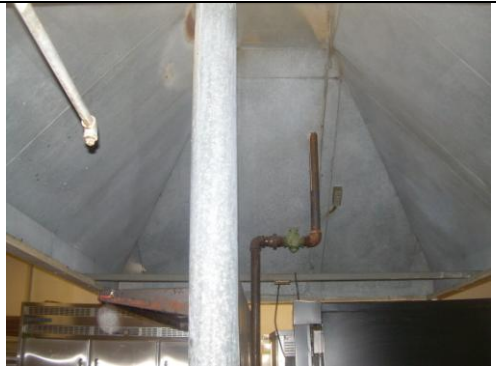
<p>Description:</p> <p>Kitchen vent hood is old, not working properly and does not have a fire suppression system.</p>

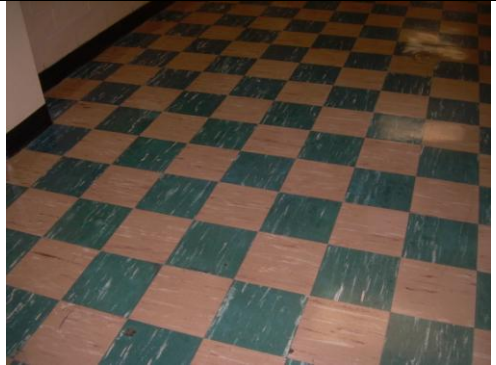
<p>Description:</p> <p>Floor tile contains asbestos and is in poor condition.</p>

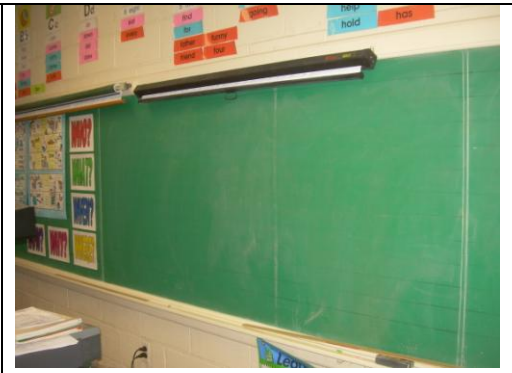
<p>Description:</p> <p>Whiteboards needed in some classrooms.</p>

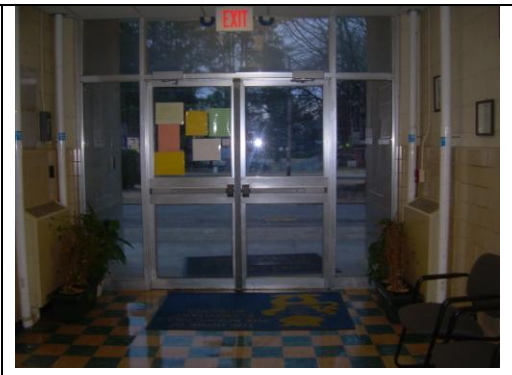
<p>Description:</p> <p>Store front doors and windows in poor condition.</p>

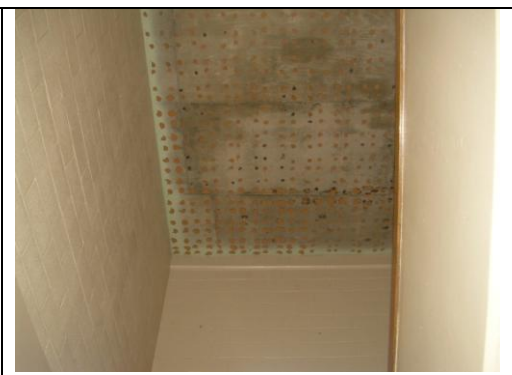
<p>Description:</p> <p>Ceiling tile glue spots are exposed from missing ceiling tiles in stairwells.</p>

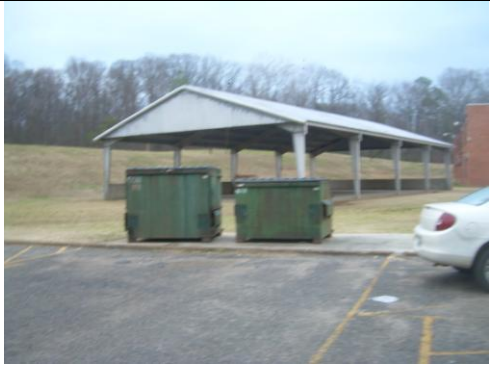
Description: Dumpsters (2) need enclosures.

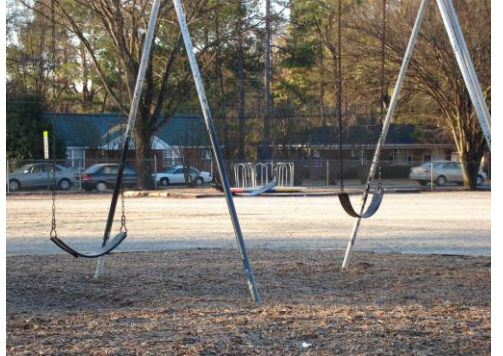
<p>Playground/Surfaces Equipment Status:</p> <p>Partially equipped Has woodchips w/crossties border surface</p>	 
<p>Playground Equipment / Surface Condition:</p> <p>Old, antiquated, and needs replacement Good surface No fence enclosure</p>

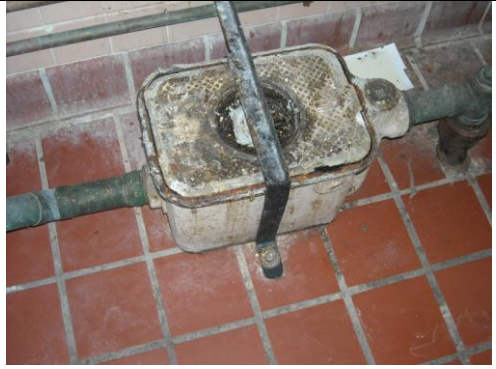
<p>Description:</p> <p>Grease trap need replacing in kitchen</p>

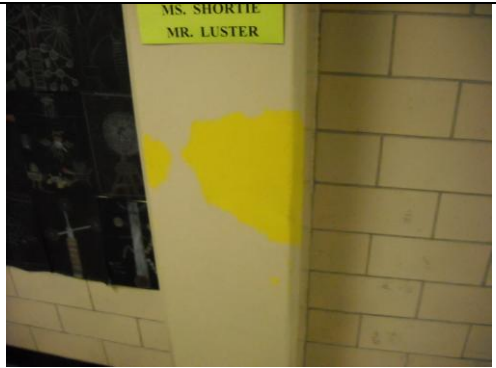
<p>Timeline:</p> <p>2009-10</p>	<p>Cost:</p> <p>\$20,000</p>
<p>Description:</p> <p>Paint interior of building</p>

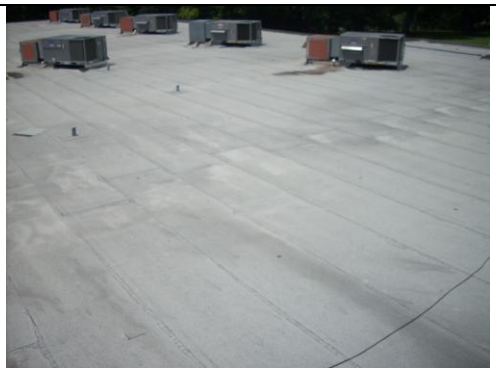
<p>Timeline:</p> <p>2010-11</p>	<p>Cost:</p> <p>\$66,600</p>
<p>Description:</p> <p>PVC single ply roof: 8 years-good</p>

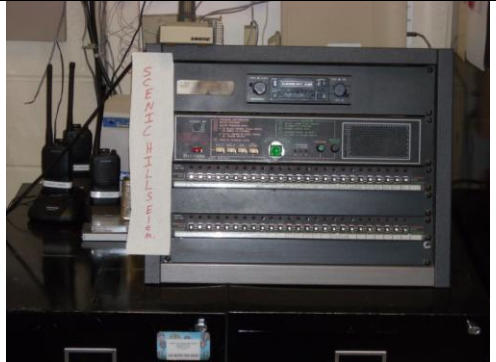
<p>Description:</p> <p>Intercom System:</p> <p>Boger MCP35A</p> <p>Installation Date: 1995</p>
