# 2010 FACILITIES ASSESSMENT

## SOUTHWEST VO- TECH CENTER

<b>Project Data</b>	
<b>Location Code:</b>	250
<b>Address:</b>	3746 Horn Lake
<b>Year Built:</b>	1976
<b>Grade Configuration:</b>	None
<b>Student Capacity:</b>	520
<b>Ideal Capacity:</b>	N/A
<b>ADA Student Enrollment:</b>	0
<b>Size:</b>	14.3 acres
<b>Portables:</b>	0
<b>Building &amp; Addition</b>	64,201 s. f.

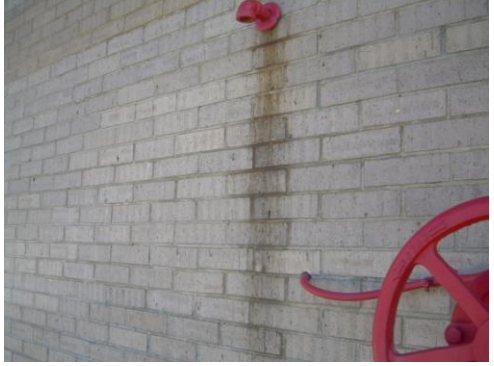
<b>Description:</b> Exterior of building needs pressure washing.

<b>Timeline:</b> <b>TBD</b>	<b>Cost:</b> <b>\$2,000</b>

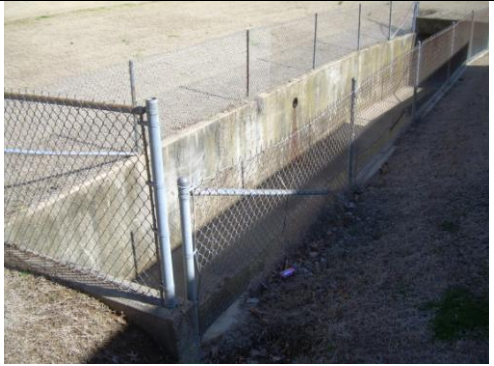
<b>Description:</b> Fencing at drainage ditch is damaged.

<b>Timeline:</b> <b>TBD</b>	<b>Cost:</b> <b>\$3,000</b>

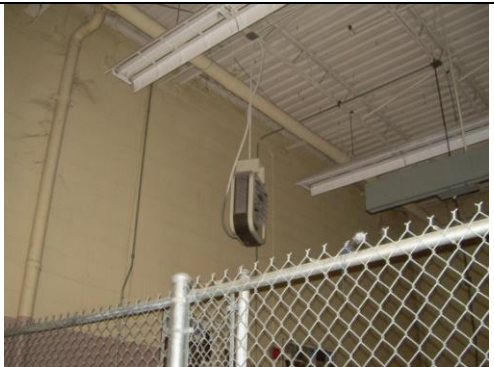
<b>Description:</b> CMU's do not provide enough heat for this area of the building.

<b>Timeline:</b> <b>TBD</b>	<b>Cost:</b> <b>\$50,000</b>
