2010 FACILITIES ASSESSMENT FOX MEADOWS ELEMENTARY

Location Code:	071
Address:	2960 Emerald Street
Year Built:	Original Building 1965
Grade Configuration:	K-5
Student Capacity:	800
Ideal Capacity:	467
ADA Student Enrollment:	0
Size:	11.0 acres
Portables:	0
Building & Additions	55,553 s. f.

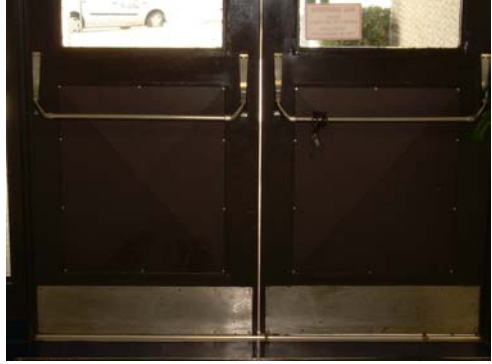
<p>Description:</p> <p>Upgrade to ADA guidelines</p>

<p>Timeline:</p> <p>TBD</p>	<p>Cost:</p> <p>\$28,000</p>

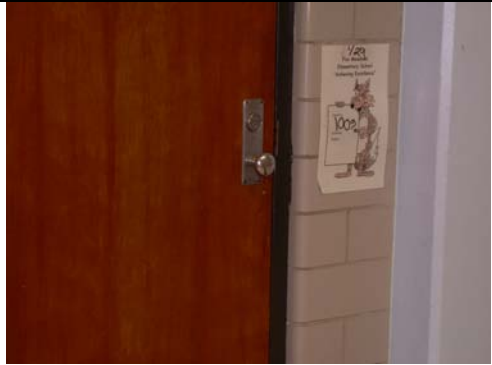
<p>Description:</p> <p>Same as previous item</p>

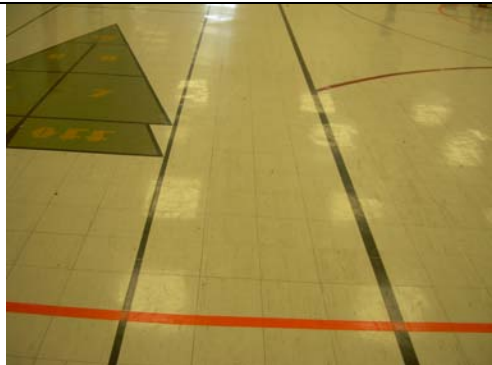
<p>Description:</p> <p>Existing floor tile in gymnasium contain asbestos and is in poor to fair condition.</p>

<p>Timeline:</p> <p>TBD</p>	<p>Cost:</p> <p>\$20,000</p>

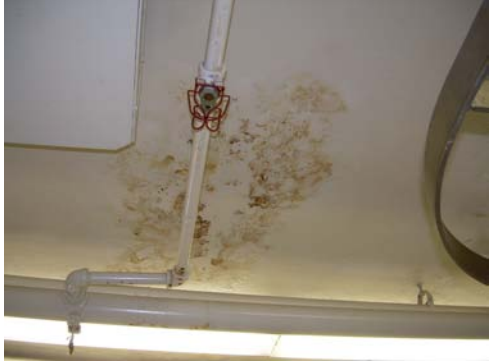
Description: Kitchen ceiling has water damage.

A photograph showing a kitchen ceiling with significant water damage. The ceiling is stained with brown and yellowish marks, and a white pipe is visible running across it.
Timeline: TBD	Cost: \$3,000

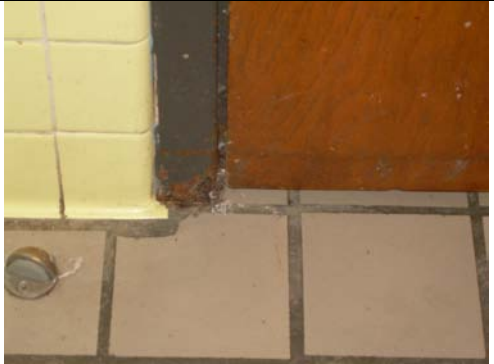
Description: Existing door frame is old, in poor condition and rusting creating health department concerns and issues.

A photograph showing a close-up of a door frame. The frame is heavily rusted and appears to be made of metal. The surrounding wall is painted yellow and orange.
Timeline: TBD	Cost: \$4,700

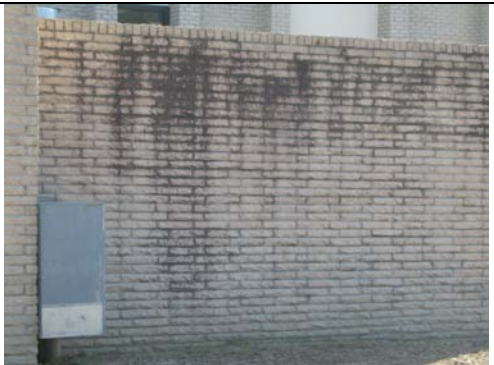
Description: Exterior of building has residual material in several areas.

A photograph showing the exterior of a brick building. There are several dark, irregular stains on the brickwork, indicating residual material or mold.
Timeline: TBD.	Cost: \$3,000

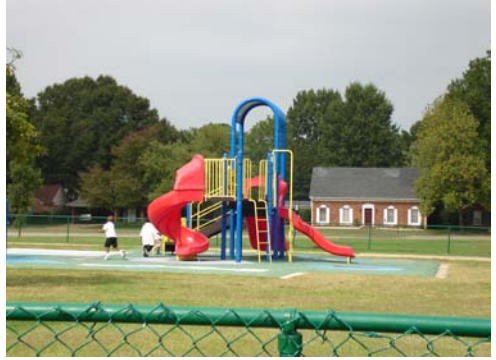
<p>Playground/Surfaces Equipment Status:</p> <p>Fully equipped Has cast in place rubber surface.</p>

<p>Playground Equipment / Surface Condition:</p> <p>New equipment, good Good, surface Fence enclosure inadequate needs replacing</p>	
<p>Description:</p> <p>Replace cooling tower</p>

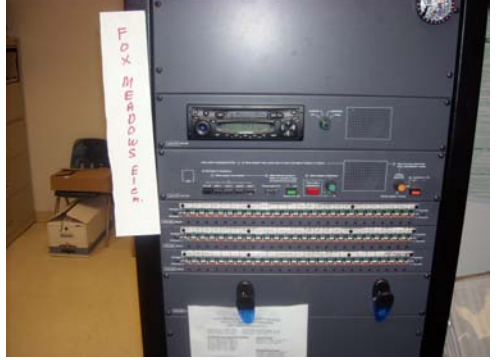
<p>Timeline:</p> <p>2016-17</p>	<p>Cost:</p> <p>\$228,000</p>
<p>Description:</p> <p>Intercom System Rauland MCZ3000 Installation Date: 2001</p>

<p>Timeline:</p> <p>TBD</p>	<p>Cost:</p> <p>\$50,000</p>
