# 2010 FACILITIES ASSESSMENT GARDENVIEW ELEMENTARY

<b>Project Data</b>	
<b>Location:</b>	201
<b>Address:</b>	4075 Hartz Drive
<b>Year Built:</b>	1966
<b>Grade Configuration:</b>	K-5
<b>Student Capacity:</b>	680/880
<b>Ideal Capacity:</b>	559
<b>ADA Student Enrollment:</b>	0
<b>Size:</b>	5 acres
<b>Portables:</b>	12
<b>Building &amp; Addition</b>	55,570 s. f.

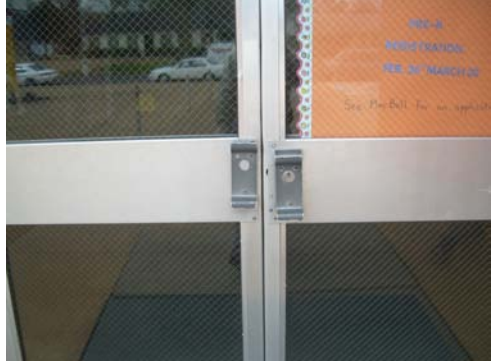
<p><b>Description:</b></p> <p>Upgrade to ADA guidelines</p>

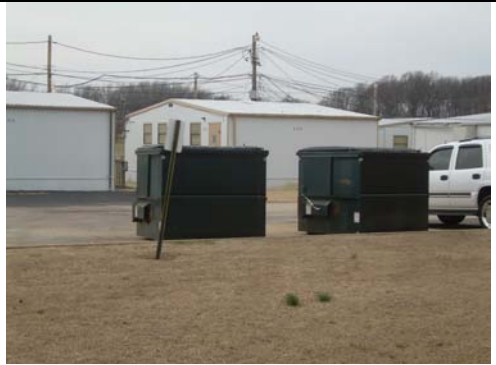
<p><b>Description:</b></p> <p>Dumpsters (2) need enclosed</p>

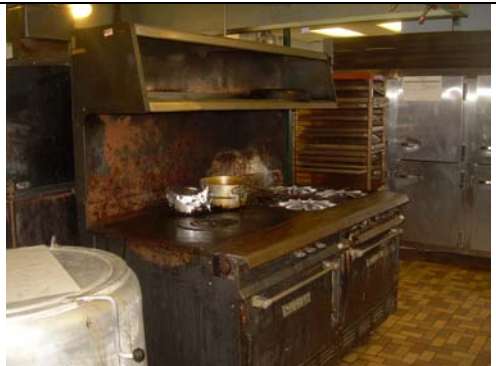
<p><b>Description:</b></p> <p>Kitchen equipment is old and in poor condition</p>

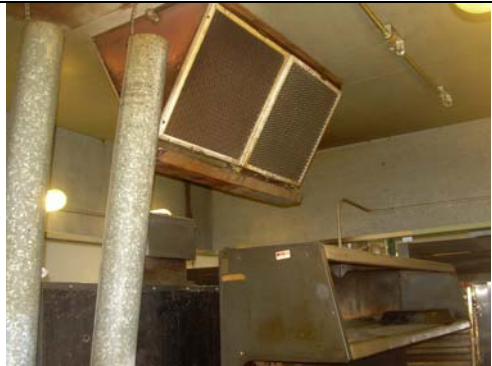
<p><b>Description:</b></p> <p>Kitchen vent-a- hood is old and not functioning properly nor does it have a fire suppression system.</p>

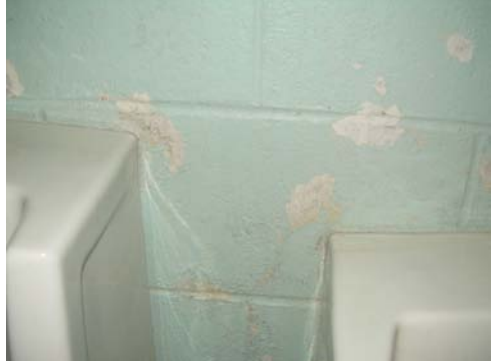
<p><b>Description:</b></p> <p>Interior of school needs painting</p>

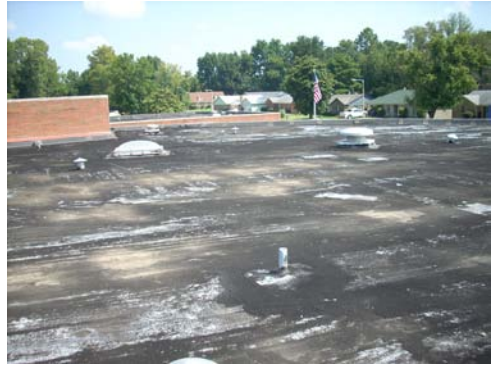
<p><b>Description:</b></p> <p>Build up modified roof: 18 years-poor</p>

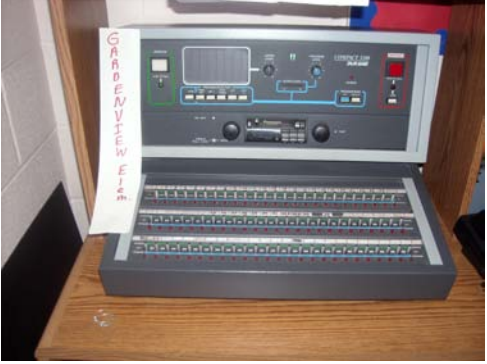
<p><b>Description:</b></p> <p>Intercom System</p> <p>Dukane 3200</p> <p>Installation Date: 1995</p>
