# 2010 FACILITIES ASSESSMENT PEABODY ELEMENTARY

<b>Project Data</b>	
<b>Location Code:</b>	046
<b>Address:</b>	2086 Young
<b>Year Built:</b>	1909
<b>Grade Configuration:</b>	K-5
<b>Student Capacity:</b>	580
<b>Ideal Capacity:</b>	403
<b>ADA Student Enrollment:</b>	0
<b>Size:</b>	2.42 acres
<b>Portables:</b>	0
<b>Building &amp; Addition</b>	53,997 s. f.

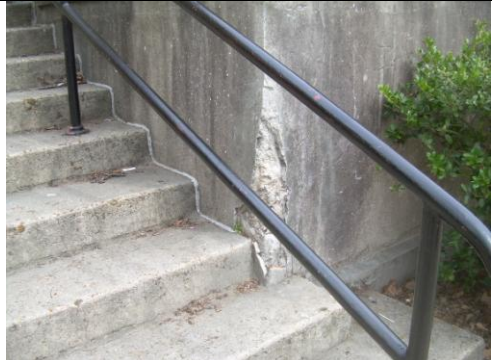
<p><b>Description:</b></p> <p>Damage to concrete wall at front stairwell.</p>

<p><b>Timeline:</b></p> <p>TBD</p>	<p><b>Cost:</b></p> <p><b>\$1,000</b></p>

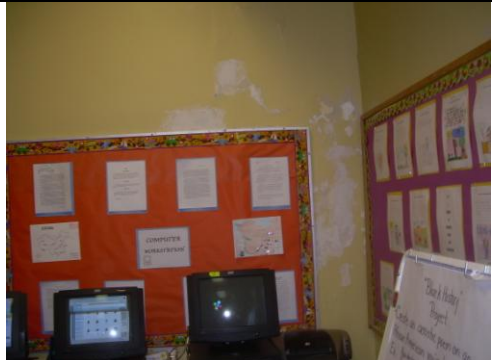
<p><b>Description:</b></p> <p>Chronic problems with water damaged plaster walls throughout facility, especially in basement or sub-grade rooms.</p>

<p><b>Timeline:</b></p> <p>TBD</p>	<p><b>Cost:</b></p> <p><b>\$45,000</b></p>

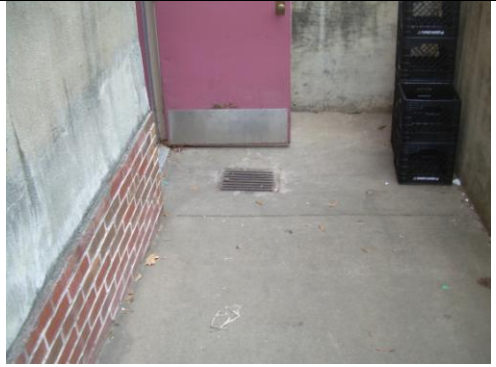
<p><b>Description:</b></p> <p>Drain not adequate for the amount of water this area receives during rain.</p>

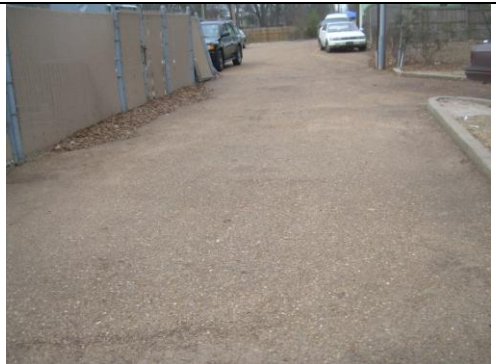
<p><b>Timeline:</b></p> <p>TBD</p>	<p><b>Cost:</b></p> <p>\$20,000</p>
<p><b>Description:</b></p> <p>Facility does not have an adequate amount of parking spaces.</p>

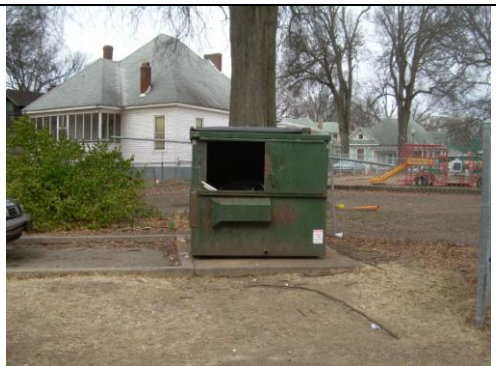
<p><b>Timeline:</b></p> <p>TBD</p>	<p><b>Cost:</b></p> <p>\$45,000</p>
<p><b>Description:</b></p> <p>Dumpster has no enclosure.</p>
