2010 FACILITIES ASSESSMENT SEA ISLE ELEMENTARY

Location Code:	053
Address:	5250 Sea Isle
Year Built:	1955
Grade Configuration:	K-5
Student Capacity:	680
Ideal Capacity:	764
ADA Student Enrollment:	0
Size:	32.94 acres
Portables:	0
Building & Additions:	79,703 s. f.

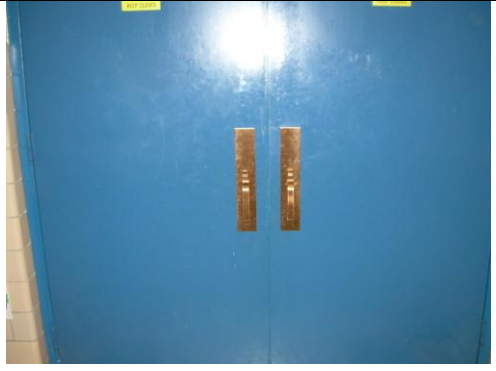
<p>Description:</p> <p>Upgrade to ADA guidelines.</p>

<p>Timeline:</p> <p>2010-11</p>	<p>Cost:</p> <p>\$408,000</p>
<p>Description:</p> <p>Whiteboards needed in some classrooms.</p>

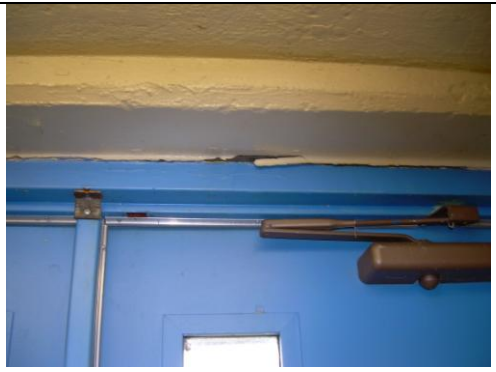
<p>Timeline:</p> <p>TBD</p>	<p>Cost:</p> <p>\$3,200</p>
<p>Description:</p> <p>Door frame contains asbestos, loose and / or missing in several areas.</p>

<p>Timeline:</p> <p>TBD</p>	<p>Cost:</p> <p>\$2,000</p>

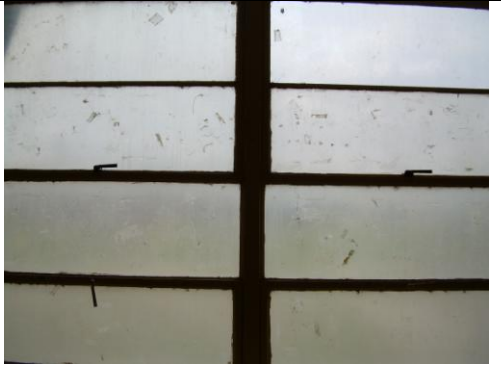
Description: Window putty / glazing contain asbestos, windows not working properly and need replacing.

Timeline: TBD	Cost: \$560,000

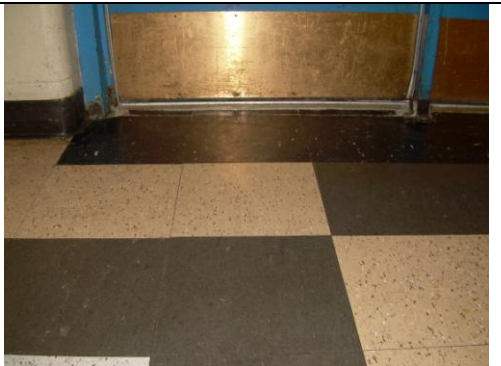
Description: Exterior door frames are rusting in several areas of school.

Timeline: TBD	Cost: \$17,500

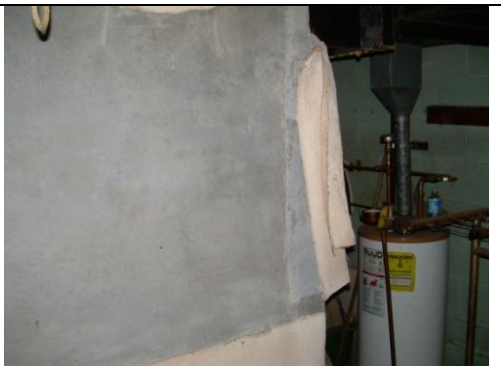
Description: Boiler room has excessive amount of asbestos insulating materials including the boiler insulation, as well as on piping- All in very poor condition.

Timeline: TBD	Cost: \$16,000

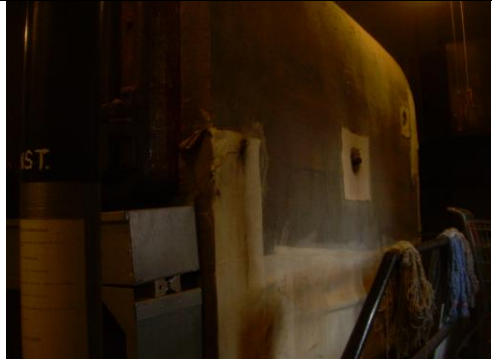
<p>Description:</p> <p>Replace boiler and HVAC/EMS controls</p>

<p>Timeline:</p> <p>2012-13</p>	<p>Cost:</p> <p>\$1,908,000</p>

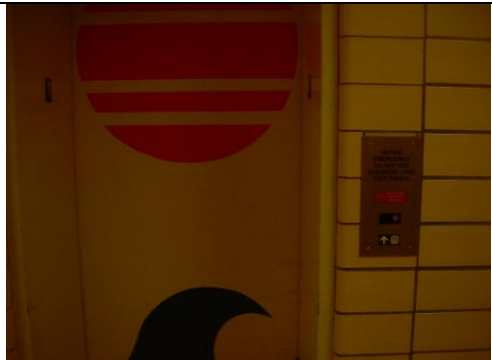
<p>Description:</p> <p>Replace major components and parts to bring the elevator up to ADA compliance</p>

<p>Timeline:</p> <p>2010-11</p>	<p>Cost:</p> <p>\$71,400</p>

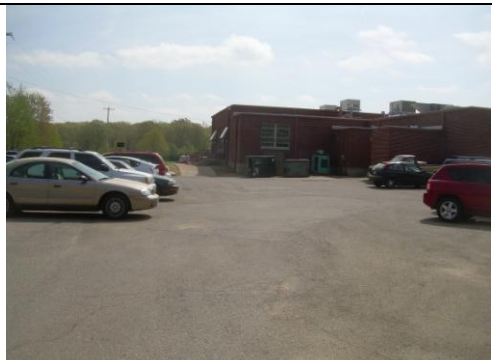
<p>Description:</p> <p>Patch, crack repair and overlay (11,850) sq. yd of asphalt parking lot</p>

<p>Timeline:</p> <p>2012-13</p>	<p>Cost:</p> <p>\$131,000</p>

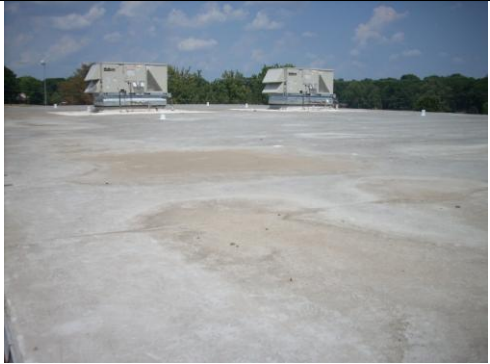
<p>Description:</p> <p>PVS Single ply roof: 12 years-fair</p>

<p>Timeline:</p> <p>TBD</p>	<p>Cost:</p> <p>\$262,750</p>

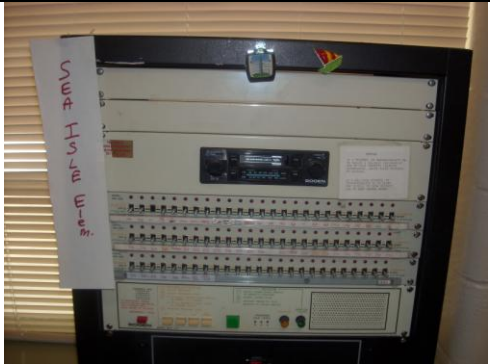
<p>Description:</p> <p>Intercom System: Bogen MCP35A Installation Date: 1993</p>

<p>Timeline:</p> <p>TBD</p>	<p>Costs:</p> <p>\$50,000</p>
