2010 FACILITIES ASSESSMENT
 SPRINGDALE ELEMENTARY

Project Data	
Location Code:	059
Address:	880 N. Hollywood
Year Built:	1939
Grade Configuration:	K-5
Student Capacity:	480
Ideal Capacity:	416
ADA Student Enrollment:	0
Size:	6.14 acre
Portables:	0
Building & Additions:	58,986 s. f.

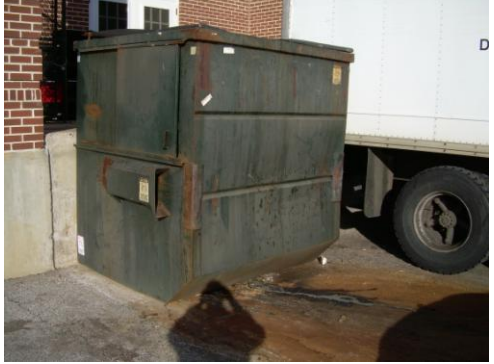
Description: Dumpster needs enclosure.

Timeline: TBD	Cost: \$5,000

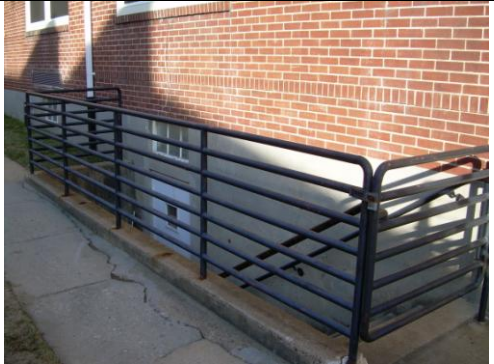
Description: Exterior railing leading to basement is to code, but the children climb on them after school hours.

Timeline: TBD	Cost: \$2,000

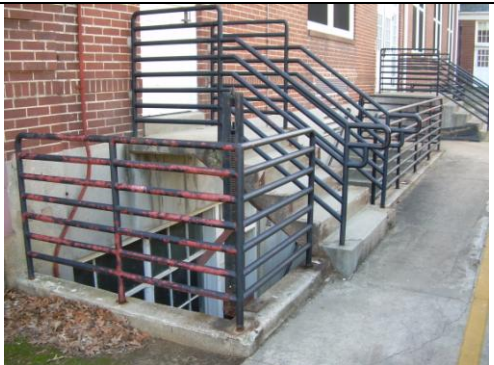
Description: Paint on rails in poor condition.

Timeline: TBD	Cost: \$2,000

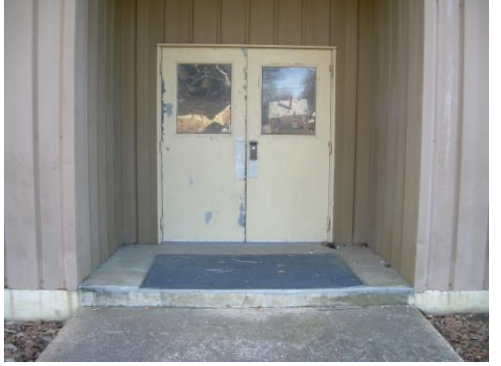
Description: Upgrade to ADA guidelines.

Timeline: TBD	Cost: \$24,000

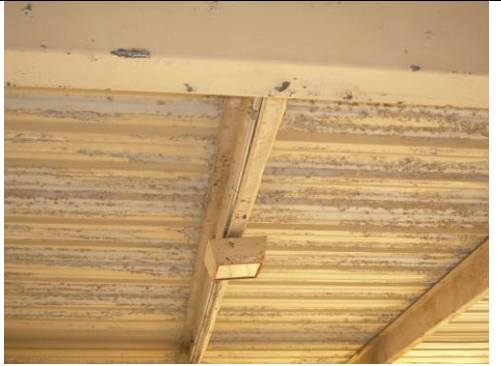
Description: Walkway canopy to old metal building in need of painting.

Timeline: TBD	Cost: \$1,500

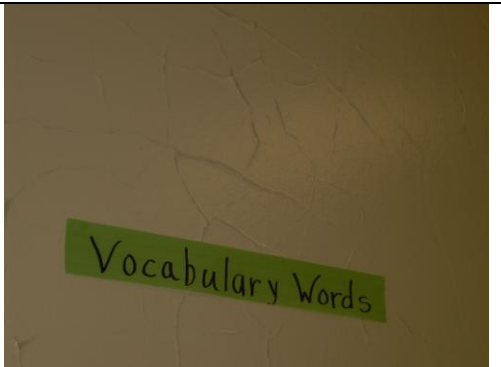
Description: Foundation and structural issues.

Timeline: TBD	Cost: N/A

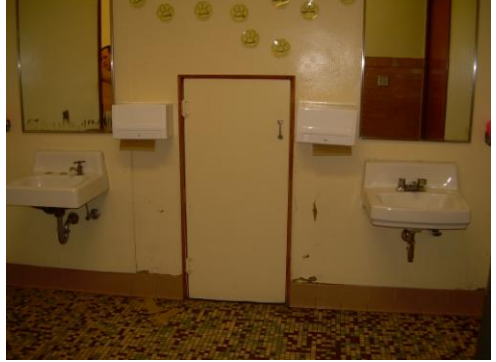
<p>Description:</p> <p>Existing restroom sinks are old and do not meet ADA standards.</p>

<p>Timeline:</p> <p>TBD</p>	<p>Cost:</p> <p>\$20,000</p>

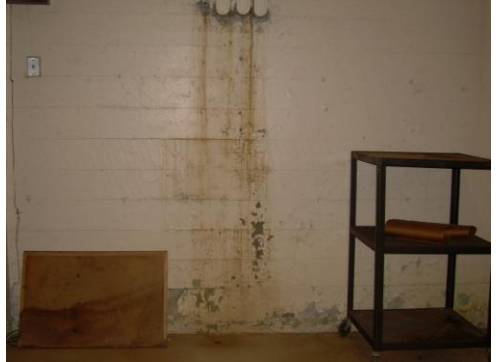
<p>Description:</p> <p>Basement needs painting.</p>

<p>Timeline:</p> <p>TBD</p>	<p>Cost:</p> <p>\$5,000</p>

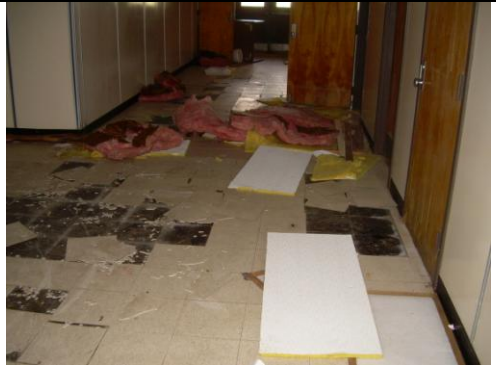
<p>Description:</p> <p>This picture and the following (4) pictures, are of the abandoned metal building located directly to the north of the main building currently not in use:</p> <p>Damaged Asbestos floor tiles, ADA hardware needed, whiteboards needed, etc.</p>

<p>Timeline:</p> <p>TBD</p>	<p>Cost:</p> <p>\$250,000</p>

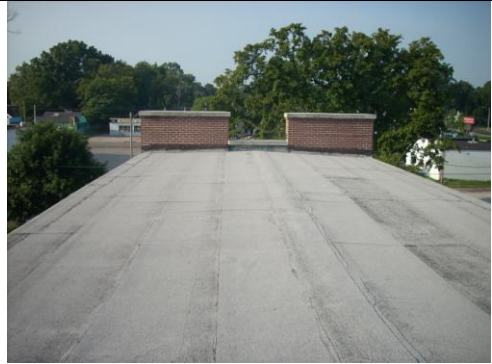
<p>Description:</p> <p>Build up modified roof: 11 years-fair</p> <p>Shingled roof: 11 years-poor</p> <p>Metal roof: 30 years-poor</p>

<p>Timeline:</p> <p>TBD</p>	<p>Cost:</p> <p>\$382,500</p>

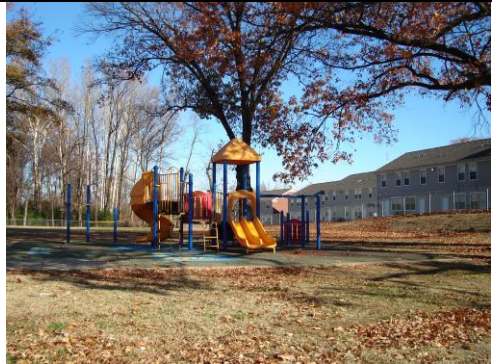
<p>Playground/Surfaces Equipment Status:</p> <p>Fully equipped Has cast in place rubber surface</p> <p>Playground Equipment / Surface Condition:</p> <p>Good equipment Good surface No fence enclosure</p>

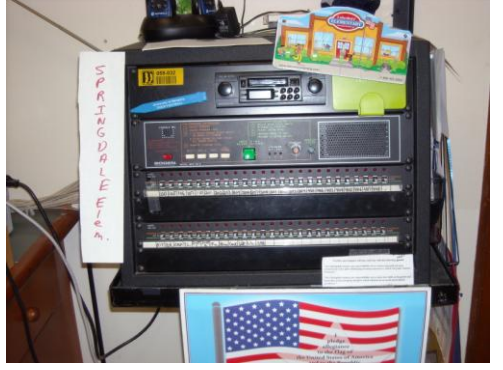
<p>Description:</p> <p>Intercom System:</p> <p>Bogen MCP35A</p> <p>Installation Date: 2001</p>

<p>Timeline:</p> <p>TBD</p>	<p>Cost:</p> <p>\$50,000</p>
