2010 FACILITIES ASSESSMENT
WELLS STATION ELEMENTARY

Project Data	
Location Code:	063
Address:	1610 Wells Station
Year Built:	1954
Grade Configuration:	K-6
Student Capacity:	680/740
Ideal Capacity:	537
ADA Student Enrollment:	2
Size:	N/A
Campus:	8.43 acres
Portables:	0
Building & Addition:	69,435 s. f.

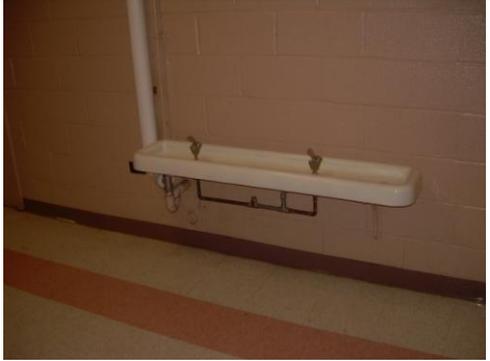
Description: Upgrade to ADA guidelines.

Timeline: 2018-19	Cost: \$17,700

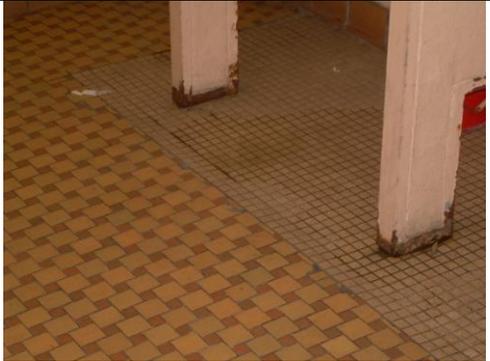
Description: Restroom stall doors are missing and stalls have physical damage throughout.

Timeline: TBD	Cost: \$3,000

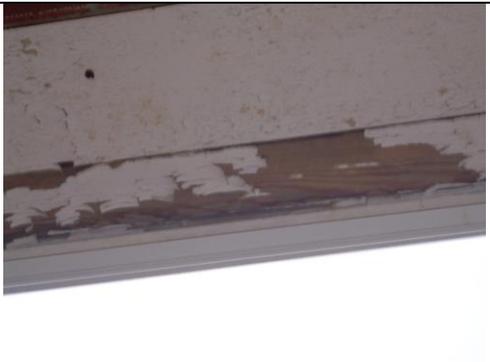
Description: Clean, seal and paint exterior

Timeline: 2013-14	Cost: \$119,000

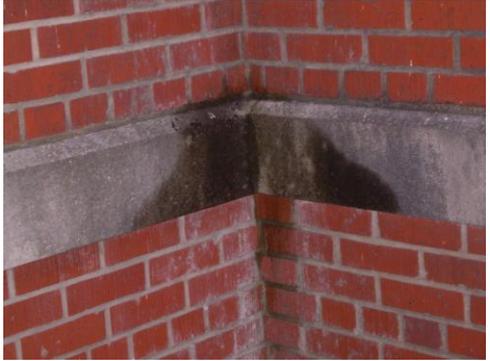
<p>Description:</p> <p>Exterior of building need pressure washing.</p>

<p>Timeline:</p> <p>TBD</p>	<p>Cost:</p> <p>\$2,000</p>

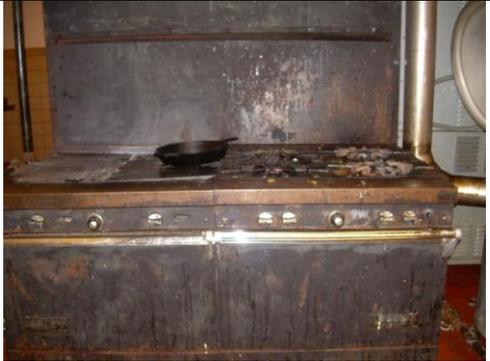
<p>Description:</p> <p>Kitchen equipment is in poor condition and not functioning properly.</p>

<p>Timeline:</p> <p>TBD</p>	<p>Cost:</p> <p>\$18,000</p>

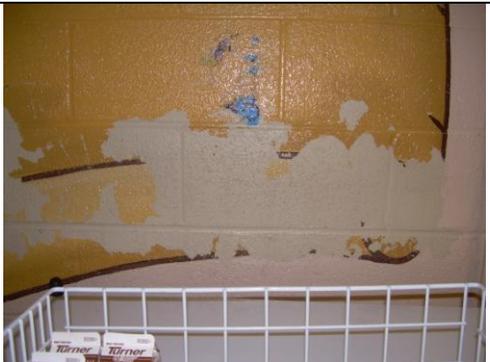
<p>Description:</p> <p>Paint interior of building</p>

<p>Timeline:</p> <p>2013-14</p>	<p>Cost:</p> <p>\$108,700</p>

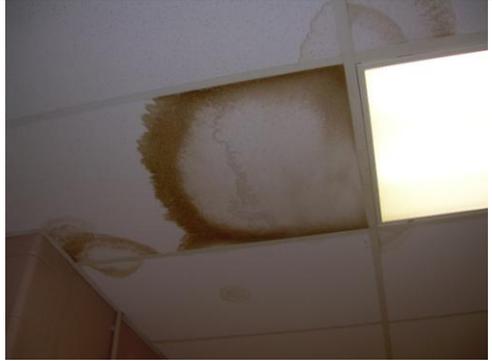
<p>Description:</p> <p>Lay-in ceiling tile in poor condition, mold is forming and creates potential health concerns.</p>

<p>Timeline:</p> <p>TBD</p>	<p>Cost:</p> <p>\$4,100</p>

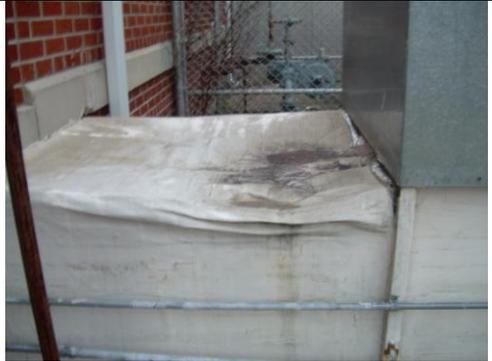
<p>Description:</p> <p>Mechanical duct damaged.</p>

<p>Timeline:</p> <p>TBD</p>	<p>Cost:</p> <p>\$800</p>

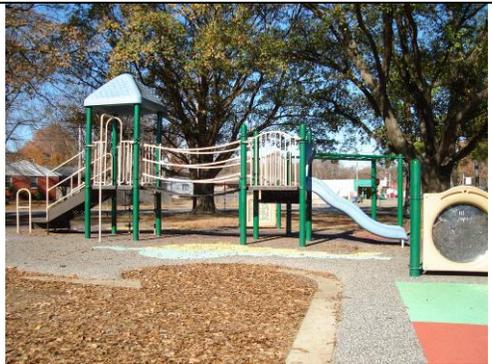
<p>Playground/Surfaces Equipment Status:</p> <p>Fully equipped Has cast in place rubber surface</p> <p>Playground Equipment / Surface Condition:</p> <p>Good equipment (new) Good surface No fence enclosure</p>

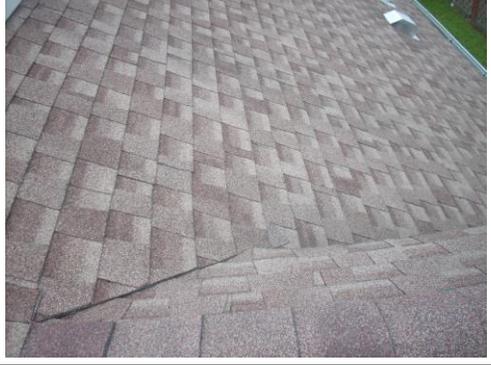
<p>Description:</p> <p>PVC Single Ply Roof: 8 Years-Good</p>

<p>Timeline:</p> <p>TBD</p>	<p>Cost:</p> <p>\$338,000</p>
