PEABODY ELEMENTARY FIRST FLOOR LIMITED HAZMAT SURVEY	
DESCRIPTION: LBP AND ACM SAMPLE LOCATIONS	PROJECT #: 251504.00
LOCATION: 2086 YOUNG AVE, MEMPHIS, TN 38104	DATE: FEBRUARY 2024

CLIENT PROJECT: Peabody Elementary ACM, 251504.00
CEI LAB CODE: B242959

PEABODY ELEMENTARY SCHOOL RENOVATION

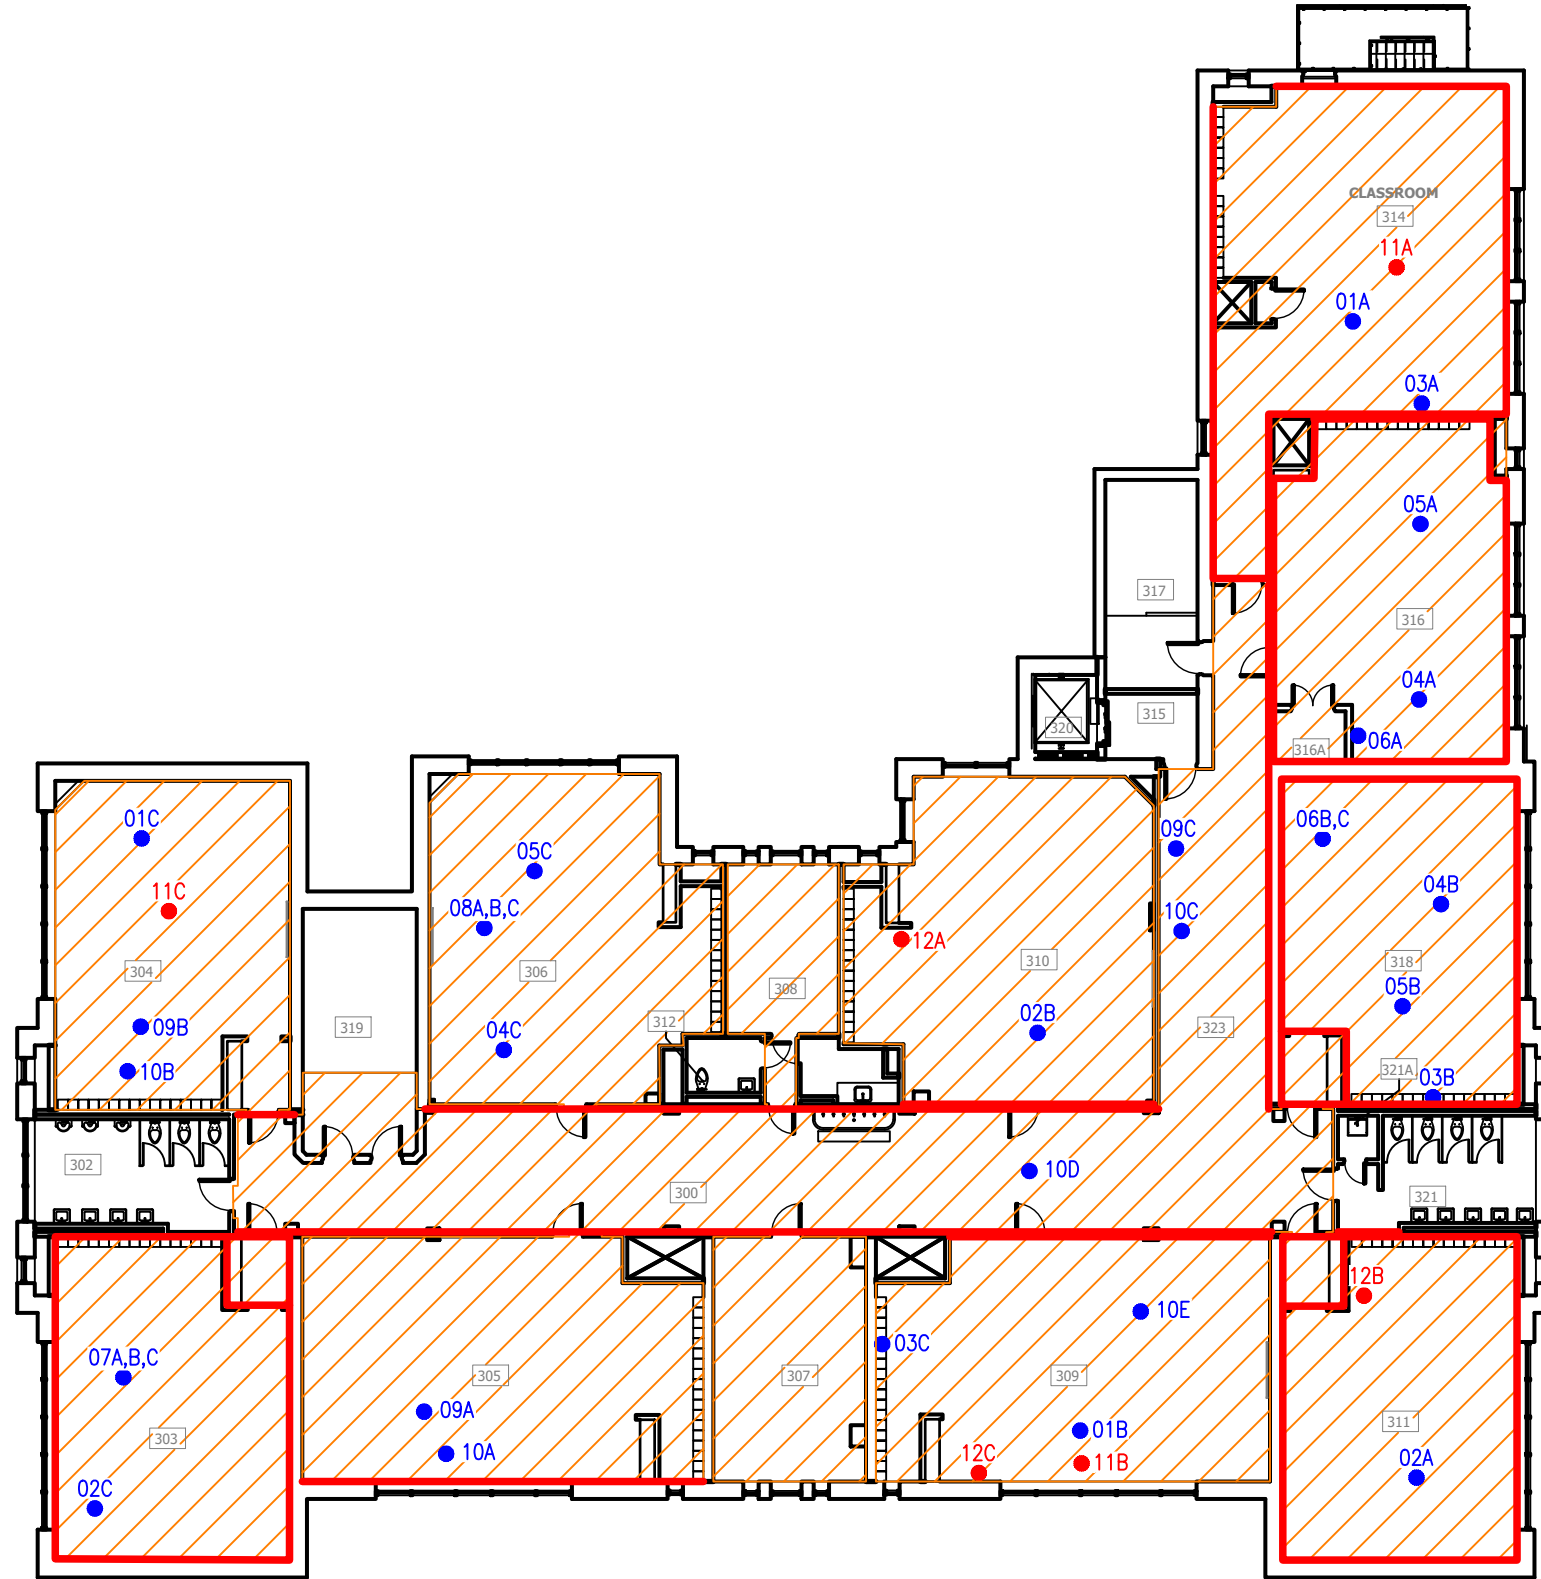
SAMPLE SERIES: PE-02-

= BROWN AND GRAY ACM FLOOR TILE
