# 2010 FACILITIES ASSESSMENT DOUGLASS ELEMENTARY

Project Data	
<b>Location Code:</b>	016
<b>Address:</b>	1650 Ash Street
<b>Year Built:</b>	1967
<b>Grade Configuration:</b>	K-7
<b>Student Capacity:</b>	920
<b>Ideal Capacity:</b>	720
<b>ADA Student Enrollment:</b>	31
<b>Portables:</b>	8.00 acres
<b>Building &amp; Addition</b>	36,171 s. f.

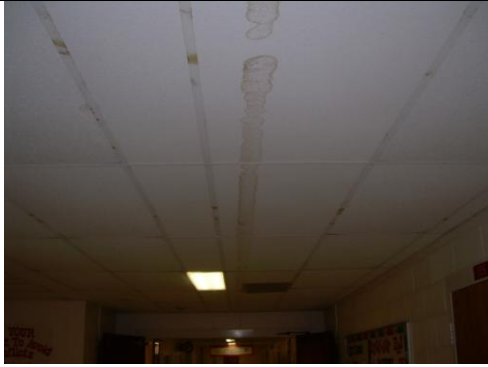
<p><b>Description:</b></p> <p>Chronic condensation problems from piping. Also causing damage to ceiling tile.</p>

<p><b>Timeline:</b></p> <p>TBD</p>	<p><b>Cost</b></p> <p><b>\$10,000</b></p>
<p><b>Description:</b></p> <p>Wooden shelves in pantry.</p>

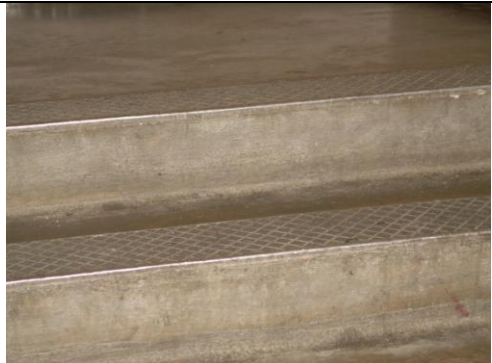
<p><b>Description:</b></p> <p>Stairwell treads have lost their integrity.</p>

<p><b>Timeline:</b></p> <p><b>TBD</b></p>	<p><b>Cost</b></p> <p><b>\$17,000</b></p>

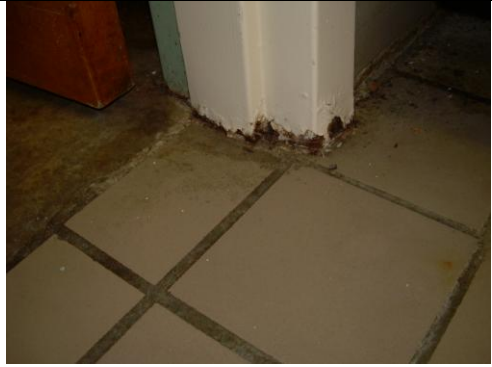
<p><b>Description:</b></p> <p>Door frames in kitchen are rusting creating health department issues.</p>

<p><b>Timeline:</b></p> <p>TBD</p>	<p><b>Cost</b></p> <p>\$3,700</p>

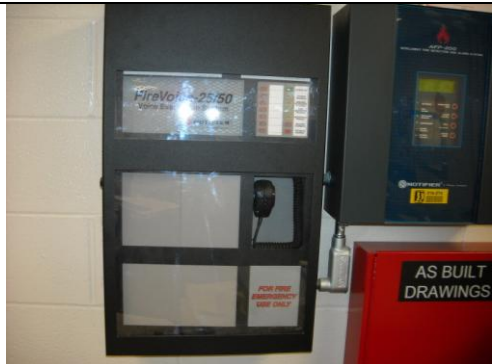
<p><b>Description:</b></p> <p>Replace EMS system and controls</p>

<p><b>Timeline:</b></p> <p>2010-11</p>	<p><b>Cost</b></p> <p>\$212,000</p>

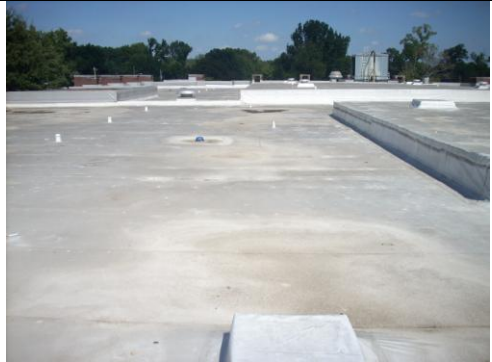
<p><b>Description:</b></p> <p>PVC Single ply roof: 10 years-poor</p>

<p><b>Timeline:</b></p> <p>TBD</p>	<p><b>Cost:</b></p> <p>\$250,000</p>

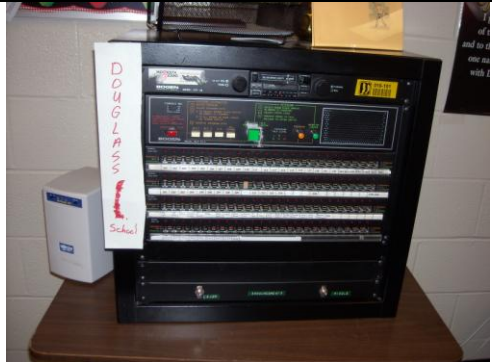
<p><b>Description:</b></p> <p>Intercom System: Bogen MCP35A Installation Date: 1995</p>

<p><b>Timeline:</b></p> <p>2013-14</p>	<p><b>Cost:</b></p> <p>\$50,000</p>
