2010 FACILITIES ASSESSMENT  
LAROSE ELEMENTARY

<b>Project Data</b>	
<b>Location Code:</b>	033
<b>Address:</b>	851 S. Wellington
<b>Year Built:</b>	1963
<b>Grade Configuration:</b>	K-5
<b>Student Capacity:</b>	640
<b>Ideal Capacity:</b>	552
<b>ADA Student Enrollment:</b>	0
<b>Portables:</b>	0
<b>Building &amp; Addition</b>	94,426 s. f.

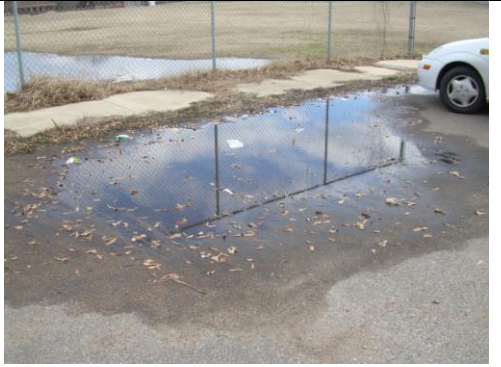
<b>Description:</b> Water ponding on asphalt parking lot.

<b>Timeline:</b>  <b>TBD</b>	<b>Cost:</b>  <b>\$35,000</b>

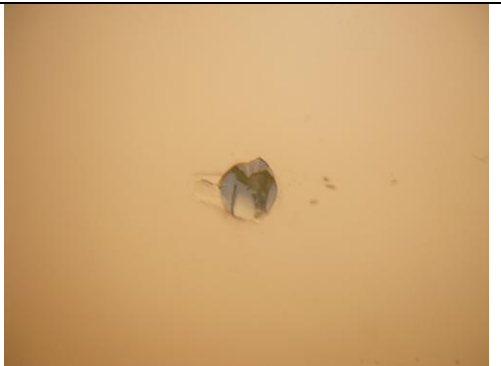
<b>Description:</b> Missing / damaged light fixture.

<b>Timeline:</b>  <b>TBD</b>	<b>Cost:</b>  <b>\$500</b>

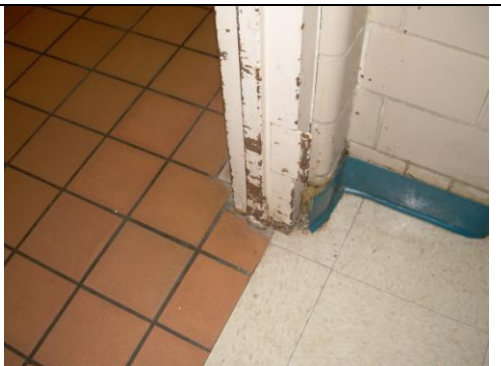
<b>Description:</b> Door frames in kitchen are rusting causing health department issues.

<b>Timeline:</b>  <b>TBD</b>	<b>Cost:</b>  <b>\$3,700</b>

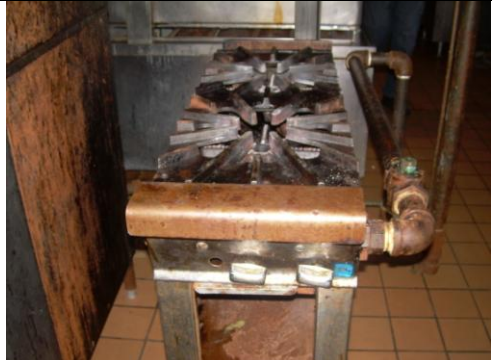
<p><b>Description:</b></p> <p>Existing kitchen appliances are old and in poor working condition.</p>

<p><b>Timeline:</b></p> <p><b>TBD</b></p>	<p><b>Cost:</b></p> <p><b>\$20,000</b></p>

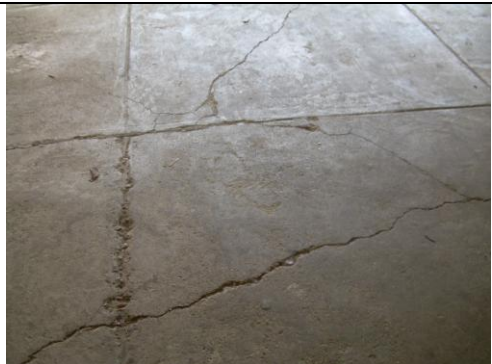
<p><b>Description:</b></p> <p>Pedestrian walkway cracked / damaged.</p>

<p><b>Timeline:</b></p> <p><b>TBD</b></p>	<p><b>Cost:</b></p> <p><b>\$1,000</b></p>

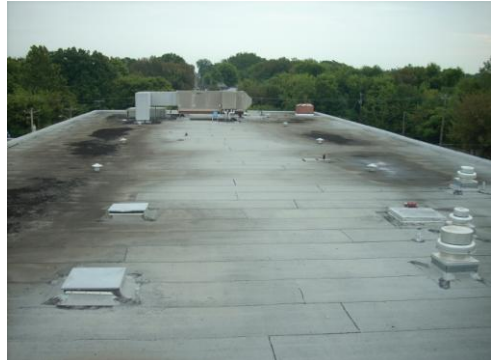
<p><b>Description:</b></p> <p>Built up roof: 12 years-fair</p> <p>Metal roof: 12 years-fair</p> <p>Built up modified roof: 16 years-poor</p>

<p><b>Timeline:</b></p> <p><b>TBD</b></p>	<p><b>Cost:</b></p> <p><b>\$212,500</b></p>

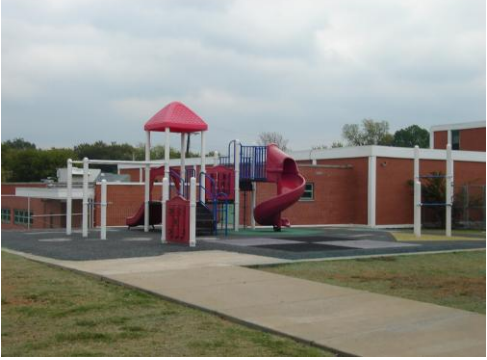
<p><b>Playground/Surfaces Equipment Status:</b></p> <p>Fully equipped Has cast in place rubber surface</p>

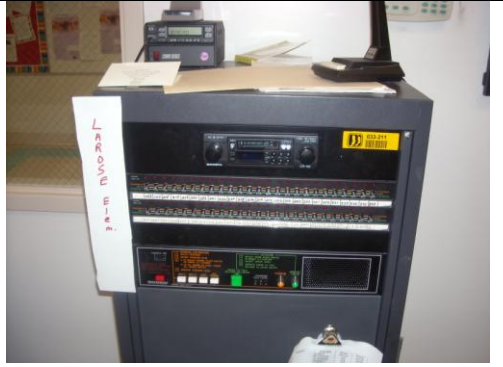
<p><b>Description:</b></p> <p>Intercom System: Bogen MCP35A Installation Date: 1998</p>

<p><b>Timeline:</b></p> <p>TBD</p>	<p><b>Costs:</b></p> <p>\$50,000</p>
