2010 FACILITIES ASSESSMENT VOLLENTINE ELEMENTARY

Project Data

| Address: | 1682 Volleentine |
| Year Built: | 1930 |

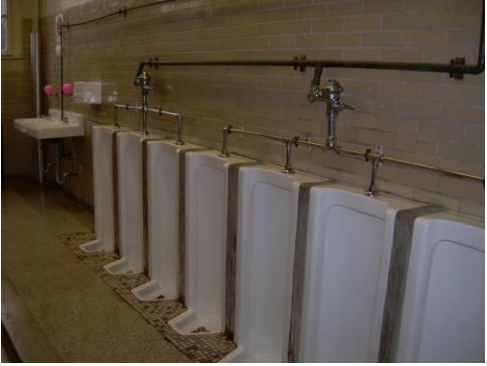
| Description: Upgrade to ADA guidelines. | |

| Timeline: TBD | Cost: \$56,000 |

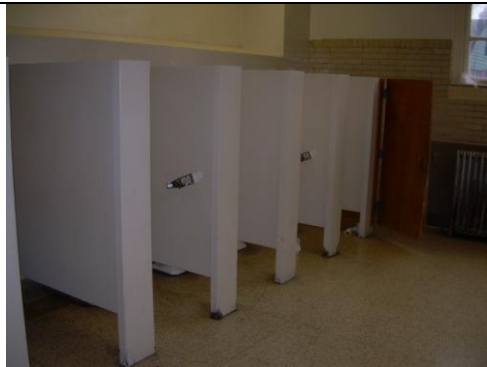
| Description: Restroom stall doors are missing. | |

| Timeline: TBD | Cost: \$2,800 |

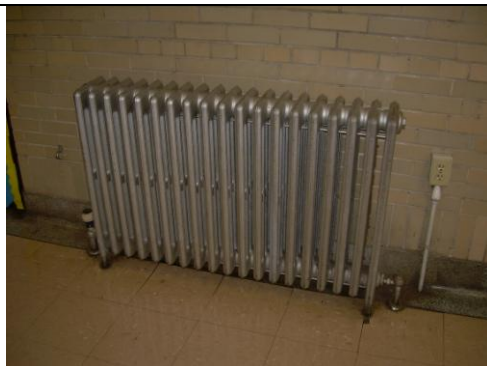
| Description: Radiators are old, antiquated and some do not function properly. | |

| Timeline: TBD | Cost: \$44,000 |

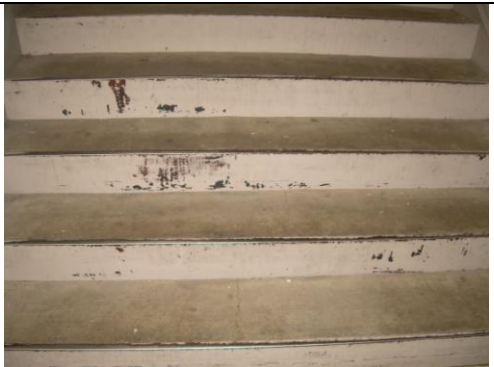
| Description: Stairwell treads have lost integrity, | |

| Timeline: TBD | Cost: \$17,000 |

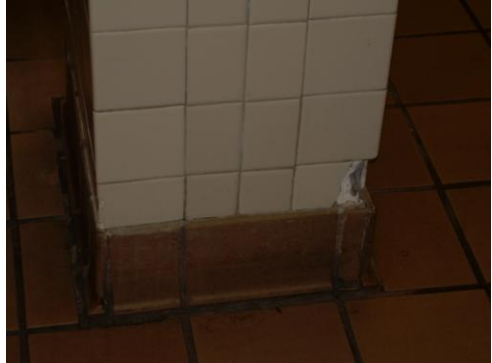
| <p>Description:</p> <p>Ceramic wall in kitchen is damaged and/or missing.</p> | |

| <p>Timeline:</p> <p>TBD</p> | <p>Cost:</p> <p>\$800</p> |

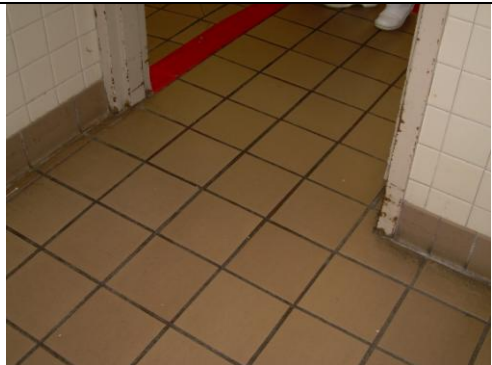
| <p>Description:</p> <p>Door frames in the kitchen are rusting creating health department issues</p> | |

| <p>Timeline:</p> <p>TBD</p> | <p>Cost:</p> <p>\$4,700</p> |

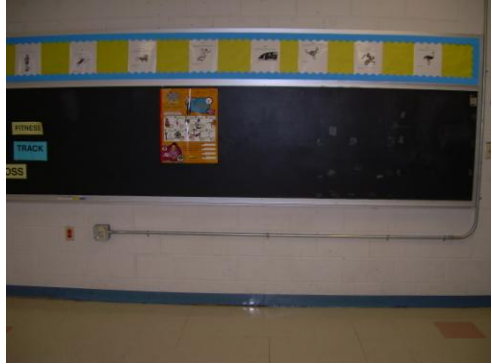
| <p>Description:</p> <p>Whiteboards needed in some classrooms</p> | |

| <p>Timeline:</p> <p>TBD</p> | <p>Cost:</p> <p>\$1,700</p> |

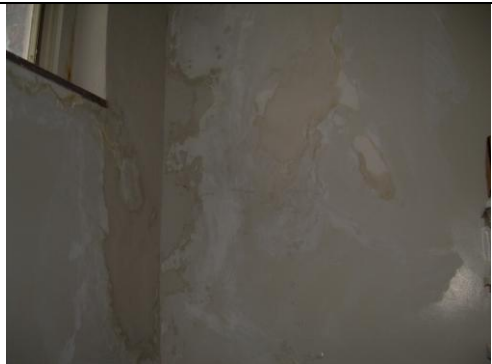
| <p>Description:</p> <p>Plaster walls in several areas in poor condition.</p> | |

| <p>Timeline:</p> <p>TBD</p> | <p>Cost:</p> <p>\$70,000</p> |

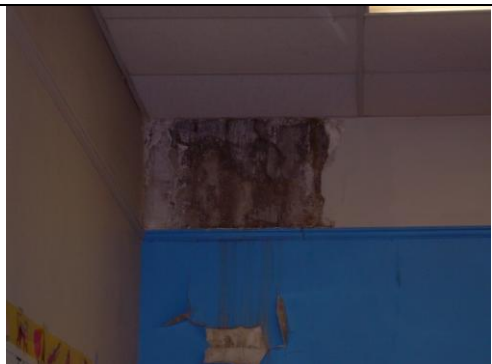
| <p>Description:</p> <p>Water is damaging plaster walls. This is a problem with their gutter system along with the amount of trees at the location.</p> | |

| <p>Timeline:</p> <p>TBD</p> | <p>Cost:</p> <p>\$100,000</p> |

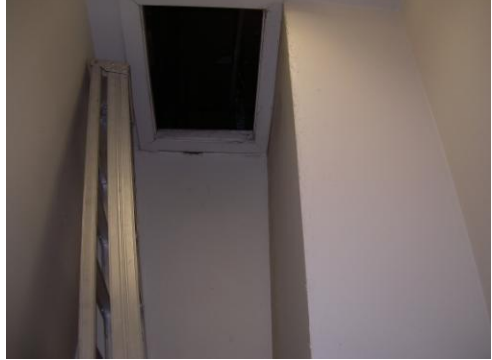
| <p>Description:</p> <p>Ladder needed to roof hatch.</p> | |

| <p>Timeline:</p> <p>TBD</p> | <p>Cost:</p> <p>\$3,500</p> |

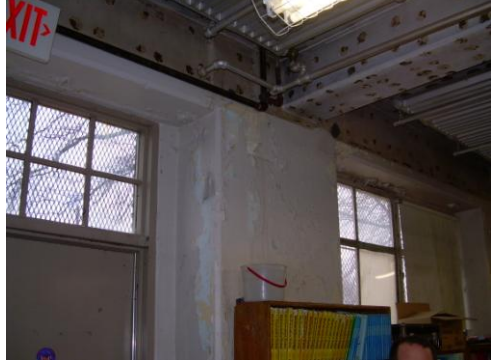
| <p>Description:</p> <p>Ceiling tile glue spots are exposed from missing ceiling tile in basement.</p> | |

| <p>Timeline:</p> <p>TBD</p> | <p>Cost:</p> <p>\$70,000</p> |

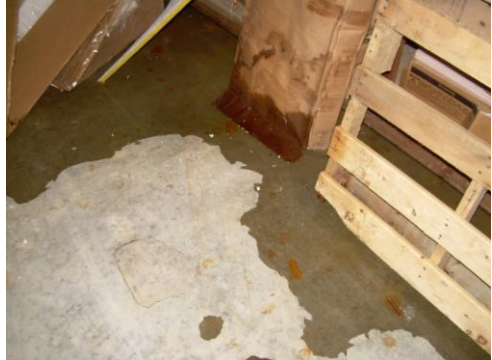
| <p>Description:</p> <p>Water penetrates around schools perimeter.</p> | |

| <p>Timeline:</p> <p>TBD</p> | <p>Cost:</p> <p>\$125,000</p> |

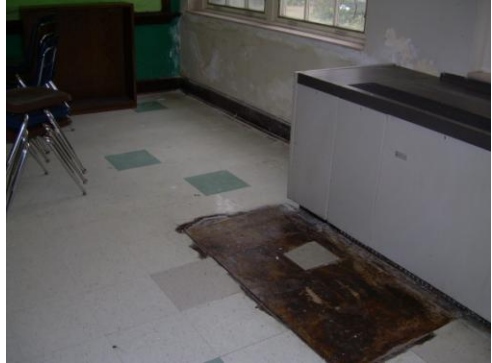
| <p>Description:</p> <p>Self-contained unit ventilators leak badly causing damage to floor tile and sub-floor. Chronic maintenance issues.</p> | |

| <p>Timeline:</p> <p>TBD</p> | <p>Cost:</p> <p>\$1,100,000</p> |

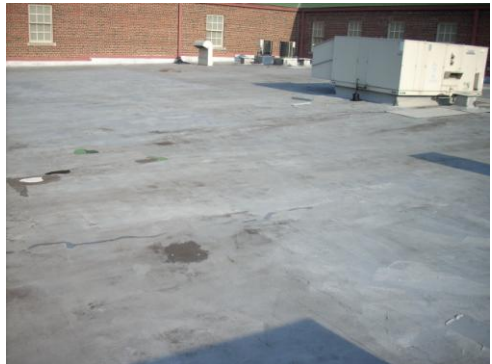
| <p>Description:</p> <p>Built up roof: 18 years-poor</p> <p>Shingled roof: 18 years-poor</p> <p>Tile: 40 years-poor</p> | |

| <p>Timeline:</p> <p>TBD</p> | <p>Cost:</p> <p>\$143,100</p> |
