FACILITY CONDITION ASSESSMENT

Shelby County Board of Education
160 South Hollywood Street
Memphis, Tennessee 38112-4892
Michelle Stuart

Ridgeway High School
2009 Ridgeway Road
Memphis, Tennessee 38119

September 29, 2024

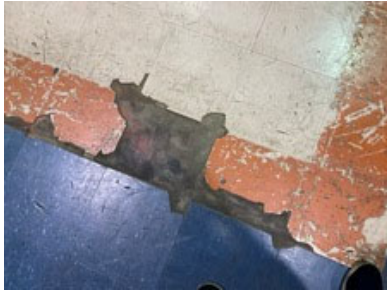
Vinyl Tile (VCT)
Ridgeway High School 2nd Gym

Flooring in Failed condition.

Flooring is missing and peeling up and there's a potential safety hazard - AssetCALC ID: 7830019

Uniformat Code: C2030
Recommendation: **Replace in 2024**

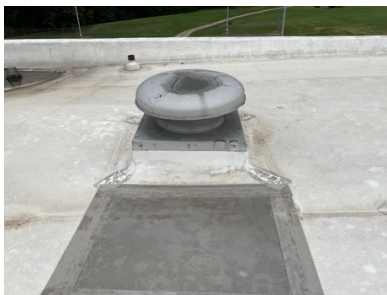
Roof or Wall-Mounted, 16" Damper, 1001 to 2000 CFM
Ridgeway High School Roof

Exhaust Fan in Failed condition.

Does not function - AssetCALC ID: 7830026

Uniformat Code: D3060
Recommendation: **Replace in 2024**

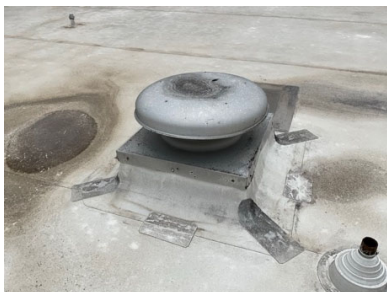
Roof or Wall-Mounted, 16" Damper, 1001 to 2000 CFM
Ridgeway High School Roof

Exhaust Fan in Failed condition.

Does not function - AssetCALC ID: 7830043

Uniformat Code: D3060
Recommendation: **Replace in 2024**

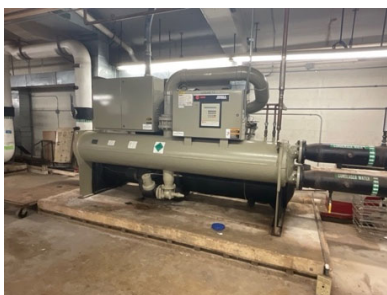
Water-Cooled
Ridgeway High School Boiler Room

Chiller in Failed condition.

Unit does not function. - AssetCALC ID: 7829989

Uniformat Code: D3030
Recommendation: **Replace in 2024**

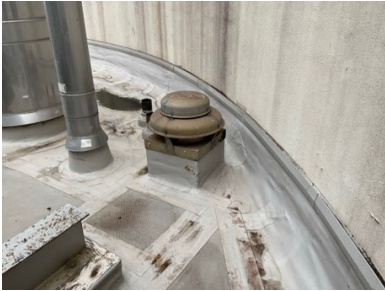
Centrifugal, 16" Damper
Ridgeway High School Roof

Exhaust Fan in Failed condition.

Not functional - AssetCALC ID: 7830031

Uniformat Code: D3060
Recommendation: **Replace in 2024**

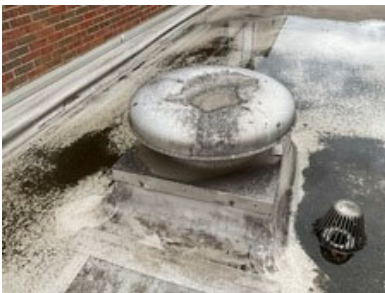
Centrifugal, 16" Damper, 1001 to 2000 CFM
Ridgeway High School Roof

Exhaust Fan in Failed condition.

Does not function - AssetCALC ID: 7830066

Uniformat Code: D3060
Recommendation: **Replace in 2024**

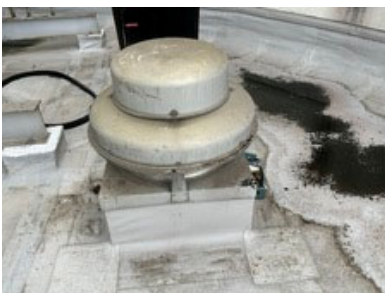
Roof or Wall-Mounted, 16" Damper, 1001 to 2000 CFM
Ridgeway High School Roof

Exhaust Fan in Failed condition.

Not functional - AssetCALC ID: 7830007

Uniformat Code: D3060
Recommendation: **Replace in 2024**

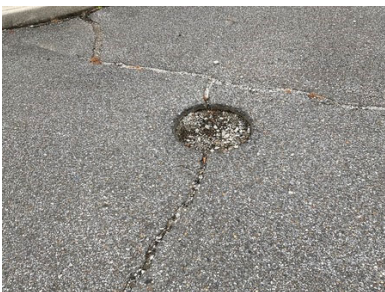
Pavement, Asphalt
Ridgeway High School North Parking lot

Parking Lots in Failed condition.

Northern parking lot has some potholes that should be repaired. - AssetCALC ID: 7830047

Uniformat Code: G2020
Recommendation: **Cut and Patch in 2024**

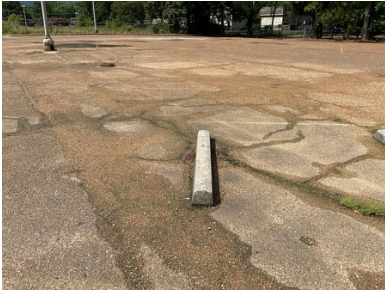
Pavement, Asphalt
Ridgeway High School Site

Parking Lots in Failed condition.

Parking lot is mostly loose, gravel and potholes. - AssetCALC ID: 7830091

Uniformat Code: G2020
Recommendation: **Mill and Overlay in 2024**

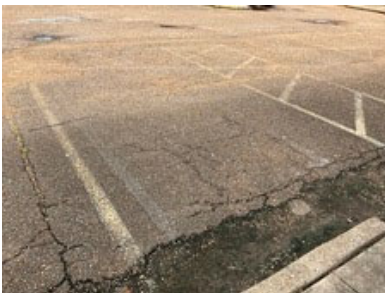
Pavement, Asphalt
Ridgeway High School Site

Parking Lots in Failed condition.

Striping is almost completely gone from pavement - AssetCALC ID: 7830039

Uniformat Code: G2020
Recommendation: **Seal and Stripe in 2024**

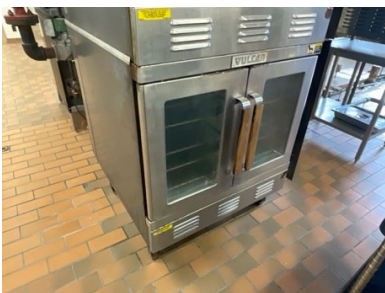
Convection Oven, Single
Ridgeway High School Commercial Kitchen

Foodservice Equipment in Failed condition.

Unit does not work - AssetCALC ID: 7835514

Uniformat Code: E1030
Recommendation: **Replace in 2024**

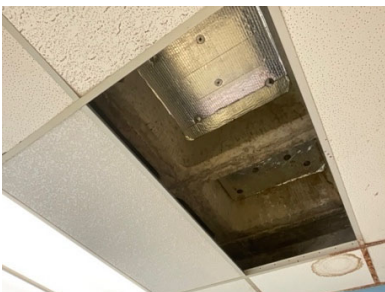
Structural, Superstructure
Ridgeway High School Cafeteria

Water drips into the northeast corner of the lunchroom and areas of the kitchen from the exterior walkway above. Multiple attempts to repair and keep the walkway from dripping in have been attempted and have all failed. A professional consultant must be retained to analyze the existing condition, provide recommendations and, if necessary, estimate the scope and cost of any required repairs. Due to the ambiguity of the required repair scope at the time of this assessment, the cost for any possible subsequent repairs is not included.

Recommended Follow-up Study: Structural, Superstructure

Water is leaking through the exterior walkway and into the cafeteria below. Many repairs have been made, but no solution to the dripping water has been found. - AssetCALC ID: 7835459

Uniformat Code: P2030
Recommendation: **Evaluate/Report in 2024**

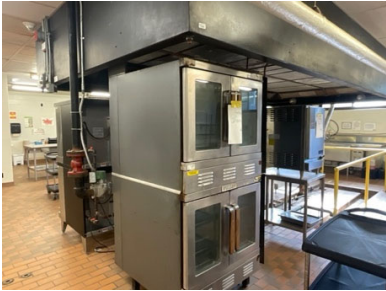
Convection Oven, Single
Ridgeway High School Commercial Kitchen

Foodservice Equipment in Failed condition.

Unit does not work - AssetCALC ID: 7835492

Uniformat Code: E1030
Recommendation: **Replace in 2024**

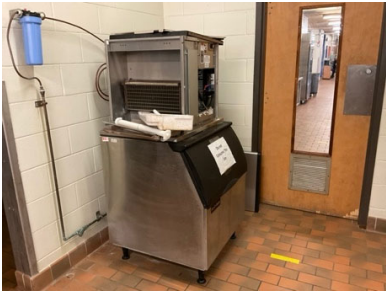
Icemaker, Freestanding
Ridgeway High School Commercial Kitchen

Foodservice Equipment in Failed condition.

Unit does not work - AssetCALC ID: 7835484

Uniformat Code: E1030
Recommendation: **Replace in 2024**

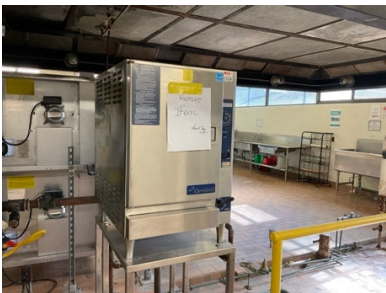
Convection Oven, Single
Ridgeway High School Commercial Kitchen

Foodservice Equipment in Failed condition.

Unit does not work - AssetCALC ID: 7835467

Uniformat Code: E1030
Recommendation: **Replace in 2024**

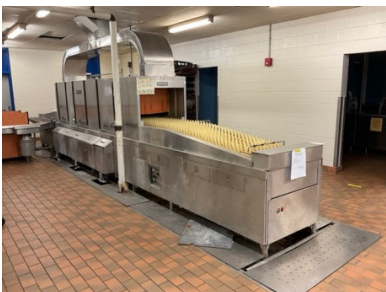
Dishwasher Commercial
Ridgeway High School Kitchen

Foodservice Equipment in Failed condition.

Unit does not work. - AssetCALC ID: 7835437

Uniformat Code: E1030
Recommendation: **Replace in 2024**

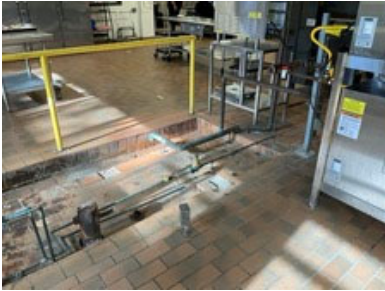
Tilting Skillet
Ridgeway High School Kitchen

Foodservice Equipment in Failed condition.

Old tilt skillet or soup latrine was removed and has not been replaced. - AssetCALC ID: 7835523

Uniformat Code: E1030
Recommendation: **Replace in 2024**

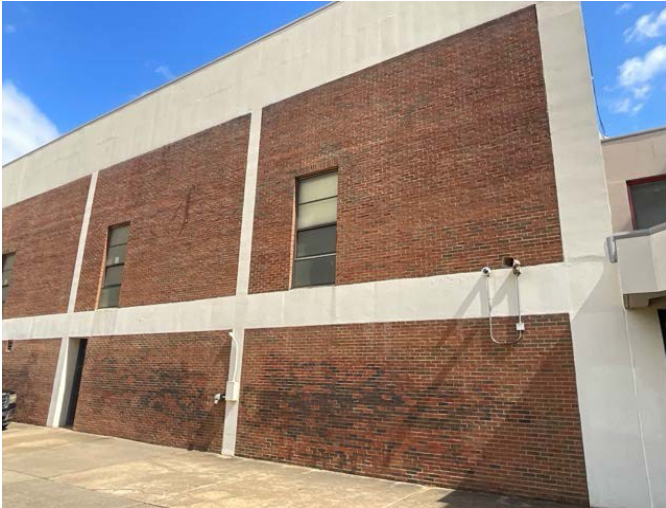
7 - EXTERIOR WALL

The structure is a three-story brick-faced concrete structure with flat TPO roofing. The building exterior is having mostly good mortar joints, but exterior windows are almost all original and have been temporarily replaced with plexiglass. All windows and glazed doors should be replaced. The interior of the school is mostly VCT flooring with painted walls throughout and ACT ceilings. Many of the fixtures and surfaces including floors, ACT, doors, bathrooms, auditorium, and more date back to the 1970s and the school is in desperate need of refresh.

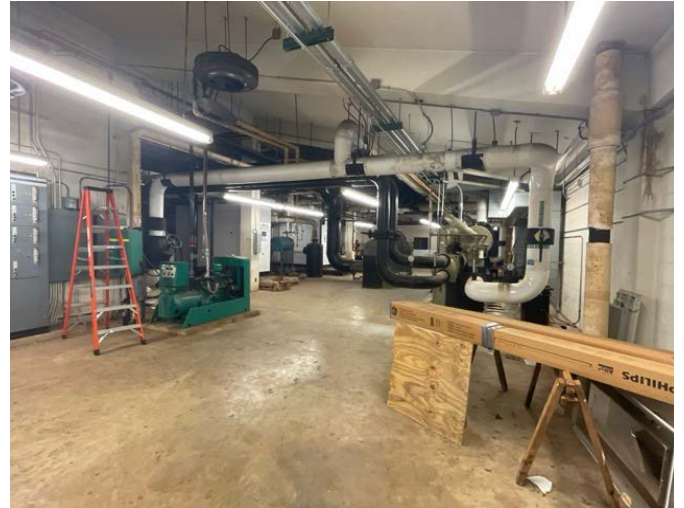
20 - BOILER ROOM

The northeast wall in the boiler room has a large crack in it. This crack appears to have been painted over at some point, and does not seem to have broken the paint, but could indicate intense stressing on the wall it cannot support. A professional consultant must be retained to analyze the existing condition, provide recommendations and, if necessary, estimate the scope and cost of any required repairs. Due to the ambiguity of the required repair scope at the time of this assessment, the cost for any possible subsequent repairs is not included.

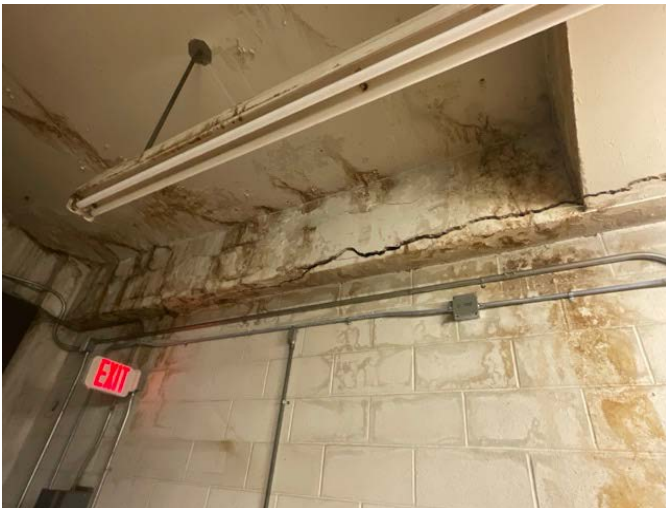
21 - STRUCTURAL CRACK IN BOILER ROOM

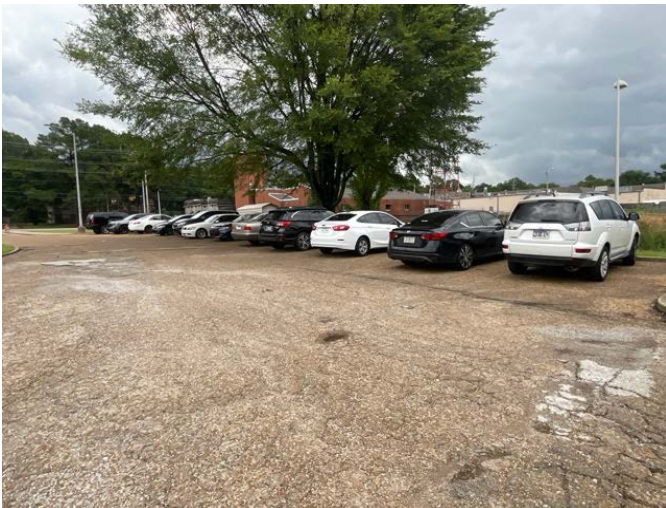
27 - PARKING LOT

The school sits on a roughly 25-acre parcel with parking lots, sports fields, open grassy areas and some forested land. Southern and western parking lots are at end of life and some of the potholes are safety hazards. Parking lots should be replaced. Additionally, baseball dugouts and sports apparatuses such as goal posts and score boards are also near or at end of life and should be updated.

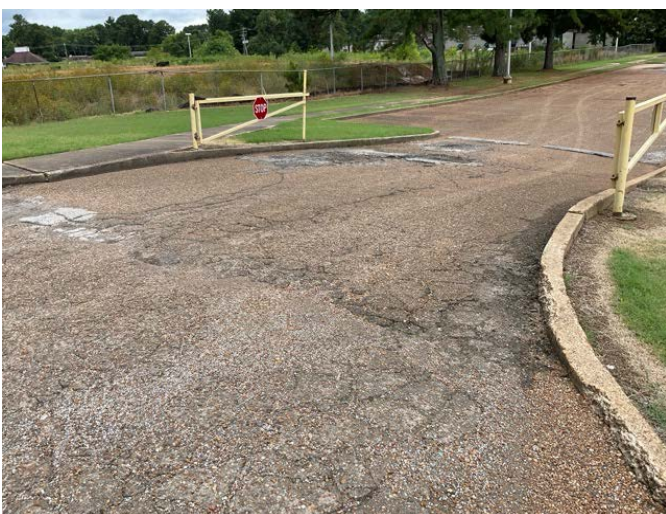
29 - DAMAGED PARKING AREA

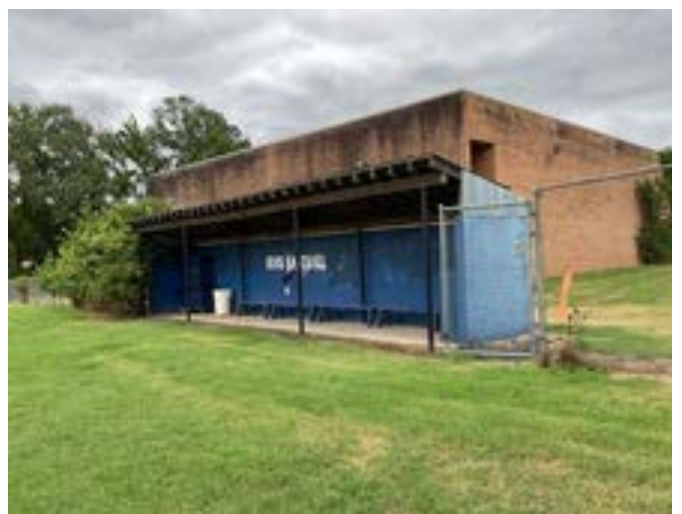
30 - DUGOUT

Site Information		
System	Description	Condition
Pavement/Flatwork	Asphalt lots with adjacent concrete sidewalks and curbs	Poor
Site Development	Property entrance signage; chain link fencing Playgrounds and sports fields and courts with bleachers, dugouts, fencing, and site lights Furnished with park benches, picnic tables, trash receptacles	Fair
Landscaping and Topography	Limited landscaping features including lawns, trees, bushes, and planters Irrigation not present Concrete walls Low to moderate site slopes throughout	Fair
Utilities	Municipal water and sewer Local utility-provided electric and natural gas	Good
Site Lighting	Pole-mounted: LED, metal halide Building-mounted: LED and HPS Pedestrian walkway and landscape accent lighting	Fair
Ancillary Structures	Dugouts	Poor
Accessibility	Presently it does not appear an accessibility study is needed for the exterior site areas. See Appendix D.	
Key Issues and Findings	Parking lot is mostly loose, gravel and potholes, sidewalks are cracked and aged, sports equipment and dugout are falling apart

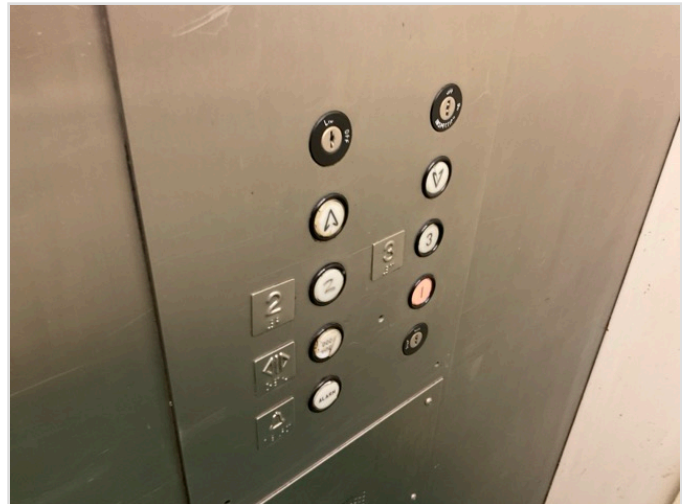
IN-CAB CONTROLS

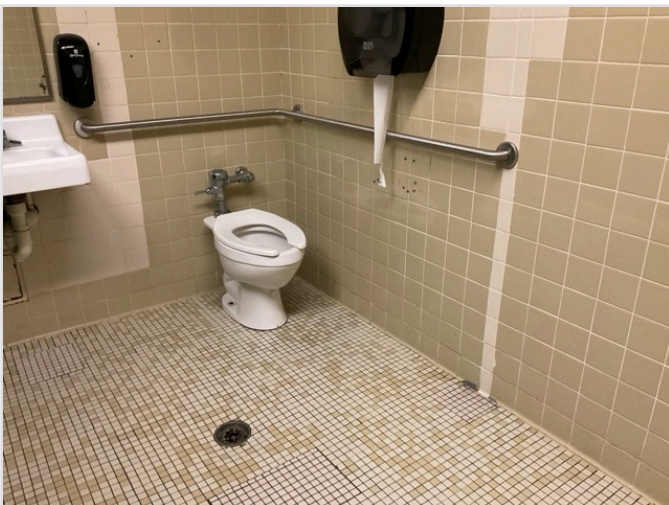
TOILET STALL OVERVIEW

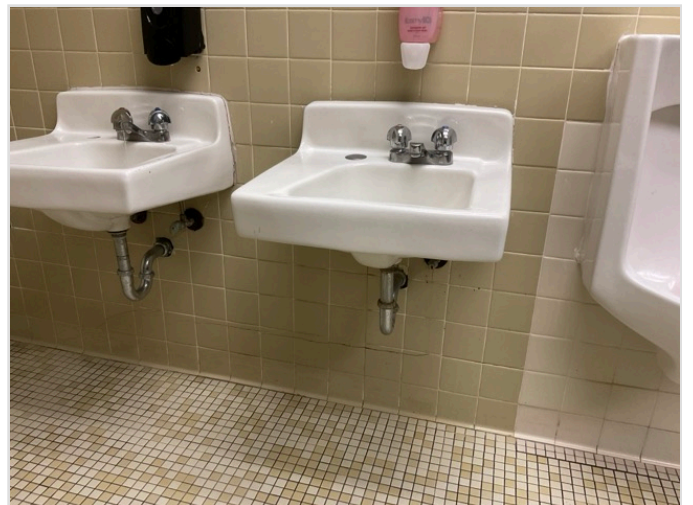
SINK, FAUCET HANDLES AND ACCESSORIES
