# 2010 FACILITIES ASSESSMENT GRAHAMWOOD ELEMENTARY

<b>Project Data</b>	
<b>Location Code:</b>	025
<b>Address:</b>	3950 Grahamwood
<b>Year Built:</b>	1950
<b>Grade Configuration:</b>	K-6
<b>Student Capacity:</b>	1080
<b>Ideal Capacity:</b>	1,041
<b>ADA Student Enrollment:</b>	0
<b>Size:</b>	18.47 acres
<b>Portables:</b>	8
<b>Building &amp; Addition</b>	77,156 s. f.

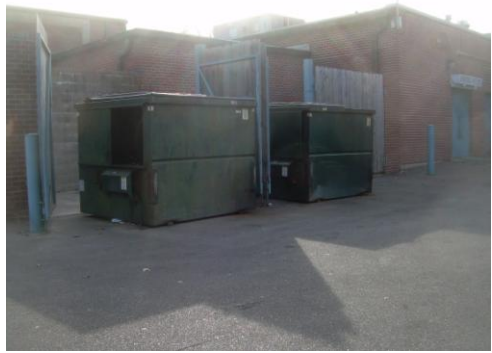
<p><b>Description:</b></p> <p>Dumpsters (2) needs enclosed</p>

<p><b>Timeline:</b></p> <p><b>TBD</b></p>	<p><b>Cost:</b></p> <p><b>\$10,000</b></p>

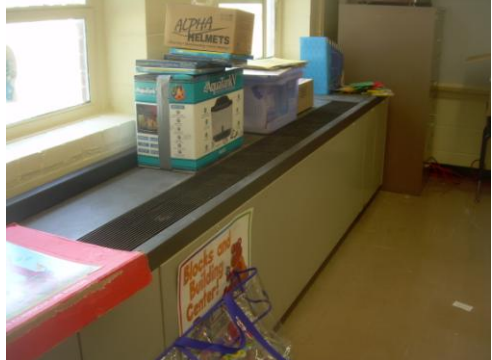
<p><b>Description:</b></p> <p>Self contained unit ventilators do not operate properly. History of costly maintenance issues.</p>

<p><b>Timeline:</b></p> <p><b>TBD</b></p>	<p><b>Cost:</b></p> <p><b>\$140,000</b></p>

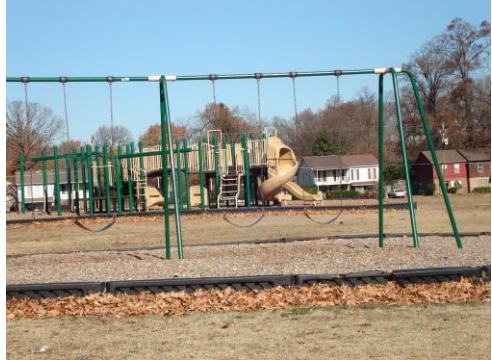
<p><b>Playground/Surfaces Equipment Status:</b></p> <p>Fully equipped Has woodchips w/ heavy plastic border surface.</p> <p><b>Playground Equipment / Surface Condition:</b></p> <p>New equipment, good Adequate, surface No fence enclosure</p>

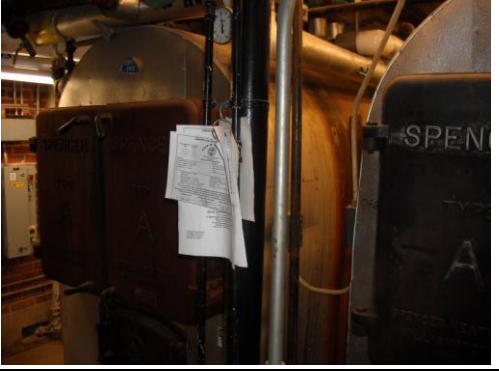
<p><b>Description:</b></p> <p>Replace 1970 annexed boiler</p>

<p><b>Timeline:</b></p> <p>2010-11</p>	<p><b>Cost:</b></p> <p>\$204,000</p>

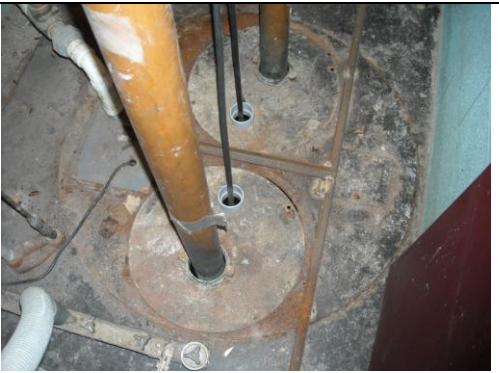
<p><b>Description:</b></p> <p>Replace main building sewer ejector pumps</p>

<p><b>Timeline:</b></p> <p>2009-10</p>	<p><b>Cost:</b></p> <p>\$25,000</p>

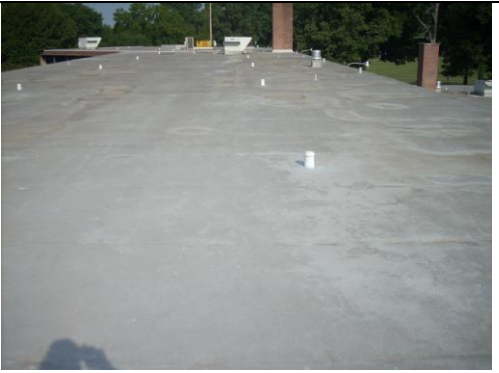
<p><b>Description:</b></p> <p>PVC Single Ply roof: 10 years-fair</p> <p>PVC Single ply roof: 8 years-fair</p>

<p><b>Timeline:</b></p> <p>TBD</p>	<p><b>Cost:</b></p> <p>\$246,000</p>

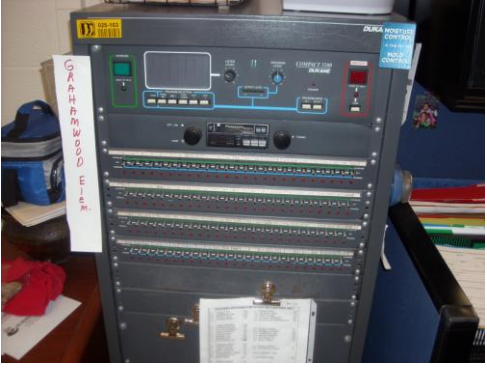
<p><b>Description:</b></p> <p>Intercom System:</p> <p>Dukane 3200</p> <p>Installation Date: 1994</p>

<p><b>Timeline:</b></p> <p>2011-12</p>	<p><b>Cost:</b></p> <p>\$50,000</p>
