2010 FACILITIES ASSESSMENT TREZEVANT HIGH SCHOOL

Project Data	
Location Code:	136
Address:	3350 Trezevant
Year Built:	1960
Grade Configuration:	9-12
Student Capacity:	1625
Ideal Capacity:	1,545
ADA Student Enrollment:	3
Size:	24.95 acres
Portables:	0
Building & additions	266,765 s. f.

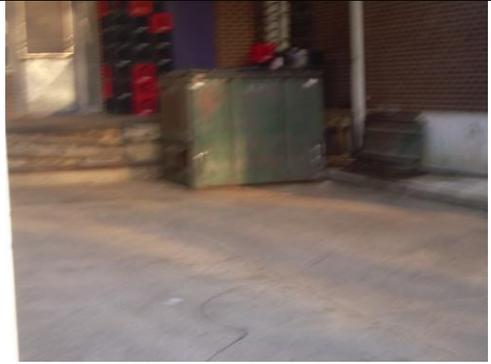
Description: Dumpster needs enclosed.

Timeline: TBD	Cost: \$5,000

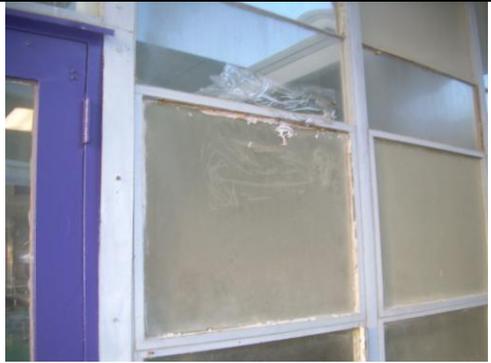
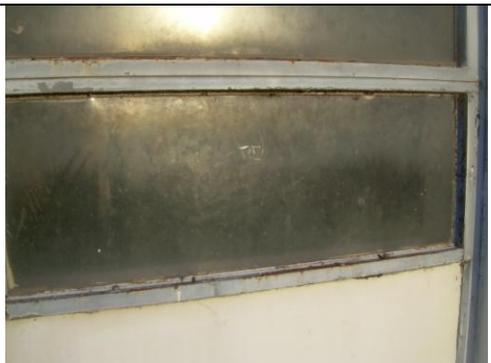
Description: Replace approximately (793) windows and storefront entrances

Description: See previous item.

Timeline: 2011-12	Cost: \$2,061,800

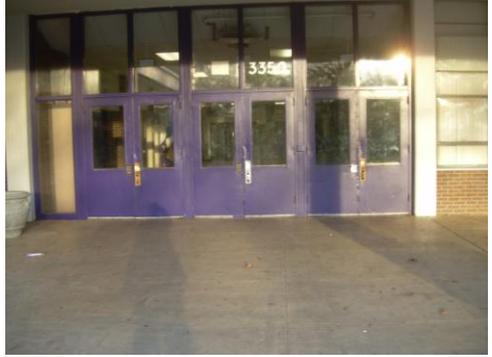
<p>Description:</p> <p>Store front doors and windows in poor condition.</p>

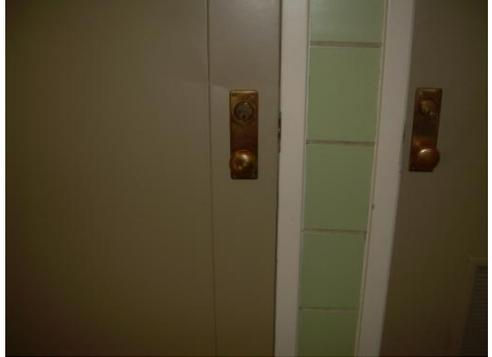
<p>Timeline:</p> <p>TBD</p>	<p>Cost:</p> <p>Included in window costs</p>
<p>Description:</p> <p>Upgrade to ADA guidelines.</p>

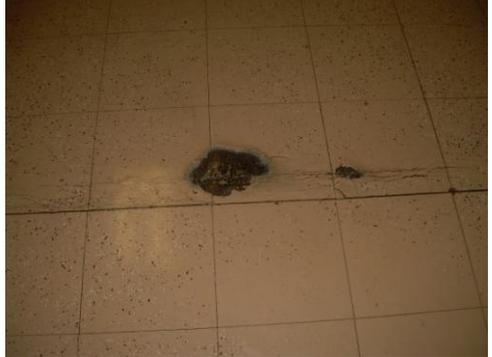
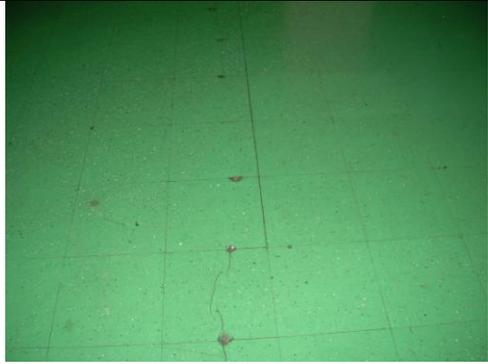
<p>Timeline:</p> <p>TBD</p>	<p>Cost:</p> <p>\$136,000</p>
<p>Description:</p> <p>Existing floor tile contains asbestos and is in poor condition.</p>

<p>Description:</p> <p>Same as previous item</p>

<p>Timeline:</p> <p>TBD</p>	<p>Cost:</p> <p>\$600,000</p>

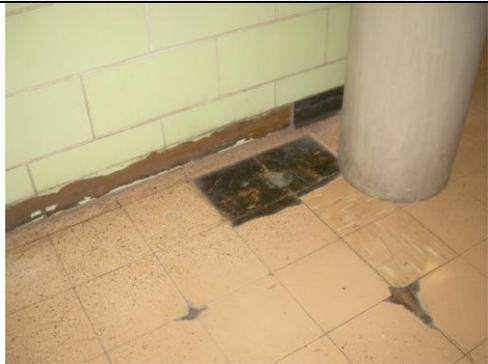
<p>Description:</p> <p>Existing floor and wall tile contain asbestos and is in poor condition.</p>

<p>Timeline:</p> <p>TBD</p>	<p>Cost:</p> <p>\$600,000</p>

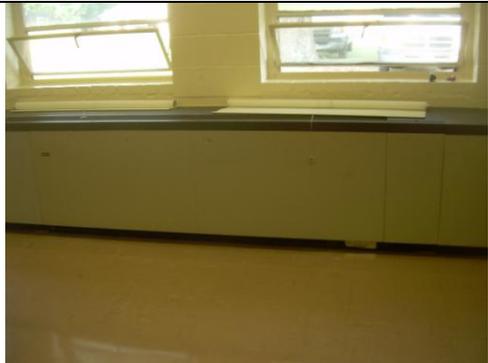
<p>Description:</p> <p>Self contained unit ventilators do not operate probably. History of costly maintenance issues.</p>

<p>Timeline:</p> <p>TBD</p>	<p>Cost:</p> <p>\$1,512,000</p>

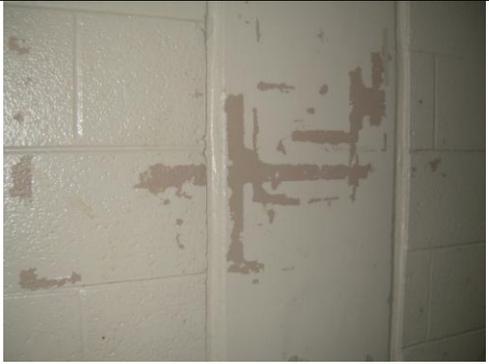
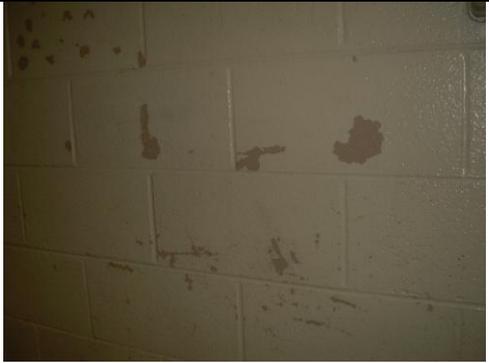
Description: Paint interior of building

Description: See previous item.

Timeline: 2011-12	Cost: \$485,700

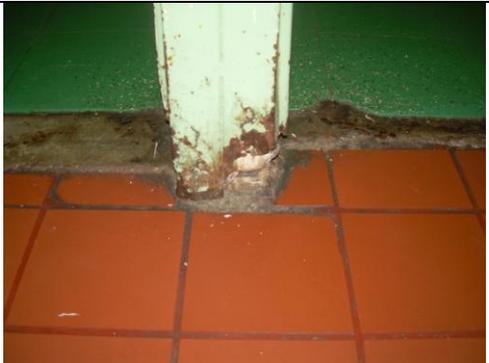
Description: Door frames in kitchen are rusting creating health department issues.

Timeline: TBD	Cost: \$4,700

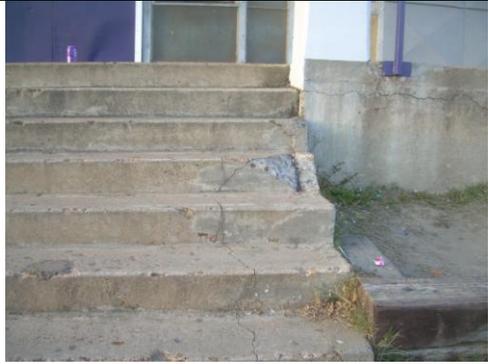
<p>Description:</p> <p>Exterior concrete steps do not have railings and are in poor condition.</p>

<p>Timeline:</p> <p>TBD</p>	<p>Cost:</p> <p>\$28,000</p>

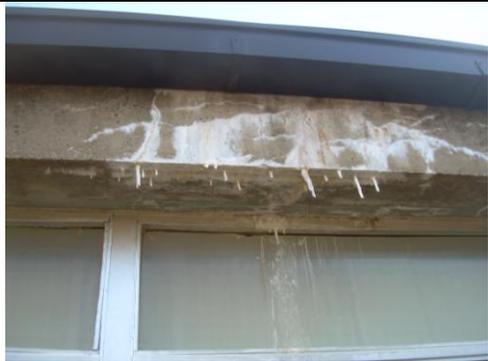
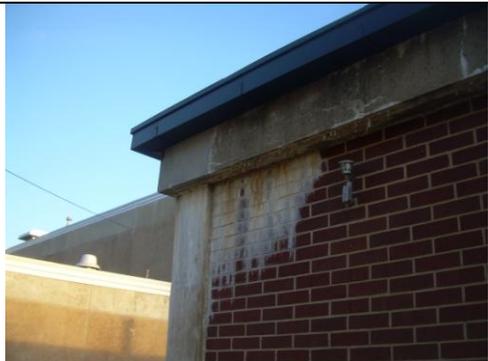
<p>Description:</p> <p>Calcium carbon.</p>

<p>Description:</p> <p>See previous item.</p>

1. The corridor is a 2-story concreted column-beam and floor structure freely standing between 2 main portions of the building and separated from both buildings with expansion joints. The corridor is also located between two courtyards.
2. The frame is in-filled with stud wall with brick fascia.
3. The concrete beams which serve as support for the corridor floor, lintel and bracing are cracked at several places. The concrete has fallen off at many places and the exposed reinforcement is corroded on both sides of the corridor.

<p>Remedy:</p> <p>See structural report.</p>

- In my opinion, the cracking and spalling of concrete has occurred due to insufficient concrete cover of the reinforcement. As the corridor is not carrying any major service loads and is completely independent, it is structurally sufficient to withstand the present service loads. However, to prevent any further deterioration of the beam, it is recommended that the exposed reinforcement be coated and covered with cement mortar.

Total cost for structural recommendations is \$80,000.

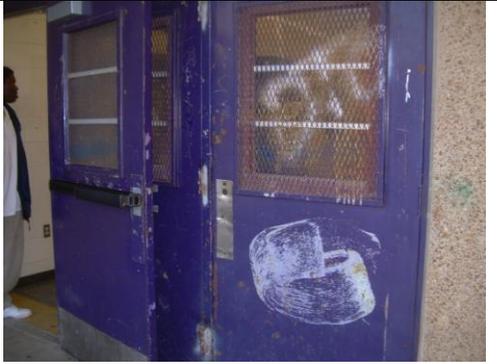
Description: Exterior doors throughout campus are in bad condition.

Timeline: TBD	Cost: \$48,000

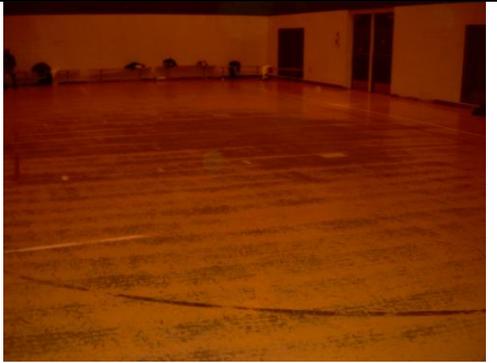
Description: Existing gym floor in poor condition, it has met its life expectancy. "New" gym, rubber floor.

Timeline: TBD	Cost: \$156,000

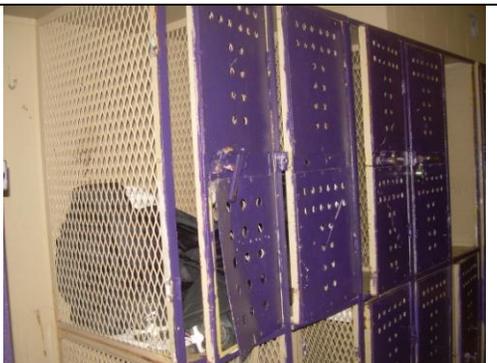
Description: Lockers in "new" school gym are in poor condition and need repairing.

Timeline: TBD	Cost: \$10,000

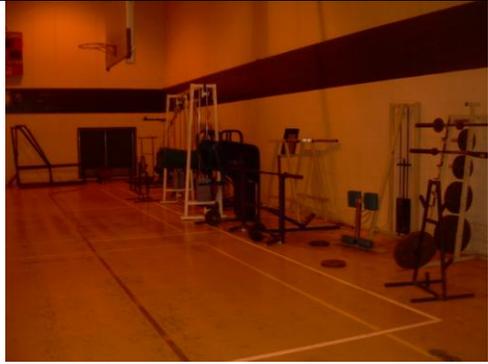
<p>Description:</p> <p>No weight room on campus. Weights are located in “new” gym creating safety issues, etc.</p>

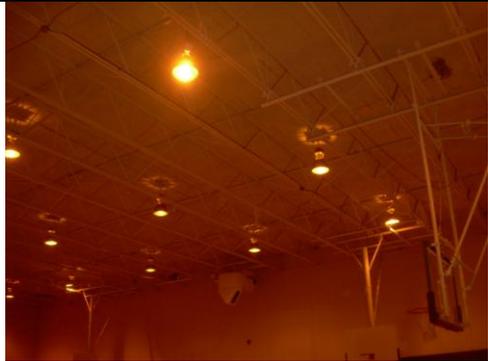
<p>Description:</p> <p>Replace gymnasium lighting</p>

<p>Timeline:</p> <p>2011-12</p>	<p>Cost:</p> <p>\$38,800</p>

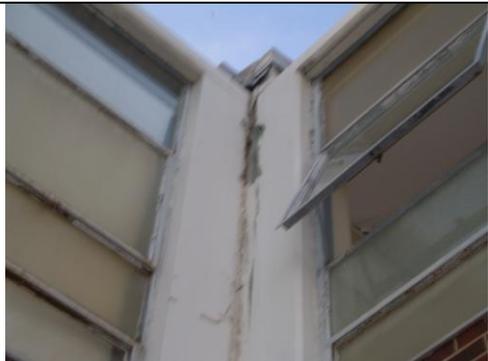
<p>Description:</p> <p>See structural report.</p>

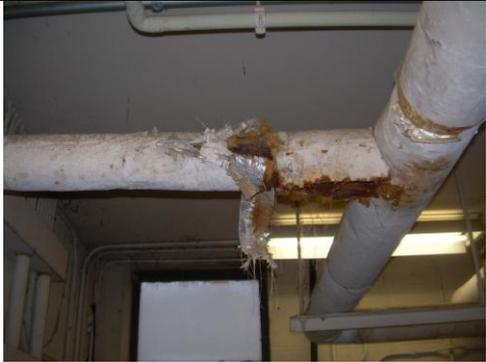
<p>Description:</p> <p>Non-asbestos pipe insulation in damaged in several locations.</p>

<p>Timeline:</p> <p>TBD</p>	<p>Cost:</p> <p>\$4,000</p>

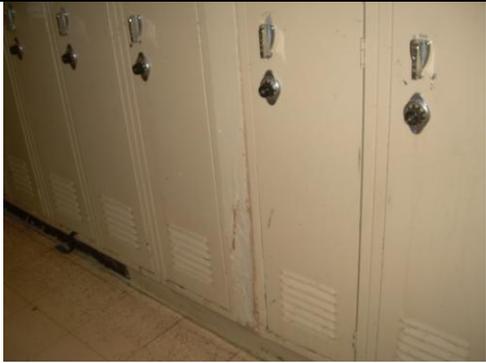
<p>Description:</p> <p>Wood expansions between lockers have deteriorated.</p>

<p>Remedy:</p> <p>Replace wood expansions.</p>	<p>Cost: \$3,000</p> <p>Priority: III</p>

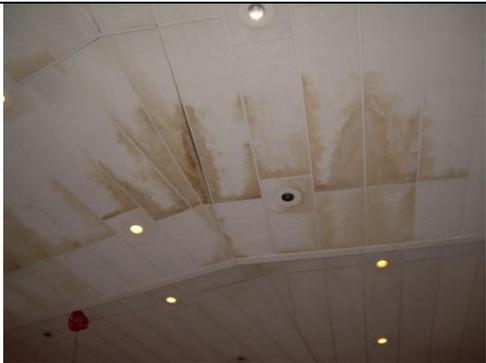
<p>Description:</p> <p>Auditorium ceiling tile has mold forming causing potential health concerns.</p>

<p>Timeline:</p> <p>TBD</p>	<p>Cost:</p> <p>\$60,000</p>

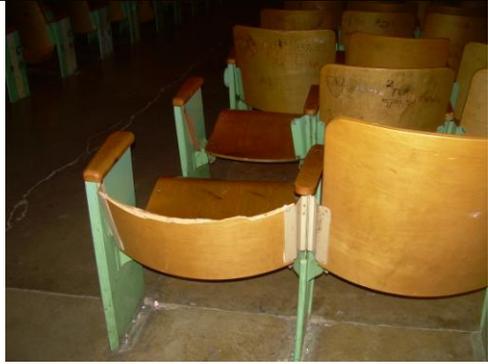
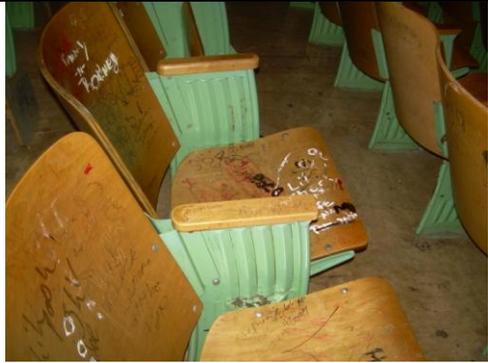
<p>Description:</p> <p>Auditorium chairs in very poor condition, seats broken etc.</p>

<p>Description:</p> <p>See previous item.</p>

<p>Timeline:</p> <p>TBD</p>	<p>Cost:</p> <p>\$80,000</p>

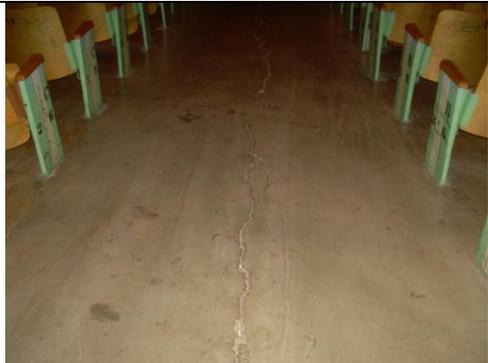
<p>Description:</p> <p>Auditorium has no runners which can cause a slipping hazard.</p>

<p>Timeline:</p> <p>TBD</p>	<p>Cost:</p> <p>\$18,000</p>

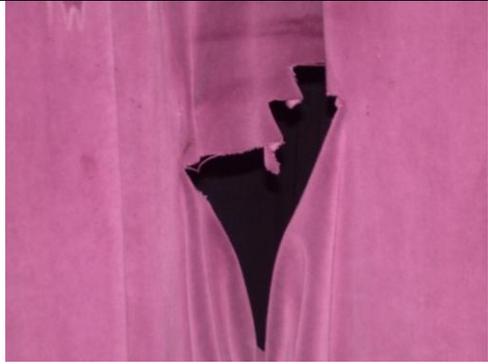
<p>Description:</p> <p>Stage curtains torn and need repairing.</p>

<p>Timeline:</p> <p>TBD</p>	<p>Cost:</p> <p>\$35,000</p>

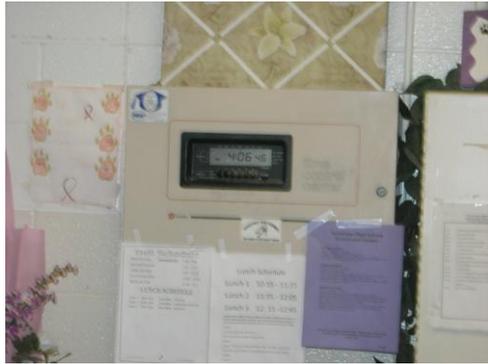
<p>Description:</p> <p>Replace Clocks and Bells</p>

<p>Timeline:</p> <p>TBD</p>	<p>Cost:</p> <p>\$25,000</p>

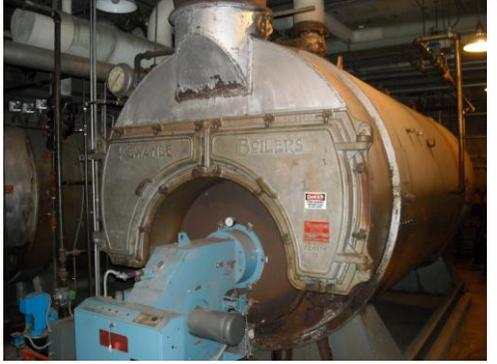
Description: Replace (2) boilers, pumps, HVAC piping and (88) FCU

Timeline: 2011-12	Cost: \$3,120,000

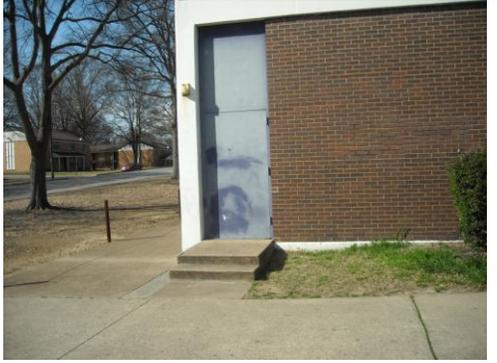
Description: Pressure wash and paint exterior

Timeline: 2010-11	Cost: \$183,600

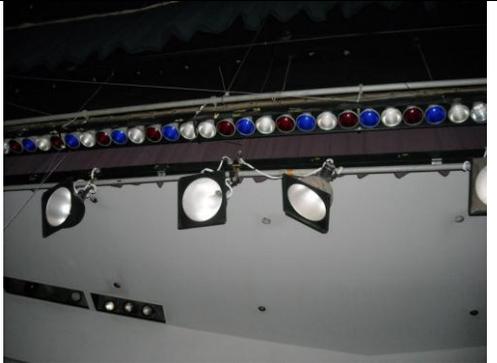
Description: Replace auditorium house lighting

Timeline: 2011-12	Cost: \$49,000

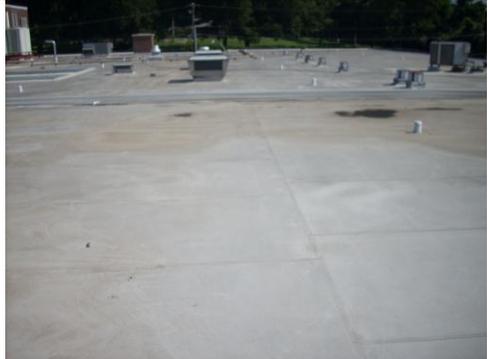
<p>Description:</p> <p>PVC Single Ply roof: 8 years-fair</p>

<p>Timeline:</p> <p>TBD</p>	<p>Cost:</p> <p>\$833,550</p>

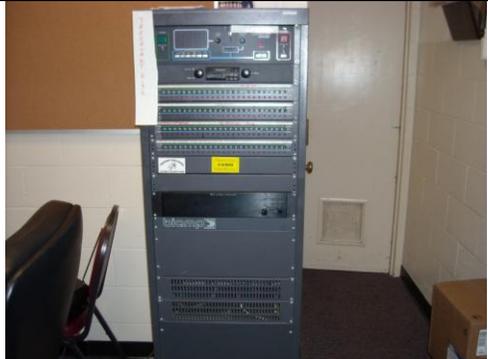
<p>Description:</p> <p>Intercom System:</p> <p>Dukane 3200</p> <p>Installed Date: 1994</p>

<p>Timeline:</p> <p>TBD</p>	<p>Cost:</p> <p>\$90,000</p>
