2010 FACILITIES ASSESSMENT HAVENVIEW MIDDLE

Project Data	
Location Code:	204
Address:	1481 Hester Road
Year Built:	1958
Grade Configuration:	6-8
Student Capacity:	1100
Ideal Capacity:	876
ADA Student Enrollment:	0
Size:	16.28 Acres
Portables:	0
Building & additions	103,702 s. f.

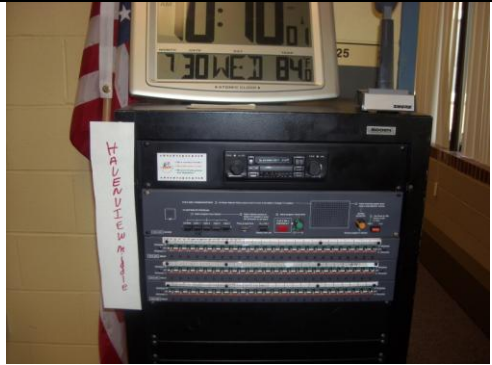
A white metal cabinet mounted on a wall. The top label reads "Master Time Programmer 1400". Below the label is a digital display showing "1:00" and "43". At the bottom right, there is a "STANDARD" logo.
<p>Timeline:</p> <p>2016-17</p>	<p>Cost:</p> <p>\$38,000</p>
<p>Description:</p> <p>Intercom System:</p> <p>Rauland MCZ300</p> <p>Installation Date: 2001</p>
