2010 FACILITIES ASSESSMENT SEA ISLE ELEMENTARY

Location Code:	053
Address:	5250 Sea Isle
Year Built:	1955
Grade Configuration:	K-5
Student Capacity:	680
Ideal Capacity:	764
ADA Student Enrollment:	0
Size:	32.94 acres
Portables:	0
Building & Additions:	79,703 s. f.

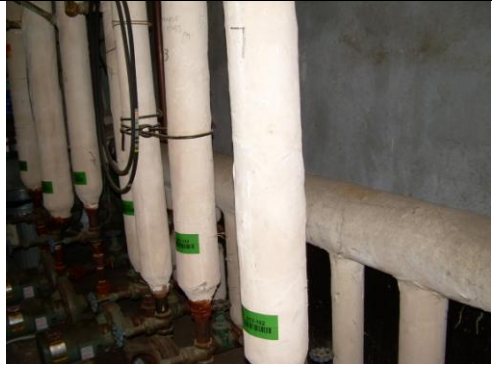
Description: Boiler room has excessive amount of asbestos insulating materials including the boiler insulation, as well as on piping- All in very poor condition.

<p>Description:</p> <p>See previous item.</p>
