# 2010 FACILITIES ASSESSMENT OVERTON HIGH SCHOOL

Project Data	
<b>Address:</b>	1770 Lanier Rd 38117
<b>Year Built:</b>	Original Building 1959
<b>Grade Configuration:</b>	9-12
<b>Student Capacity:</b>	1575
<b>Ideal Capacity:</b>	1,567
<b>ADA Student Enrollment:</b>	0
<b>Size:</b>	16.01 acres Campus/ 65 Classrooms
<b>Portables:</b>	None
<b>Building &amp; Additions:</b>	177,940 s. f.

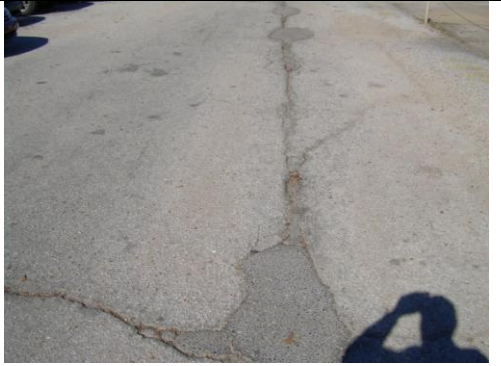
<b>Description:</b>  Existing parking area in poor condition

<b>Timeline:</b>  TBD	<b>Cost:</b>  \$140,000

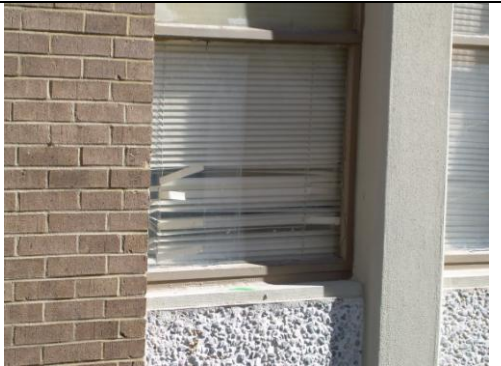
<b>Description:</b>  Replace approximately (487) windows

<b>Timeline:</b>  2015-16	<b>Cost:</b>  \$1,364,000

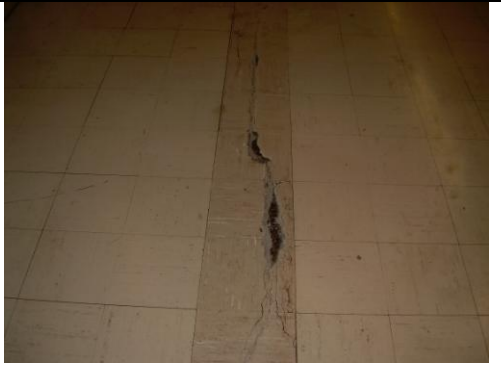
<b>Description:</b> Existing floor tile contains Asbestos and is damaged in several areas of school.

<b>Timeline:</b>  <b>TBD</b>	<b>Cost:</b>  <b>\$375,000</b>

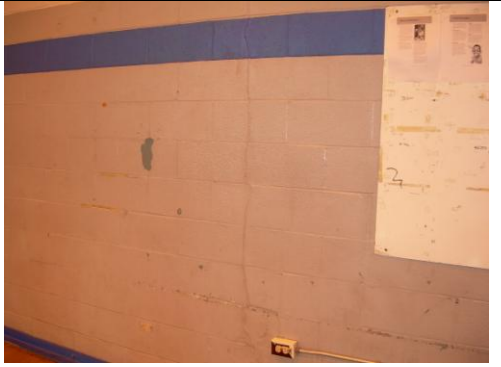
<b>Description:</b>  Paint interior of building

<b>Timeline:</b>  2010-11.	<b>Cost:</b>  \$263,400

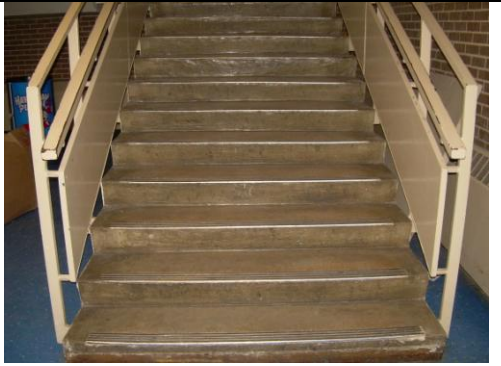
<b>Description:</b>  Stairwell treads have lost their integrity.

<b>Timeline:</b>  TBD	<b>Cost:</b>  \$17,000

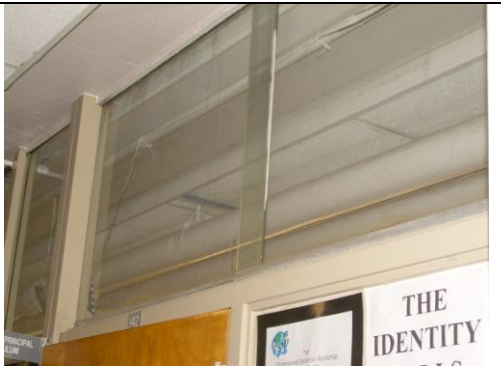
<b>Description:</b>  Transom windows do not provide code required 1 hour fire rating of compliance.

<b>Timeline:</b>  TBD	<b>Cost:</b>  \$20,000

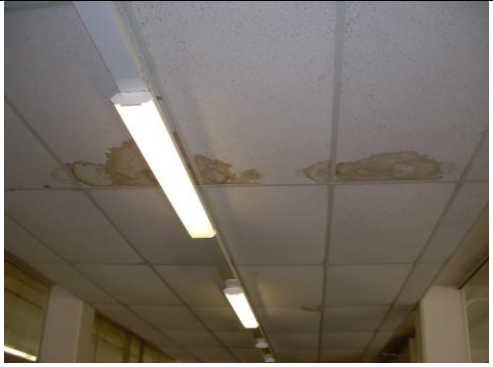
<b>Description:</b>  Lay-in ceiling tile in poor condition, apparent mold growth and causes potential health concerns.

<b>Timeline:</b>  TBD	<b>Cost:</b>  \$40,000

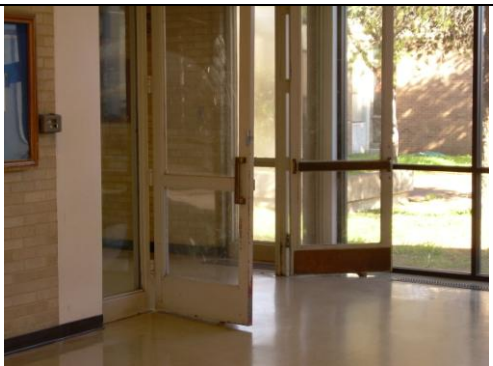
<b>Description:</b>  Store front doors and windows are in poor condition.

<b>Timeline:</b>  TBD	<b>Cost:</b>  \$60,000

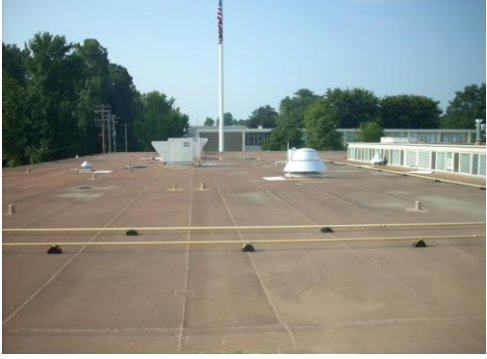
<p><b>Description:</b></p> <p>PVC Single ply roof: 13 years-fair</p> <p>PVC single ply gym roof: 2 years-good</p> <p>PVC Single ply High part of Aud roof: 8 years-fair</p>

<p><b>Timeline:</b></p> <p><b>TBD</b></p>	<p><b>Cost:</b></p> <p><b>\$803,170</b></p>

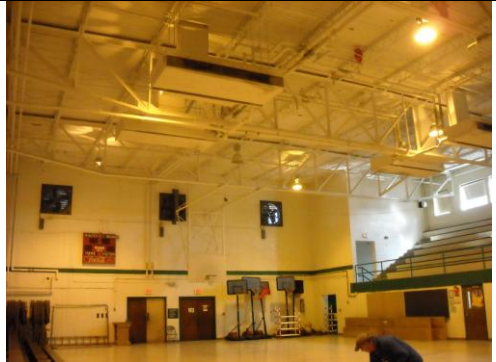
<p><b>Description:</b></p> <p>Replace gymnasium lighting</p>

<p><b>Timeline:</b></p> <p>2011-12</p>	<p><b>Cost:</b></p> <p>\$36,400</p>

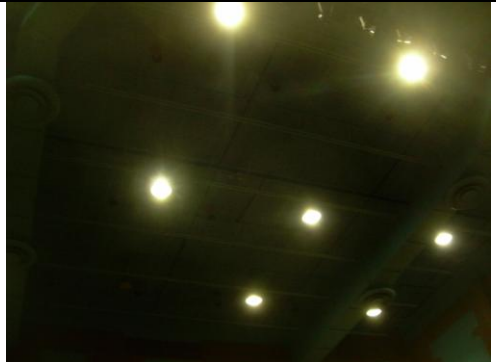
<p><b>Description:</b></p> <p>Replace auditorium house lighting</p>

<p><b>Timeline:</b></p> <p>2010-11</p>	<p><b>Cost:</b></p> <p>\$48,000</p>

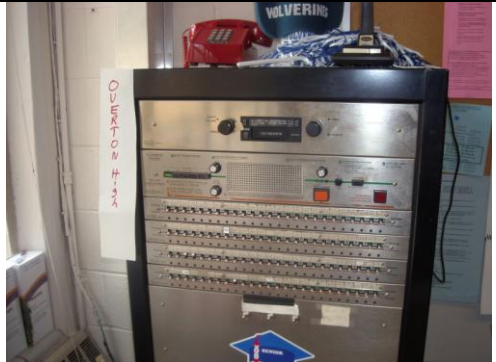
<p><b>Description:</b></p> <p>Intercom System: Rauland MC12000 Installation Date: 1987</p>

<p><b>Timeline:</b></p> <p>2011-12</p>	<p><b>Cost:</b></p> <p>\$90,000</p>
