2010 FACILITIES ASSESSMENT
GEORGIAN HILLS ELEMENTARY

| Project Data | |
| Location Code: | 023 |
| Address: | 3930 Leweir |

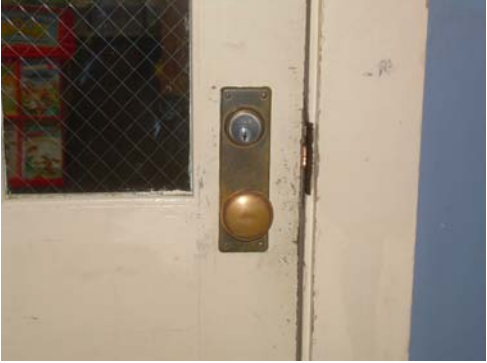
| <p>Description:</p> <p>Upgrade to ADA guidelines</p> | |

| <p>Timeline:</p> <p>TBD</p> | <p>Cost:</p> <p>Cost: \$60,000</p> |

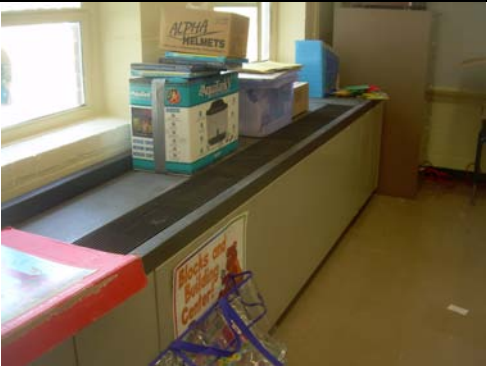
| <p>Description:</p> <p>Self contained unit ventilators do not operate properly. History of costly maintenance issues.</p> | |

| <p>Timeline:</p> <p>TBD</p> | <p>Cost:</p> <p>\$952,000</p> |

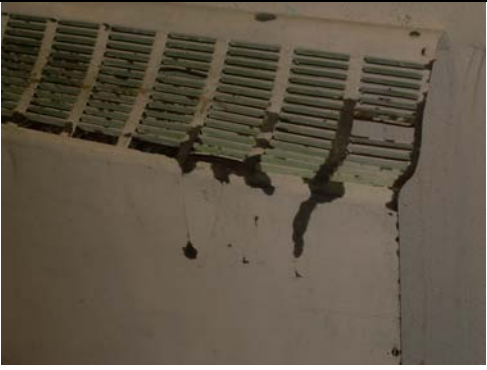
| <p>Description:</p> <p>Hallway radiator is damaged and in overall poor condition.</p> | |

| <p>Timeline:</p> <p>TBD</p> | <p>Cost:</p> <p>\$2,000</p> |

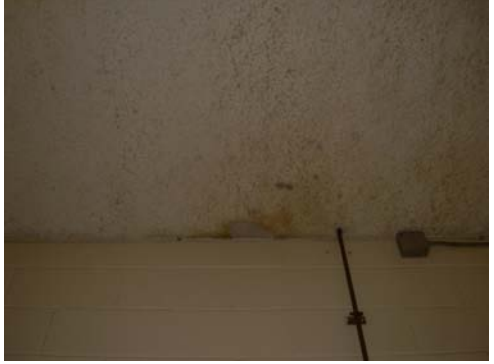
| Description: Non-asbestos spray applied ceiling in cafeteria is filthy and carries potential health hazards. | |

| Timeline: TBD | Cost: \$61,000 |

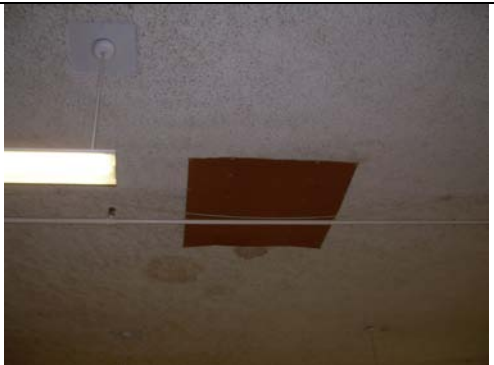
| Description: Non-Asbestos spray applied ceiling in southeast annex is filthy and carries potential health hazards. | |

| Timeline: TBD | Cost: \$8,000 |

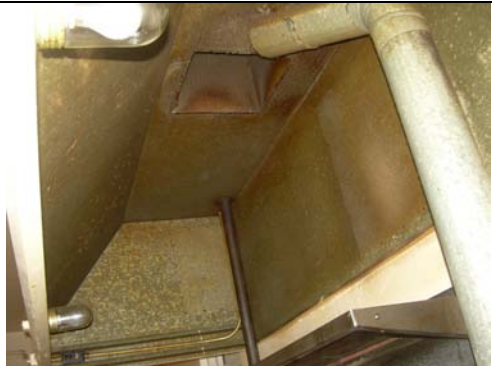
| <p>Description:</p> <p>Kitchen vent hood has no fire suppression system.</p> | |

| <p>Timeline:</p> <p>TBD</p> | <p>Cost:</p> <p>\$4,500</p> |

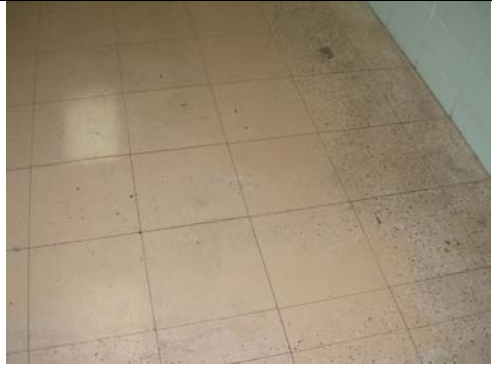
| <p>Description:</p> <p>Existing floor tile contains asbestos and is poor condition.</p> | |

| <p>Timeline:</p> <p>TBD</p> | <p>Cost:</p> <p>\$95,000</p> |

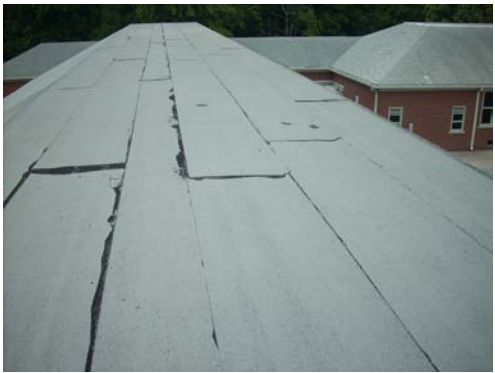
| <p>Description:</p> <p>Shingled roof: 15 years-poor</p> <p>Built up Modified roof: 15 years-poor</p> | |

| <p>Timeline:</p> <p>TBD</p> | <p>Cost:</p> <p>\$240,000</p> |

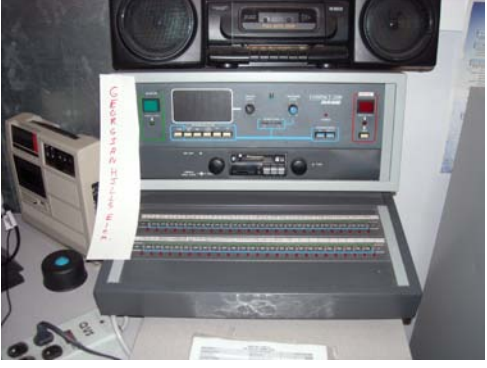
| <p>Description:</p> <p>Intercom System:</p> <p>Dukane 3200</p> <p>Installation Date: 1995</p> | |

| <p>Timeline:</p> <p>TBD</p> | <p>Cost:</p> <p>\$50,000</p> |
