2010 FACILITIES ASSESSMENT RIVERVIEW ELEMENTARY

Project Data

Location Code:	051
Address:	260 Joubert
Year Built:	1952
Grade Configuration:	K-5
Student Capacity:	840
Ideal Capacity:	690
ADA Student Enrollment:	0
Size:	12.62 acres share with Riverview Middle
Portables:	0
Building & Addition	69,422 s. f.

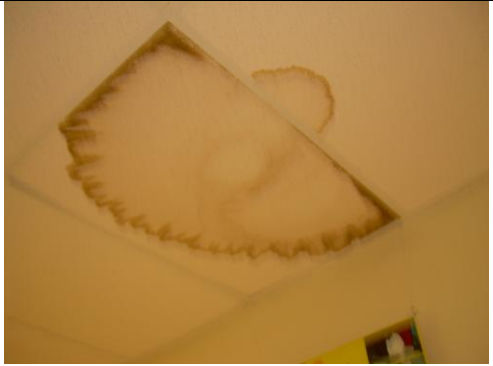
Description: Some lay-in ceiling tile has water damage.

Timeline: TBD	Cost: \$3,000

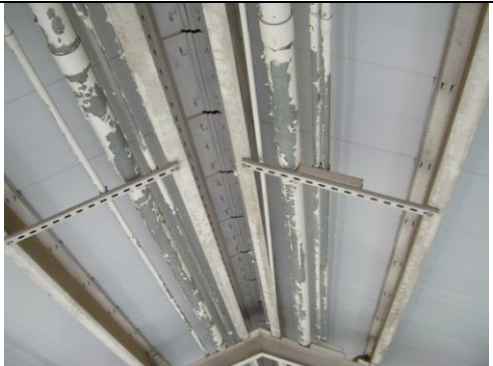
Description: Covered walkway ceiling paint is in poor condition

Timeline: TBD	Cost: \$6,000

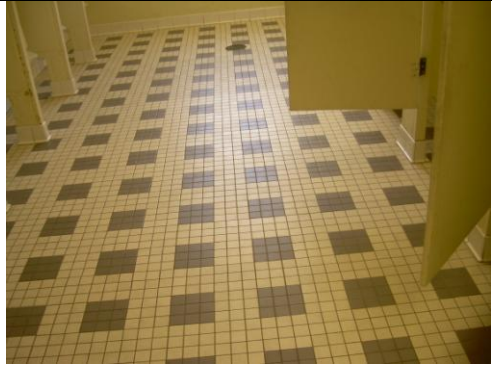
<p>Description:</p> <p>Restroom does not have a floor drain.</p>

<p>Timeline:</p> <p>TBD</p>	<p>Cost:</p> <p>\$2,000</p>
<p>Playground/Surfaces Equipment Status:</p> <p>Fully equipped Has cast in place rubber surface</p>

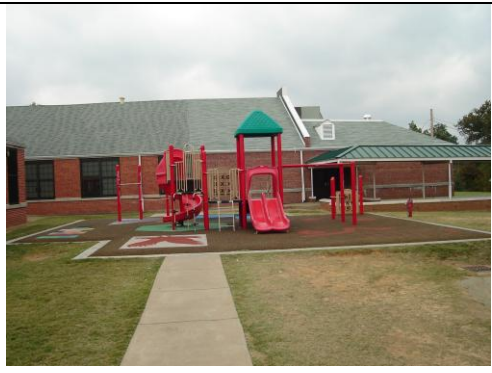
<p>Playground Equipment / Surface Condition:</p> <p>Good equipment Good surface Courtyard not enclosed</p>

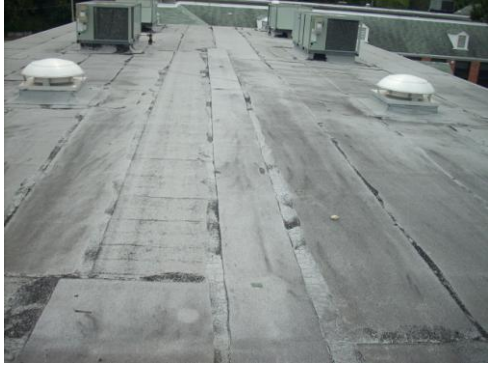
<p>Description:</p> <p>Built up roof: 16 years-poor</p> <p>Built up modified roof: 15 years-poor</p> <p>Shingled roof: 16 years-poor</p> <p>Metal roof: 15 years-fair</p>

<p>Timeline:</p> <p>TBD</p>	<p>Cost:</p> <p>\$299,100</p>

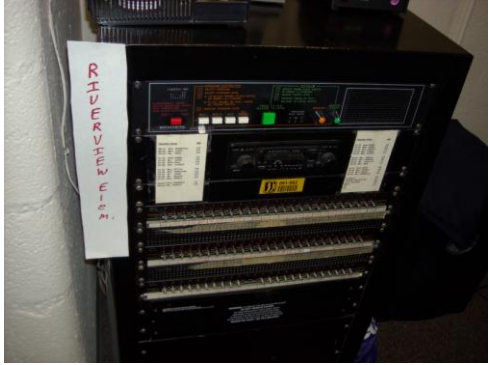
<p>Description:</p> <p>Intercom System:</p> <p>Bogen MCP35A</p> <p>Installation Date: 1995</p>

<p>Timeline:</p> <p>TBD</p>	<p>Costs:</p> <p>\$50,000</p>
